**SERIOUS INCIDENT**

<b>Aircraft Type and Registration:</b>	Piper J3C-65 Cub, G-CGIY	
<b>No &amp; Type of Engines:</b>	1 Continental Motors Corp C90-12F piston engine	
<b>Year of Manufacture:</b>	1943 (Serial no: 11535)	
<b>Date &amp; Time (UTC):</b>	12 May 2018 at 1300 hrs	
<b>Location:</b>	En route from Gamston Airport to Leeds East Airport	
<b>Type of Flight:</b>	Private	
<b>Persons on Board:</b>	Crew - 1	Passengers - None
<b>Injuries:</b>	Crew - None	Passengers - N/A
<b>Nature of Damage:</b>	Upper rudder hinge pin missing, lower hinge lugs distorted and elevator ribs damaged	
<b>Commander's Licence:</b>	Commercial Pilot's Licence	
<b>Commander's Age:</b>	71 years	
<b>Commander's Flying Experience:</b>	7,870 hours (of which 136 were on type) Last 90 days - 108 hours Last 28 days - 55 hours	
<b>Information Source:</b>	Aircraft Accident Report Form submitted by the pilot and inquiries made by the AAIB

**Synopsis**

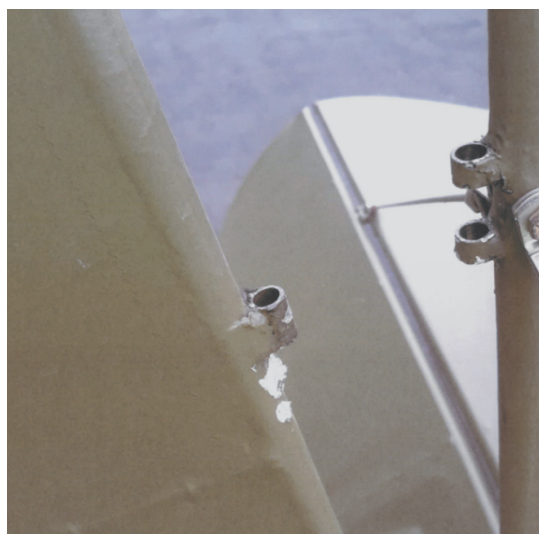
**Figure 2**

On inspection the pilot found that the rudder upper hinge pin and bearings were missing and the lower hinge lug (cylindrical portion through which the pivot pin passes) had detached from the leading edge of the rudder. The rudder was therefore held in position only by its control cables attached to the left and right control horns. There was distortion to the inboard edge frame of both elevators adjacent to the rudder. Despite this, the elevators functioned correctly, albeit with some restriction and an increased stick loading. Figure 1 is a general view of the aircraft and Figures 2 and 3 show the condition of the rudder upper hinge and elevators.

Upper rudder hinge separation, pin and bushes missing

It is likely that the upper hinge had been assembled in the same way. However, the diameter of the pivot pin head is slightly less than that of the outer diameter of the bushes. Without the upper washer there would be nothing to stop the pin and bushes 'working' out of the rudder hinge as appears to have happened in this case.

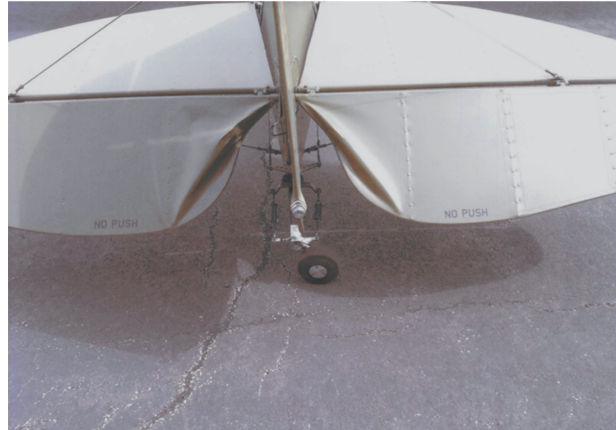
**Figure 3**

Damage caused to the elevator inboard edge frames

The damage to the elevator shows the rudder had been oscillating in the aircraft slipstream, hence the pilot describing how he had to physically restrain the rudder pedals from moving back and forth. Without the upper hinge support, the oscillation overloaded the lower hinge lug and caused it to part from the rudder leading edge frame. This left the rudder attached to the aircraft by its two control cables only. In this unusual state the rudder was not able to provide yaw control effectively. There was also a risk that the elevator could have been jammed by the loose rudder and pitch control lost as a result.

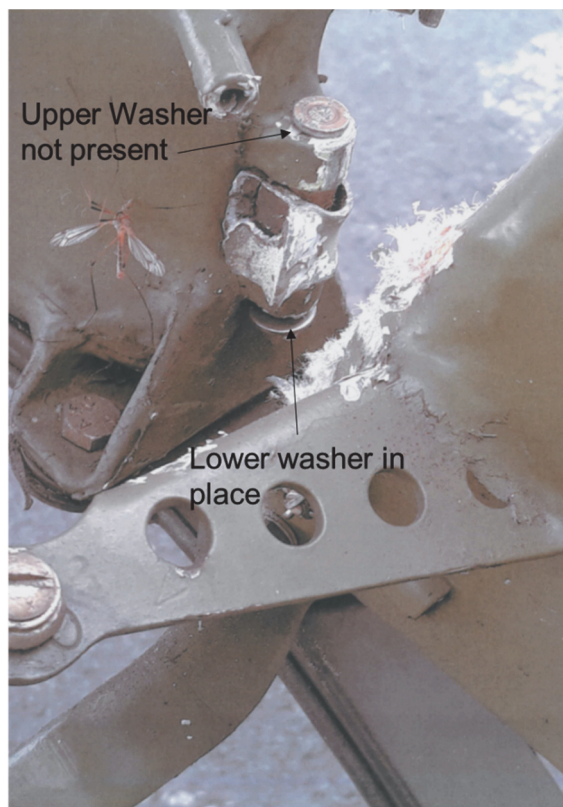
**Figure 4**

Despite the damage to the lower hinge, the pin and bushes remained in place and it appears that there was no washer fitted directly under the head of the pivot pin. However, there was a correctly fitted washer at the lower end of the pin above the split pin as shown in Figure 4.

Lower rudder hinge assembly
