SERIOUS INCIDENT

Aircraft Type and Registration:	DHC-8-402 Dash 8, G-ECOE	
No & Type of Engines:	2 Pratt & Whitney Canada PW150A turboprop engines	
Year of Manufacture:	2008 (Serial no: 4212)	
Date & Time (UTC):	11 January 2018 at 1632 hrs	
Location:	Belfast City Airport	
Type of Flight:	Commercial Air Transport (Passenger)	
Persons on Board:	Crew - 4	Passengers - 44
Injuries:	Crew - None	Passengers - None
Nature of Damage:	None	
Commander's Licence:	Airline Transport Pilot's Licence	
Commander's Age:	60 years	
Commander's Flying Experience:	14,122 hours (of which 464 were on type) Last 90 days - 91 hours Last 28 days - 39 hours	
Information Source:	AAIB Field Investigation

Synopsis

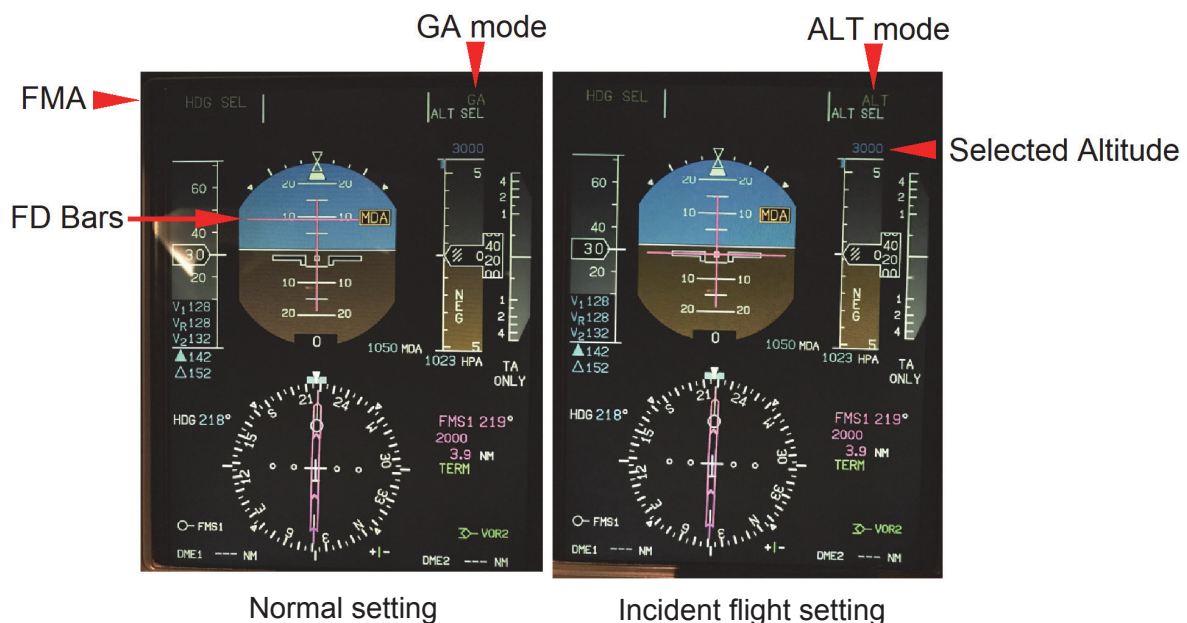
If the HDG, ALT SEL and ALT modes are selected on the ground, subsequently as the aircraft climbs after takeoff above the target altitude, the FD vertical guidance bar will progressively move to a nose-down pitch attitude. Upon engagement of the autopilot, the aircraft will pitch down to follow the FD vertical guidance bar to descend to the target altitude. For this incident this target altitude would have been set to about 0 ft amsl.

Figure 2 shows the FMA and FD vertical bar positions displayed on the PFD when the FD modes are selected in accordance with the operator's procedures prior to takeoff (GA, HDG and ALT SEL) and those selected during the incident takeoff (HDG, ALT SEL and ALT). Other than the FMA indicating that the ALT mode has been armed on the ground, there are no other indications to identify that the target altitude has been set to the airfield elevation amsl.

PFD indications when GA, HDG and ALT SEL (left PFD) and HDG, ALT SEL and ALT (right PFD) are selected for takeoff

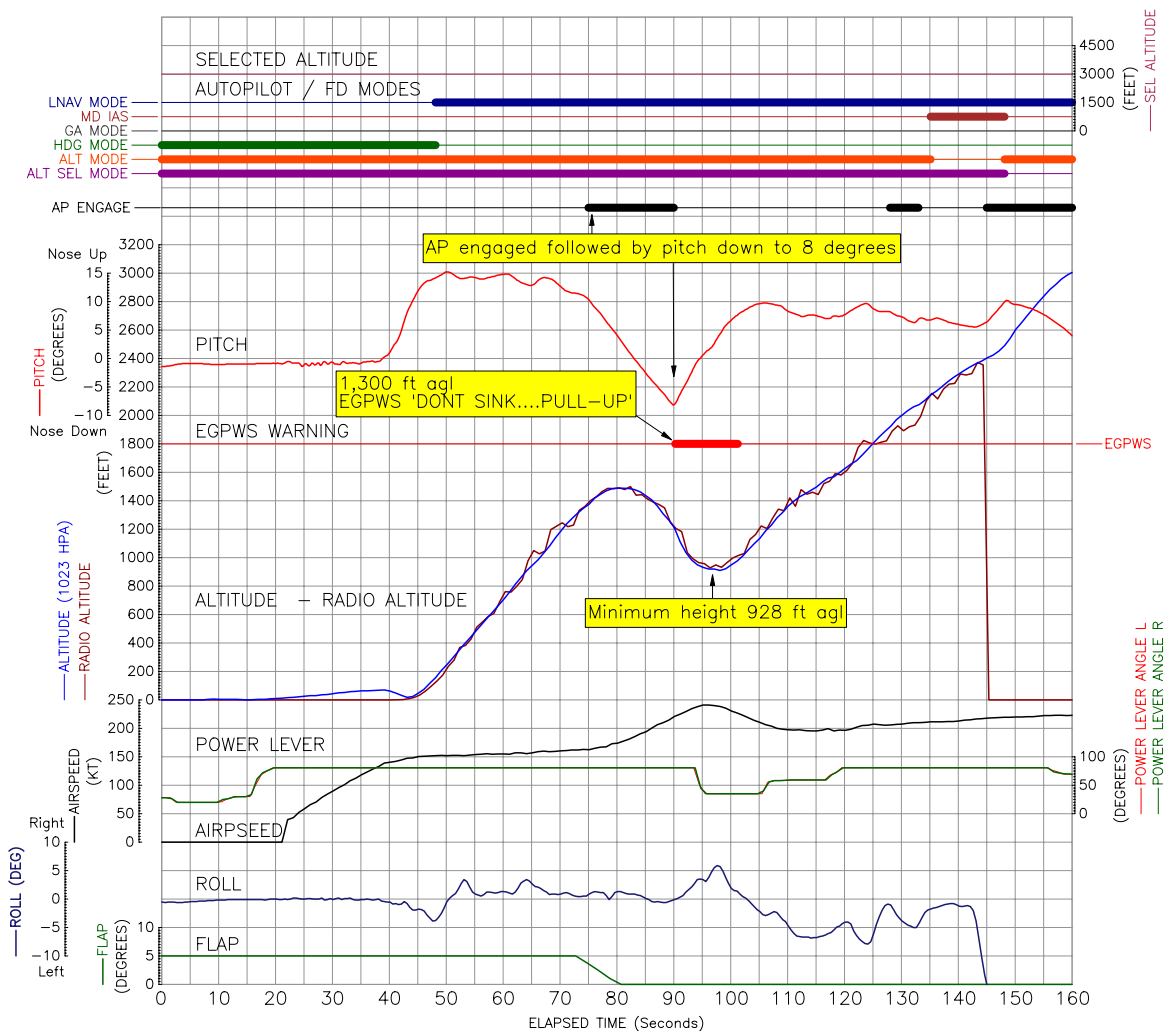
After reaching the acceleration altitude (1,000 ft aal) the flaps were retracted, which was shortly followed by the autopilot being engaged. The aircraft was now in IMC and at a height of 1,350 ft agl and its airspeed was 163 KIAS. Following the autopilot engagement the aircraft started to gradually pitch nose-down at a rate of about 1.2° per second from a height of 1,500 ft agl. During the next 15 seconds, whilst the crew were completing the 'after takeoff' checklist, the aircraft descended at an increasing rate with the pitch attitude reducing from about 10° nose-up, to 8° nose-down.

At a height of about 1,300 ft agl, an EGPWS Mode3² "DON'T SINK" caution was activated. The commander responded almost immediately, disconnected the autopilot and applied nose-up pitch to arrest the rate of descent, which had reached a maximum of 4,300 ft/min. Engine power was also simultaneously reduced, with the airspeed having increased to 235 KIAS. The aircraft continued to descend for a few more seconds, during which a EGPWS "PULL UP" warning was triggered. The aircraft then transitioned to a climb, having reached a minimum height of 928 ft agl and a maximum airspeed of 241 KIAS (V_{MO} ³ below 8,000 ft amsl is 245 KIAS); the crew subsequently reported that they had become visual with the ground during the recovery.

Figure 3
Descent following autopilot engagement
