**ACCIDENT**

<b>Aircraft Type and Registration:</b>	Skyranger Nynja 912s(1), G-CGWL	
<b>No &amp; Type of Engines:</b>	1 Rotax 912ULS piston engine	
<b>Year of Manufacture:</b>	2011 (Serial no: BMAA/HB/601)	
<b>Date &amp; Time (UTC):</b>	9 December 2017 at 1233 hrs	
<b>Location:</b>	Plaistow Farm Airfield, Hertfordshire	
<b>Type of Flight:</b>	Training	
<b>Persons on Board:</b>	Crew - 1	Passengers - None
<b>Injuries:</b>	Crew - 1 (Fatal)	Passengers - N/A
<b>Nature of Damage:</b>	Aircraft destroyed	
<b>Commander's Licence:</b>	Student Pilot	
<b>Commander's Age:</b>	58	
<b>Commander's Flying Experience:</b>	39 hours (of which 28 were on type) Last 90 days - 10 hours Last 28 days - 4 hours	
<b>Information Source:</b>	AAIB Field Investigation

**Synopsis**

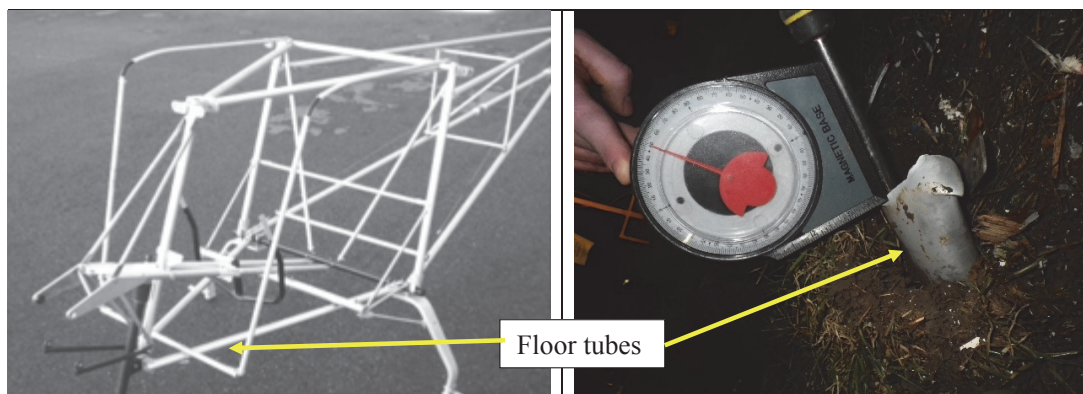
**Figure 1**

From the impact marks, it was established that the aircraft struck the ground on a heading of 140° (M). Both wings were level and there was no evidence of the aircraft rotating or spinning. The aircraft structural tubes supporting the engine mountings had failed during the impact and the floor tubes had been driven into the ground at an angle of 50° to the horizon (Figure1). There was a significant amount of oil in the area of the engine and two of the three propeller blades had broken off and were lying next to the hub. There was also a strong smell of fuel in and around the aircraft.

Floor tubes driven into the ground

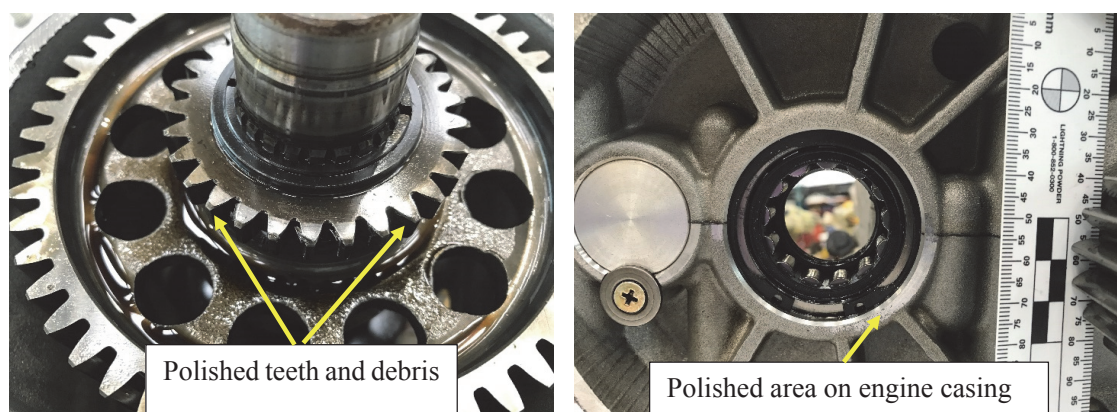
**Figure 7**

There was a small amount of debris between five of the teeth on the small gear in the reduction gearbox which was used to drive accessories such as a vacuum or hydraulic pump, however, this drive was not used on this engine. The sides of the teeth had a polished appearance which corresponded with a polished area on the engine casing that extended across an arc of approximately 80° (Figure 7). It was assessed that this damage occurred during the impact because of the propeller drive shaft being pushed into the reduction gearbox, causing the sides of the teeth to contact the engine casing. It was this contact, and possible distortion of the reduction gearbox casing, that had prevented the engine from being rotated by hand during the initial inspection.

Contact between accessory drive gear and engine casing

be explained by the attitude that the engine struck the ground. The damage to the sides of the five teeth in the reduction gearbox accessory gear drive and the engine casing is evidence that the engine had been rotating when the propeller hub struck the ground.

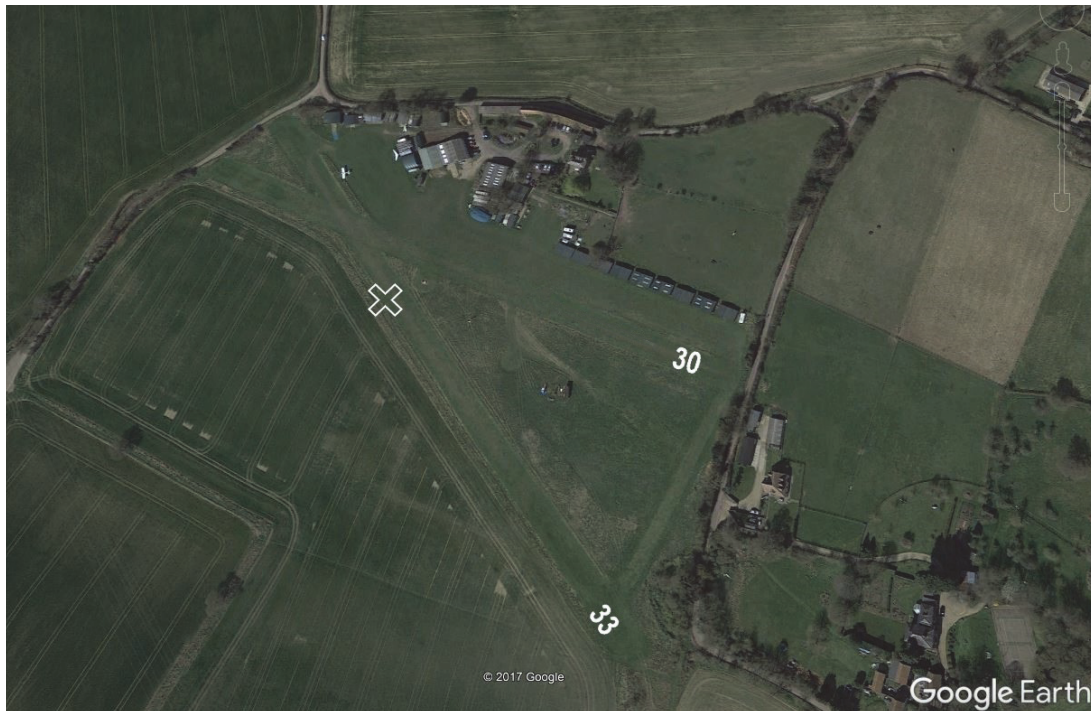
**Figure 8**

The aircraft had struck the ground within the airfield on Runway 15/33 (Figure 8), approximately 130 m from the threshold of Runway 15. Prior to the arrival of the AAIB, the aircraft had been moved several metres and the wreckage disturbed by the first responders.

Plaistow Farm Airfield, Runways 12/30 and 15/33 with accident site marked
