SERIOUS INCIDENT

Aircraft Type and Registration:	Jetstream 4100, G-MAJW	
No & Type of Engines:	2 Garrett AiResearch TPE331-14GR-807H turboprop engines	
Year of Manufacture:	1993 (Serial no: 41015)	
Date & Time (UTC):	27 February 2018 at 1200 hrs	
Location:	Aberdeen Airport	
Type of Flight:	Commercial Air Transport (Passenger)	
Persons on Board:	Crew - 3	Passengers - 18
Injuries:	Crew - None	Passengers - None
Nature of Damage:	Overwing emergency exits during evacuation	
Commander's Licence:	Airline Transport Pilot's Licence	
Commander's Age:	37 years	
Commander's Flying Experience:	3,830 hours (of which 2,325 were on type) Last 90 days - 183 hours Last 28 days - 66 hours	
Information Source:	Aircraft Accident Report Form submitted by the pilot

Synopsis

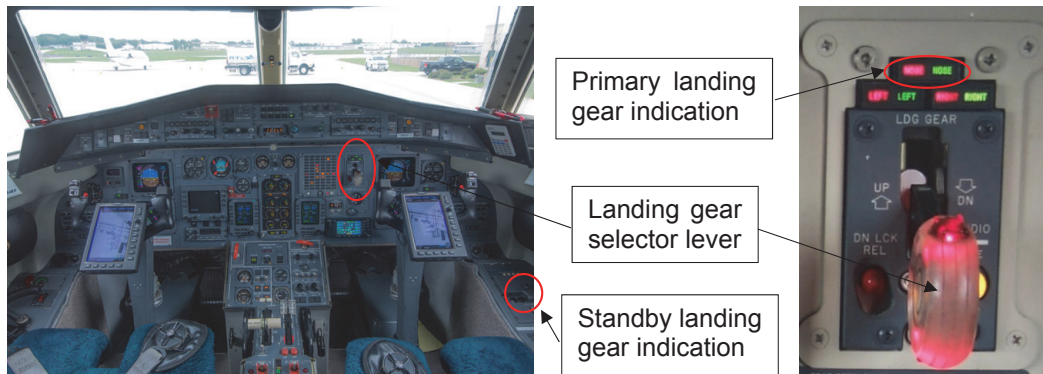
Figure 1

After an uneventful charter flight from Aberdeen Airport, the aircraft was on approach to Runway 09 at Sumburgh Airport at 1038 hrs when the crew selected the landing gear down. The primary landing gear status indicator (Figure 1) showed the nose landing gear (NLG) was not extended and downlocked (left and right-hand main landing gear (MLG) indications GREEN, NLG indication RED). The standby indicator showed GREEN for the MLG but no light for the NLG and shortly afterwards the selector lever indicator illuminated

Landing gear position is primarily indicated by illuminated captions on the landing gear selector-panel by RED or GREEN captions (Figure 1). A GREEN caption denotes the associated landing gear is 'down and locked' whereas a RED caption denotes either the gear is unlocked or in transit. When the landing gear is retracted and locked, no caption is lit. Microswitches on the downlocks and uplocks are used to control the cockpit display indicators and there are two on each downlock and one on each uplock. On the right-hand

Location of the landing gear indicators

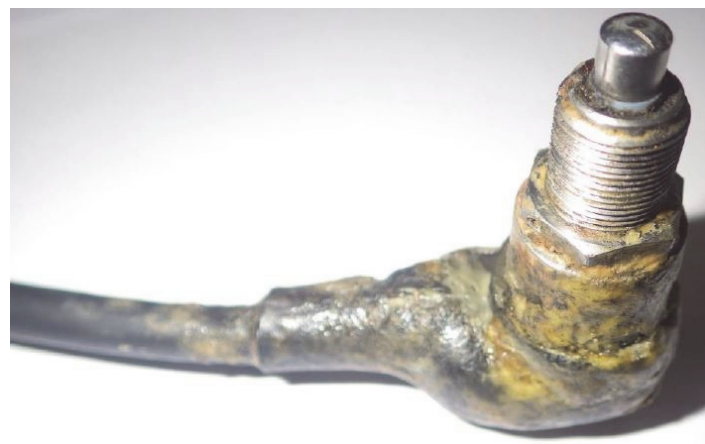
Figure 2

The NLG primary downlock microswitch and its associated wiring harness were removed from the aircraft for further examination (Figure 2). No visual defects were identified but movement could be felt between the wiring harness and the microswitch which was due to damaged and broken wires in the harness.

Primary down lock microswitch

The harness had been fitted to the aircraft during scheduled maintenance of the downlock assembly on 6 May 2016 and the aircraft had since completed 2,291 flight cycles. The harness was to the latest modification standard, the protective boots and sheathing were in good condition and with adequate moisture-inhibiting compound present. In response to this incident, the operator has introduced a 600 flight hours repetitive inspection of both indication systems and during the initial fleet-wide inspection, no further harness failures were found.

It is probable that the failure of the primary downlock harness was due to vibration as the environmental protection was in good condition. To verify the condition of the fleet, the operator has inspected all the other harnesses fitted to their aircraft and no other failures were found, so they are considering it an isolated event.

On approach to Sumburgh Airport the primary indication system for the NLG did not indicate 'down and locked' due to a failure between the microswitch and the wiring harness. The failure of the standby indication system to illuminate was because the microswitch was out of position relative to the downlock pin.

- 'One-off' inspection - Nose landing gear standby micro switch check.
- 'One-off' inspection - NLG down lock and primary and standby microswitch inspection.
- Repeat inspection every 600 flight hours - Landing gear indication system check.
- Update all Emergency and Abnormal Checklists in accordance with manufacturers latest revision.

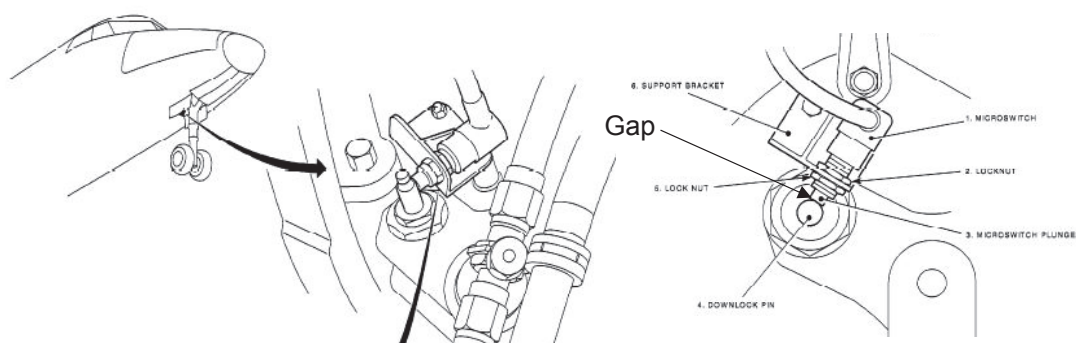
Figure 3

The NLG standby microswitch was in a serviceable condition but there was a gap between the microswitch plunger and the downlock pin resulting in the switch not operating when the landing gear was 'down and locked' (Figure 3). This condition could have resulted from being rigged incorrectly at the last maintenance interval, the microswitch support bracket having moved in-service, or a combination of both.

Standby downlock microswitch

In response to this incident, the operator has performed a fleet-wide 'one-off' inspection of the position of the standby microswitches. Of the 12 aircraft inspected; five were correctly positioned, five were marginally out of position but with no effect on operation and two were only just engaged with the downlock pin.

The gap condition between the standby microswitch and the downlock pin could have resulted from incorrect rigging, movement of the support bracket, or a combination of both. The flight crew stated that the standby indication system was working prior to the incident flight, which they had verified in accordance with their standard operating procedures, and the standby system is further checked by a maintenance programme

A further outcome of this inspection was to highlight an issue with the task '*Adjust the NLG downlock microswitch*' in the Aircraft Maintenance Manual (AMM). The task states it is '*applicable to the normal [primary] and the standby microswitches. The adjustment of one microswitch is given*'. However, this task is actually specific to the primary system as it only refers to the selector panel indicators, whereas the standby microswitch controls the standby panel indicators. The manufacturer has issued a Technical Operation Response to clarify the AMM task, on which indicators are used during the adjustment of the standby microswitch, and is revising the AMM to reflect this clarification.

- Revision to AMM to clarify NLG down lock microswitch rigging procedure.
- Review the Emergency and Abnormal Checklists to improve clarity and efficiency of application.
