ACCIDENT

Aircraft Type and Registration:	DHC-8-402 Dash 8, G-JECX
No & Type of Engines:	2 Pratt & Whitney Canada PW150A turboprop engines
Year of Manufacture:	2007 (Serial no: 4155)
Date & Time (UTC):	17 April 2018 at 1205 hrs
Location:	Newquay Airport, Cornwall
Type of Flight:	Commercial Air Transport (Passenger)
Persons on Board:	Crew - 4 Passengers - 55
Injuries:	Crew - 1 (Minor) Passengers - None
Nature of Damage:	Damage to several skin panels, frames and stringers and the aft pressure bulkhead
Commander's Licence:	Airline Transport Pilot's Licence
Commander's Age:	46 years
Commander's Flying Experience:	7,200 hours (of which 1,065 were on type) Last 90 days - 70 hours Last 28 days - 26 hours
Information Source:	Aircraft Accident Report Form submitted by the pilot and further enquires by the AAIB

Synopsis

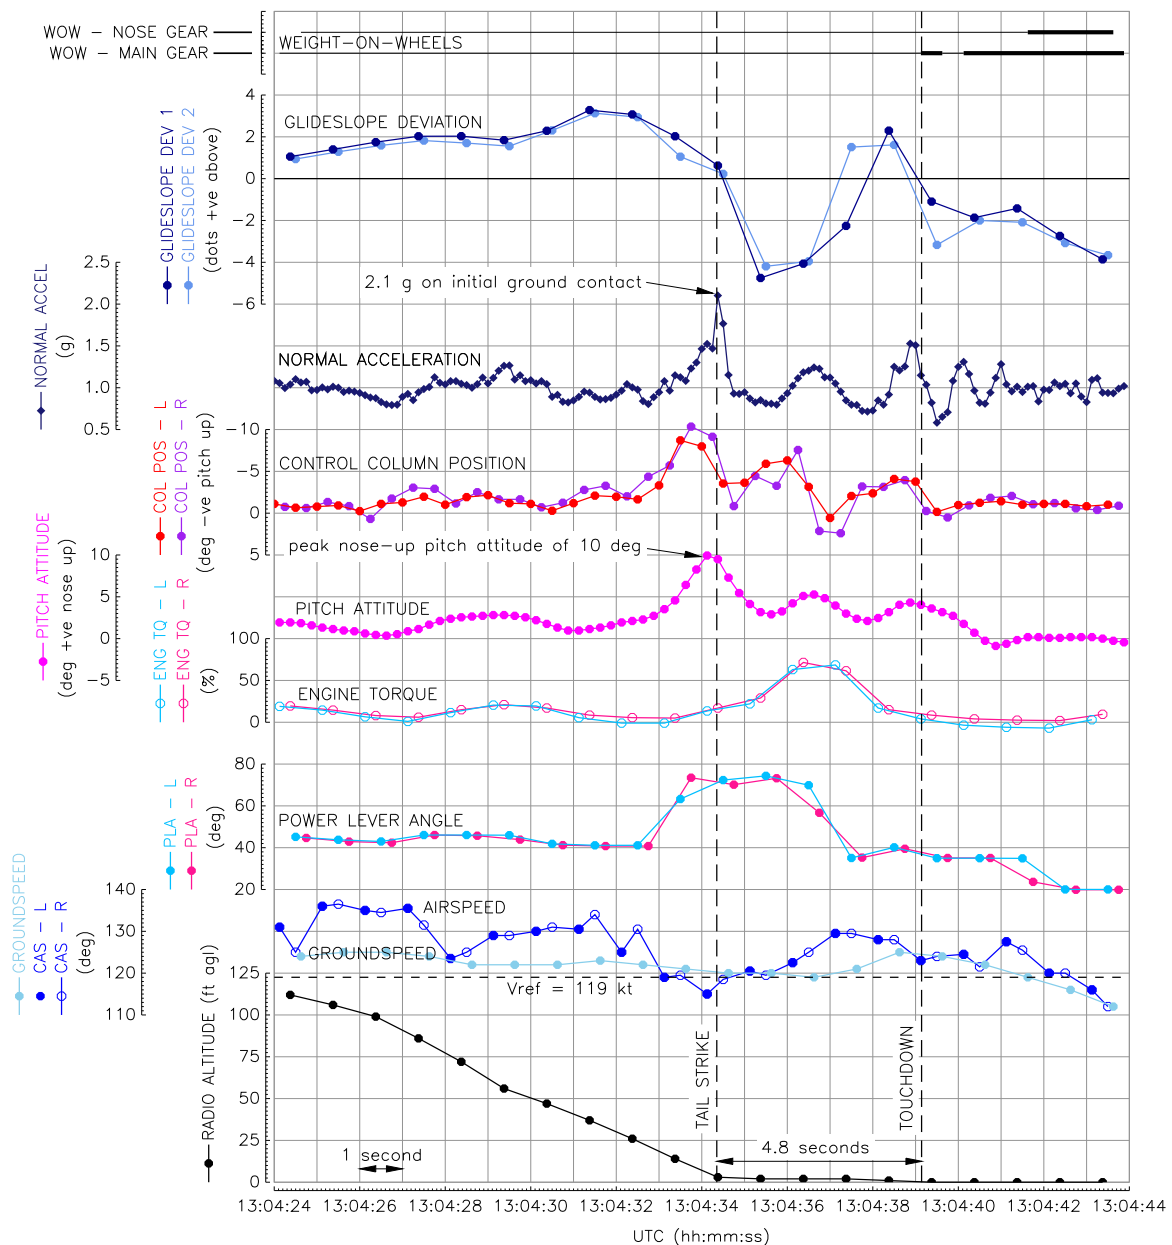
Figure 1

At approximately 100 ft, engine torque reduced corresponding to an increase in airspeed. Torque increased at approximately 80 ft as the airspeed started to reduce. Torque reduced at approximately 40 ft to idle and the airspeed reduced further. The data suggests that this corresponded with a reduction in headwind, although the sample rate is too low to determine this exactly. At approximately 20 ft power increased markedly and pitch attitude increased.

The aircraft tail touched the runway at 2.1g with the aircraft at a pitch attitude of 10° nose up. The main wheels touched down 4.8 seconds after the tail touched.

Selected information from FDR
