ACCIDENT

Aircraft Type and Registration:	Aerostar YAK-52, G-CCJK	
No & Type of Engines:	1 Ivchenko Vedeneyev M-14P piston engine	
Year of Manufacture:	1996 (Serial no: 9612001)	
Date & Time (UTC):	21 August 2018 at 0915 hrs	
Location:	East Hoe Manor private strip, Hambledon, Hampshire	
Type of Flight:	Private	
Persons on Board:	Crew - 1	Passengers - None
Injuries:	Crew - None	Passengers - N/A
Nature of Damage:	Damage to cowling, propeller and wing leading edges	
Commander's Licence:	Private Pilot's Licence	
Commander's Age:	57 years	
Commander's Flying Experience:	1,271 hours (of which 372 were on type) Last 90 days - 64 hours Last 28 days - 20 hours	
Information Source:	Aircraft Accident Report Form submitted by the pilot

Synopsis

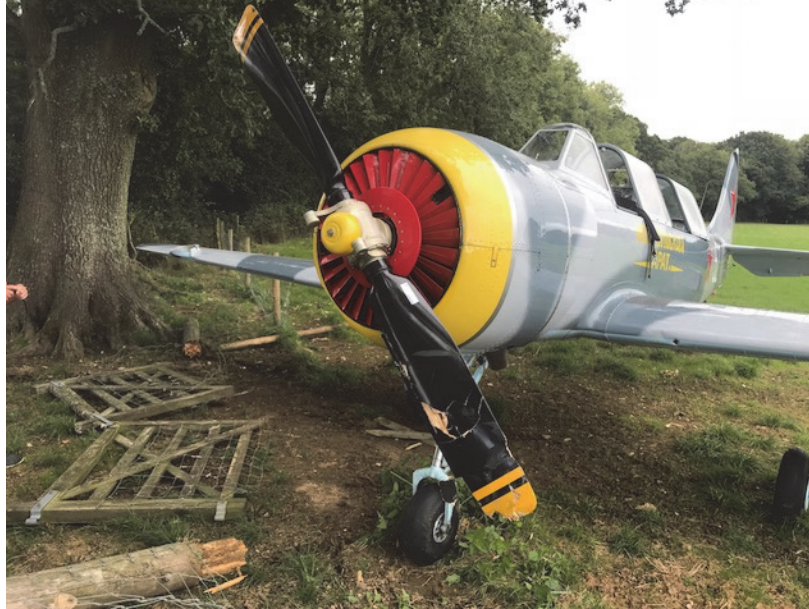
Figure 1

continued to rotate. The aircraft overran the runway at approximately 10 mph and collided with a fence. It came to a stop a few metres beyond the fence and the pilot was able to exit the aircraft unaided (Figure 1).

G-CCJK after the accident
