## ACCIDENT

| <b>Aircraft Type and Registration:</b> | DH82A Tiger Moth, G-ANRM | |
| <b>Date &amp; Time (UTC):</b> | 30 June 2018 at 1725 hrs | |
| <b>Location:</b> | Sywell Aerodrome, Northamptonshire | |

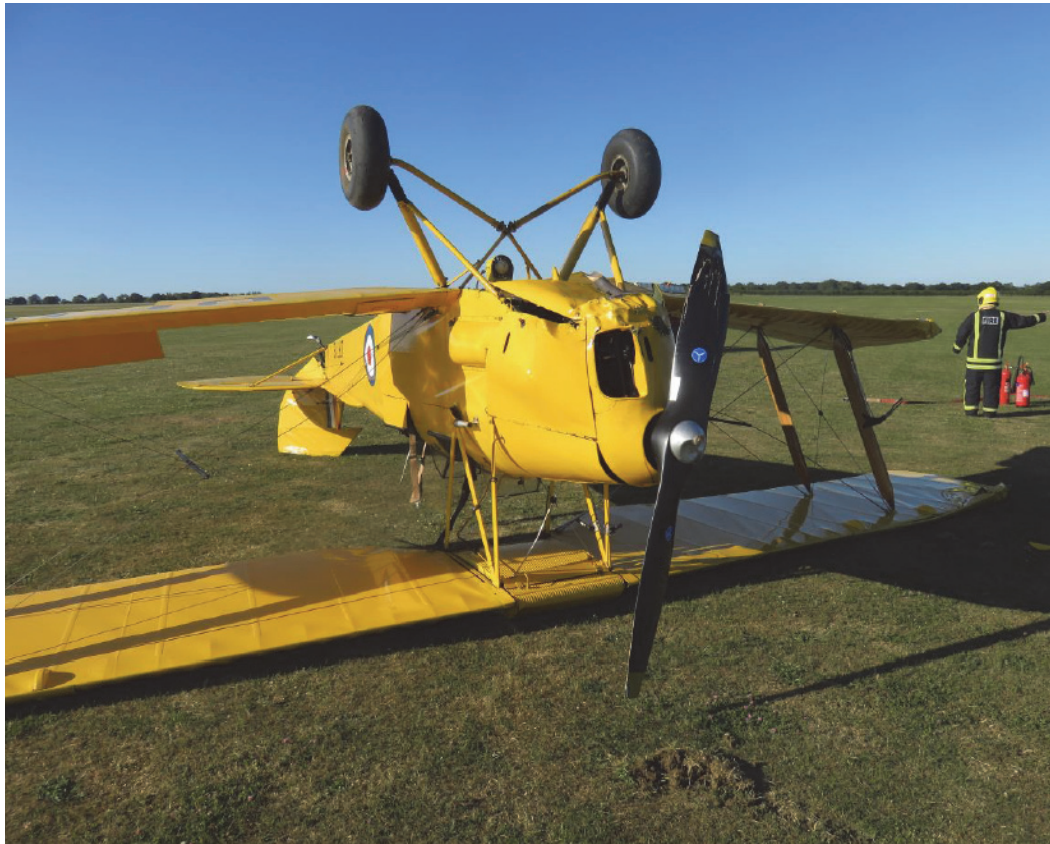
**Figure 1**

On the third flight, whilst on short final for Runway 03R, the pilot received information from Sywell that the wind was 040° at 15 kt. The approach proceeded normally. During the approach the pilot looked at the windsock at the far end of the runway. He concluded the wind was approximately 10° to the right of the runway heading and decided to use a 3-point landing technique. This was his preferred technique for landing when there was no significant crosswind. The pilot reported that during the flare a sudden gust caused the aircraft to roll to left. He attempted to correct the roll and initiate a go-around but the left wing struck the ground. The aircraft rotated to the left and overturned. It contacted the ground with the nose and right-wing, and came to rest inverted and facing opposite to the

landing direction (Figure 1). Both occupants were restrained by their 4-point harnesses and suffered only minor injuries. They were helped to evacuate by the aerodrome rescue and firefighting service.

G-ANRM at the accident site (photograph used with permission)
