ACCIDENT

Aircraft Type and Registration:	AS350 B3e Ecureuil, G-MATH	
No & Type of Engines:	1 Turbomeca Arriel 2D turboshaft engine	
Year of Manufacture:	2016 (Serial no: 8274)	
Date & Time (UTC):	5 May 2017 at 0830 hrs	
Location:	Wycombe Air Park, Buckinghamshire	
Type of Flight:	Training	
Persons on Board:	Crew - 2	Passengers - 1
Injuries:	Crew - 1 (Fatal) 1 (Serious)	Passengers - 1 (Serious)
Nature of Damage:	Extensive	
Commander's Licence:	Commercial Pilot's Licence (Helicopters)	
Commander's Age:	45 years	
Commander's Flying Experience:	5,747 hours (of which 579 were on type) Last 90 days - 53 hours Last 28 days - 17 hours	
Information Source:	AAIB Field Investigation

Synopsis

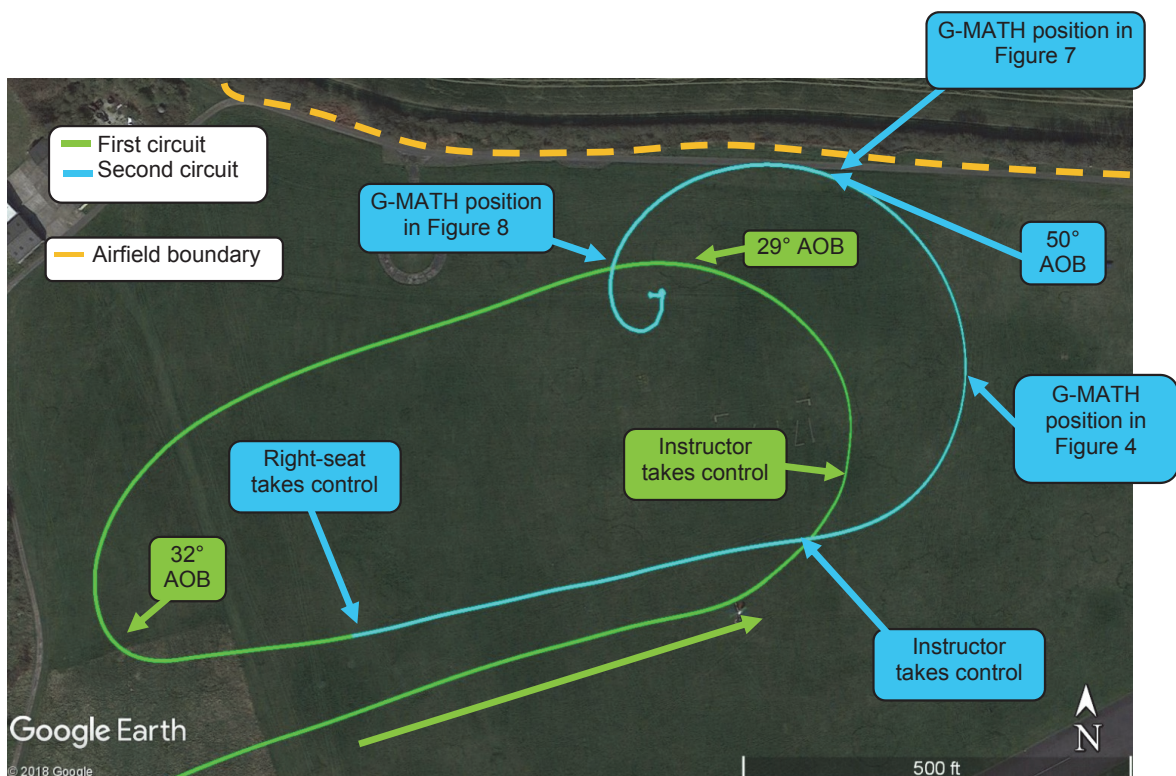
Figure 3

When the instructor took control for the second go-around, the helicopter was at approximately 35 KIAS and approximately 20 ft agl. This occurred with the helicopter positioned slightly to the north-east of the first circuit. (Figure 3).

Final 90 seconds of G-MATH flight data

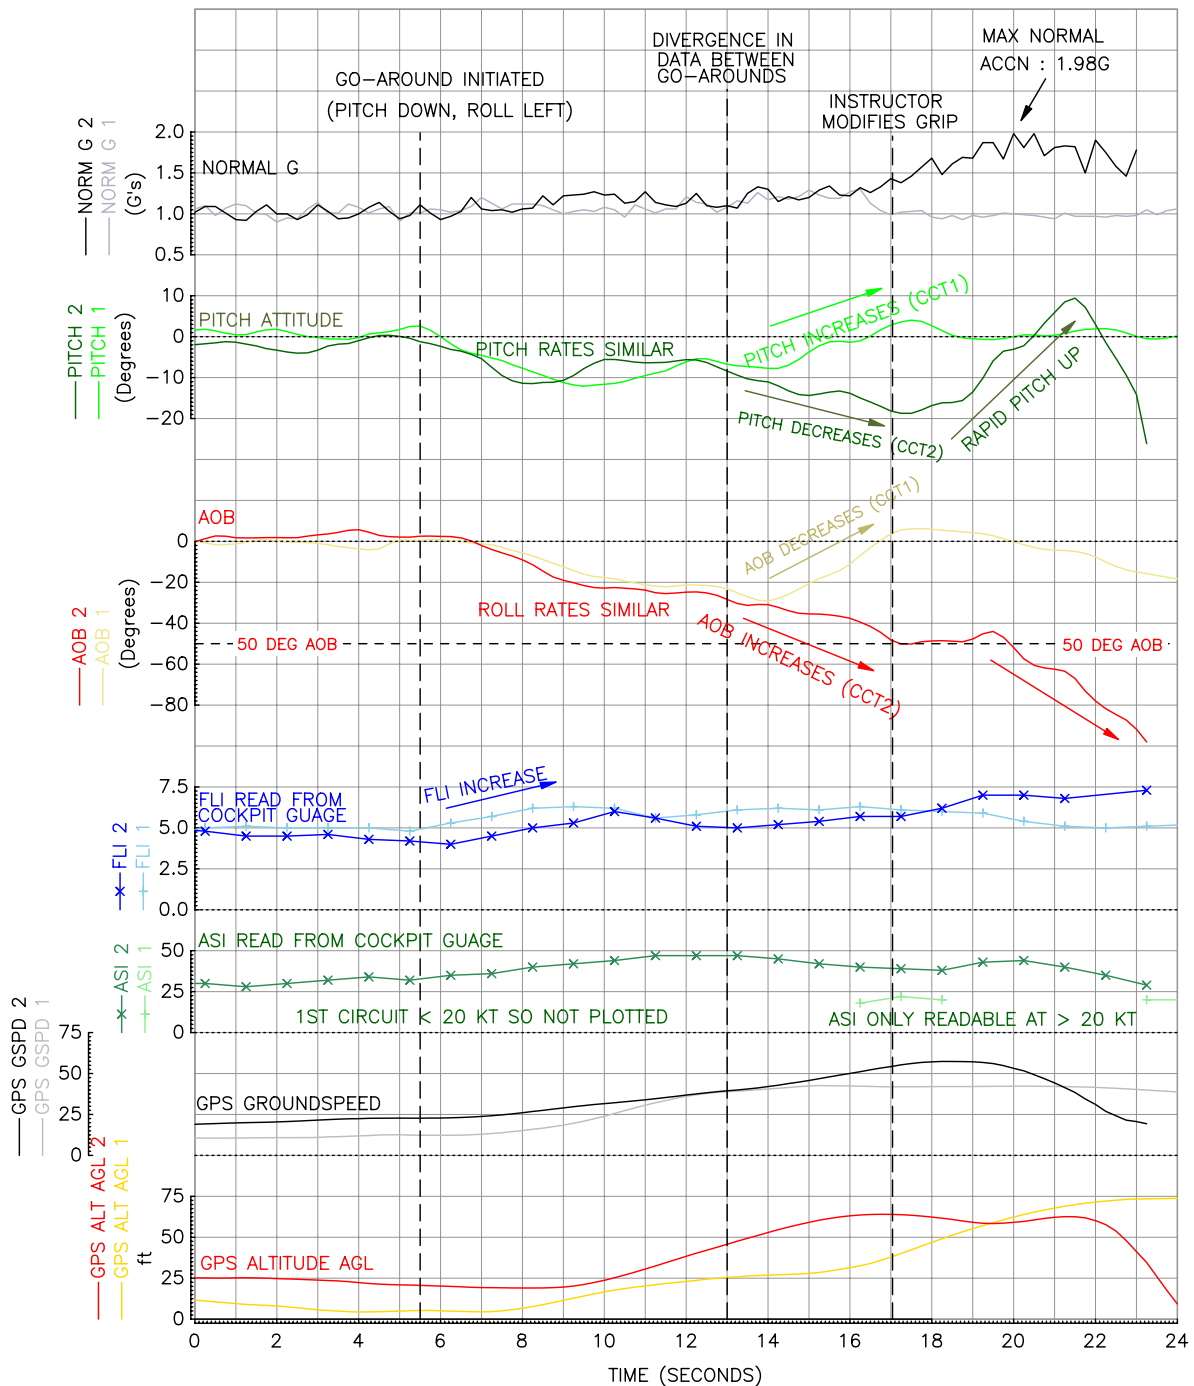
Figure 5

The recorded data shows a divergence in parameters between the two go-arounds after the first 7.5 seconds. In the first go-around, the pitch and roll attitudes began to return to zero as the helicopter rolled out of the turn onto the downwind leg. In the second go-around, the roll and nose-down pitch continued to increase; this commenced at 0832:50 hrs.

The main differences between the two manoeuvres at the point of divergence was the airspeed, which was below 20 KIAS for the first go-around but 47 KIAS for the second, and

height, with the helicopter approximately 25 ft higher on the second go-around. The Vision 1000 data also showed the instructor applying more left pedal in the second go-around.

G-MATH comparison of two go-around manoeuvres.

Lighter coloured lines and '1' denote first circuit; darker lines and '2' denote second circuit. (Data ends at impact)

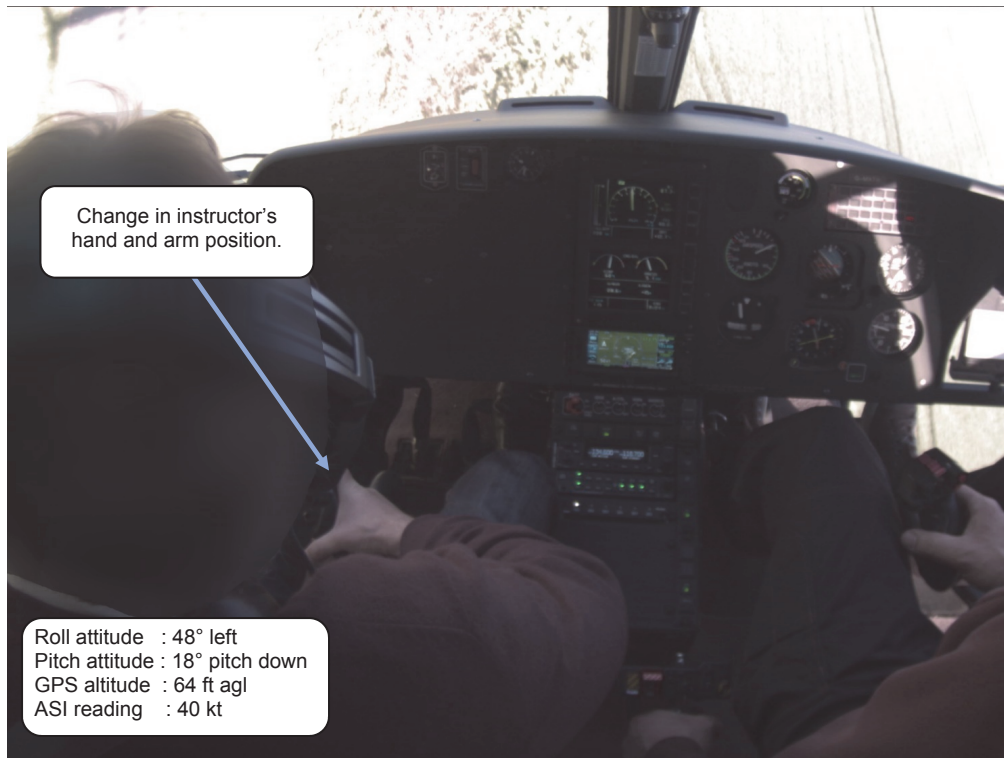
Figure 7

At 0832:54 hrs the video showed the instructor changing his grip on the cyclic (Figure 7). The AOB then briefly stabilised at approximately 49° left as the helicopter began to pitch up. The AOB then briefly recovered to 44° (Figure 6).

From this point, the cyclic is seen to move to the right and aft but the AOB continued to increase as the helicopter pitched up and the recorded normal acceleration increased, reaching a maximum of 1.98 g at 52° left AOB. One second later, the right-seat pilot tightened his grip on the cyclic and maintained his grip until the helicopter struck the ground 3.5 seconds later.

G-MATH at 0832:54 hrs during second go-around showing changed grip for instructor (compare with Figure 4). (Instructor's head has been blurred)

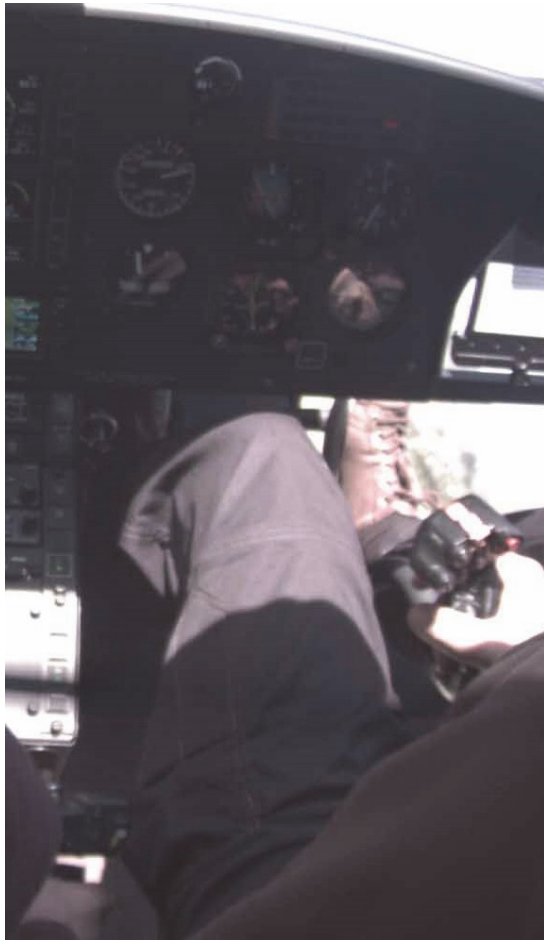
Figure 9

G-MATH Vision 1000 view showing right-seat pilot's cyclic position at its furthest right during the second go-around
