ACCIDENT

Aircraft Type and Registration:	1) Robinson R44 Raven, G-CTFL 2) Robinson R44 Raven, G-HYND
No & Type of Engines:	1) 1 Lycoming O-540-F1B5 Piston Engine 2) 1 Lycoming O-540-F1B5 Piston Engine
Year of Manufacture:	1) 2008 (Serial no: 1912) 2) 2016 (Serial no: 2433)
Date & Time (UTC):	5 May 2018 at 1125 hrs
Location:	Cumbernauld Airport, North Lanarkshire
Type of Flight:	1) Training 2) Training
Persons on Board:	1) Crew - 1 Passengers - 2 2) Crew - 1 Passengers - 3
Injuries:	1) Crew - None Passengers - None 2) Crew - None Passengers - None
Nature of Damage:	1) Extensive 2) Main rotor blade damaged
Commander's Licence:	1) Commercial Pilot's Licence 2) Commercial Pilot's Licence
Commander's Age:	1) 42 years 2) 58 years
Commander's Flying Experience:	1) 913 hours (of which 226 were on type) Last 90 days - 54 hours Last 28 days - 21 hours 2) 6,846 hours (of which 1,705 were on type) Last 90 days - 62 hours Last 28 days - 13 hours

Synopsis

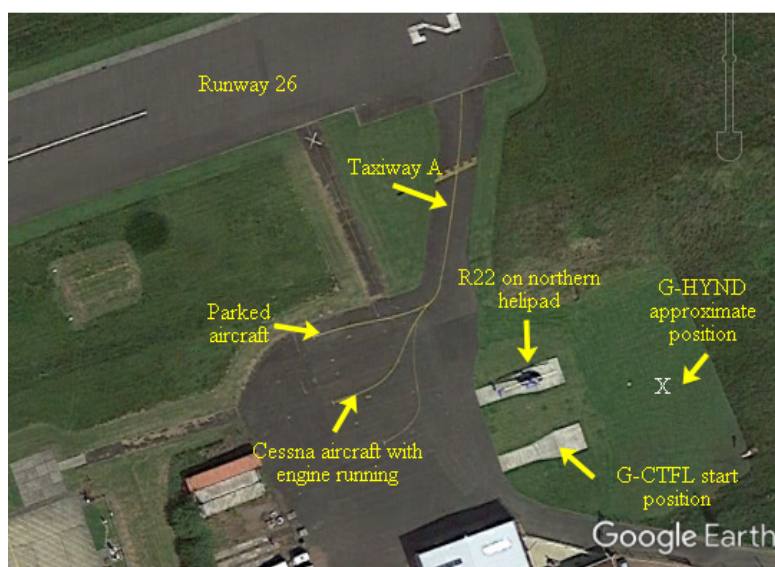
Figure 1

The pilot of G-CTFL stated that he was restricted from moving forwards and right onto Taxiway A, because of the position of the parked R22 helicopter and because of a stationary Cessna aircraft, which was in front of him and facing away with its propeller turning (Figure 1). There was a second light aircraft parked to the left of the Cessna and he did not wish to disturb these aircraft with his helicopter’s downwash. The pilot knew that, when he boarded his helicopter, the area to the rear was clear and he had no recollection of hearing any radio transmissions from G-HYND, so he was not aware of its position and was not expecting another helicopter to be parked there. After lifting to the hover, the pilot decided to move rearwards and then taxi behind the R22. He did not turn his helicopter to check that the area to his rear was clear before reversing, because of the proximity of the R22 on his right and because he did not wish to turn his tail left towards the buildings, where some spectators had assembled.

Approximate aircraft disposition in the vicinity of Apron A, at the eastern end of Cumbernauld Airport, before G-CTFL moved

- The northern helipad was extended eastwards by 12 m, so a parked helicopter is further from the apron, leaving space for other helicopters to move between the parked helicopter and the apron.

- The prepared grass area east of the helipads has been extended, to ensure helicopters parked there can remain well clear of the pads.
- A mirror has been placed at the corner of the hangar, to assist pilots using either helipad see any activity to their rear.

- The helicopter operator no longer permits helicopters to reverse from the helipads.
- The helicopter operator's safety team is due to review the procedure for turning off the avionics systems while a Robinson R44 is being shut down.
