ACCIDENT

Aircraft Type and Registration:	Piper PA-38-112 Tomahawk, G-BMVL	
No & Type of Engines:	1 Lycoming O-235-L2C Piston Engine	
Year of Manufacture:	1979 (Serial no: 38-79A0033)	
Date & Time (UTC):	12 May 2018 at 1215 hrs	
Location:	Caernarfon Airport, Gwynedd, Wales	
Type of Flight:	Private	
Persons on Board:	Crew - 1	Passengers - 1
Injuries:	Crew - 1 (Minor)	Passengers - 1 (Minor)
Nature of Damage:	Extensive	
Commander's Licence:	Private Pilot's Licence	
Commander's Age:	46 years	
Commander's Flying Experience:	199 hours (of which 57 were on type) Last 90 days - 15 hours Last 28 days - 8 hours	
Information Source:	Aircraft Accident Report Form submitted by the pilot, recorded CCTV and further enquiries by the AAIB

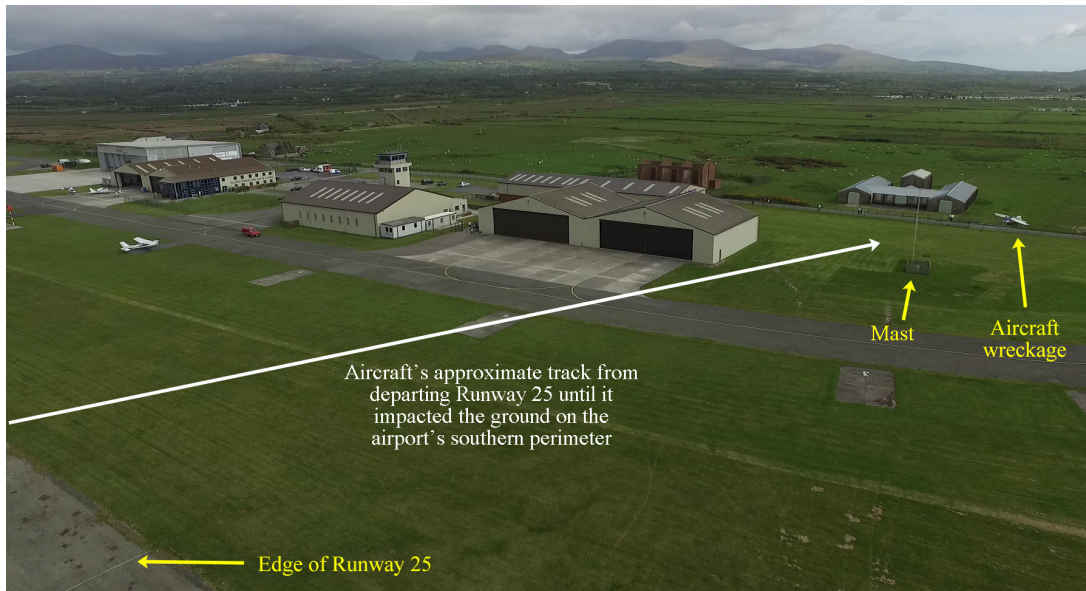
Figure 1

The aircraft appears to have flown between the hangars and a mast, bounced on the grass and then struck the ground by the airfield perimeter fence. It then passed through the fence line, travelled across a public road and hit another fence on the southern side of the road (Figure 1). The aircraft then inverted and stopped abruptly, near a farm building, with its nose pointing back towards the airfield (Figure 2).

View of Caernarfon Airport from drone positioned above Runway 25, with camera orientated towards the southeast (Picture courtesy of North Wales Police)
