ACCIDENT

| Aircraft Type and Registration: | DJI Matrice 210 (UAS, registration n/a) | |

Synopsis

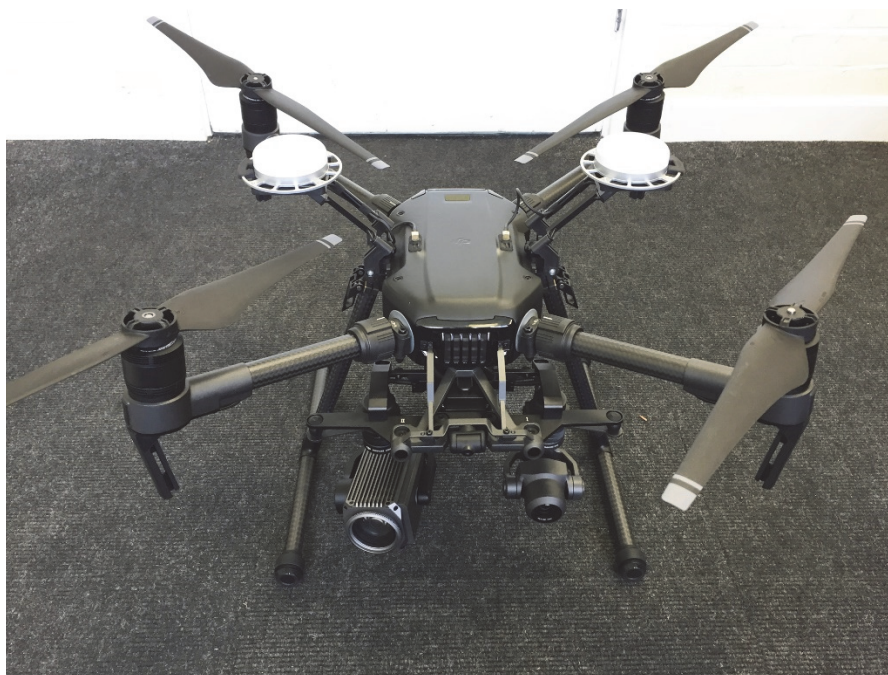
Figure 1

DJI Matrice 210
