## ACCIDENT

<b>Aircraft Type and Registration:</b>	DJI Matrice 210 (UAS, registration N/A)	
<b>No &amp; Type of Engines:</b>	4 electric motors	
<b>Year of Manufacture:</b>	2018 (Serial no: 0G0DF8F0240057)	
<b>Date &amp; Time (UTC):</b>	16 March 2019 at 1310 hrs	
<b>Location:</b>	Temple Newsam, Leeds, Yorkshire	
<b>Type of Flight:</b>	Commercial Operation	
<b>Persons on Board:</b>	Crew - N/A	Passengers - N/A
<b>Injuries:</b>	Crew - N/A	Passengers - N/A
<b>Nature of Damage:</b>	Damage to rotor arms, propellers, and camera payload	
<b>Commander's Licence:</b>	Not applicable	
<b>Commander's Age:</b>	42 years	
<b>Commander's Flying Experience:</b>	67 hours (of which 67 were on type) Last 90 days - 17 hours Last 28 days - 9 hours	
<b>Information Source:</b>	Aircraft Accident Report Form submitted by the pilot and further enquiries by the AAIB

## Synopsis

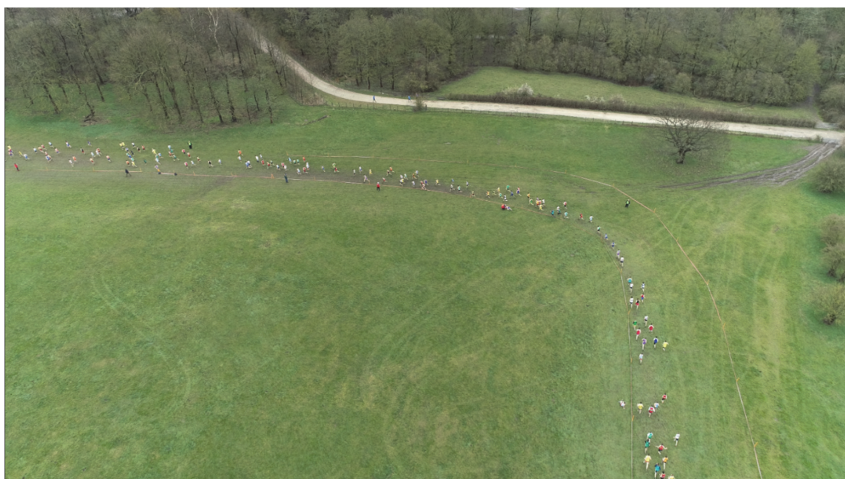
**Figure 1**

At 1303 hrs the aircraft took off from the TOLS and was positioned overhead the venue at a height of about 30 m (100 ft) agl, where filming took place (Figure 1). During the initial part of the flight it had been raining "lightly" but after about six minutes the rainfall started to increase. The pilot then decided to position the aircraft back towards the TOLS, which was about 400 m away, whilst also descending the aircraft.

Footage from aircraft at a height of about 30 m (100 ft) agl

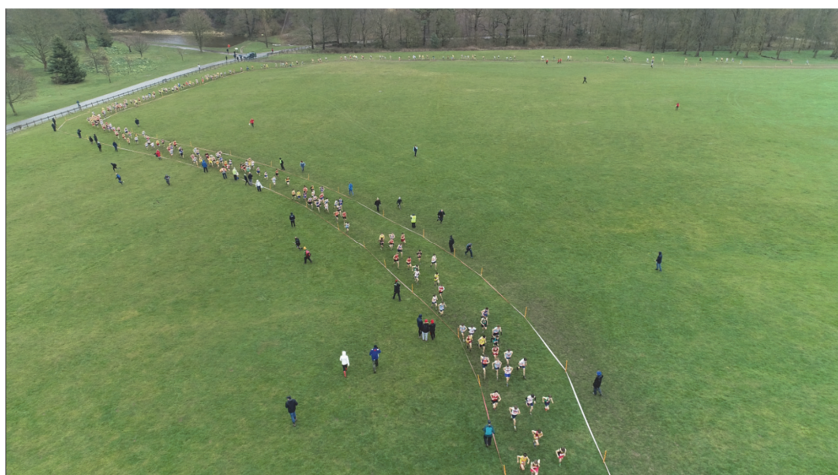
**Figure 2**

Whilst en route to the TOLS, the aircraft passed overhead people at a height of about 10 m (~30 ft) agl (Figure 2 and Figure 3). At some point during this period the pilot saw the aircraft do "a little wobble" and became concerned that there was a problem and stopped filming. As the aircraft approached the TOLS at a height of about 3 m (10 ft) agl it suddenly "flipped itself upside down and drove itself into the ground". No person was injured, but the aircraft was severely damaged. The recorded flight time was about eight minutes.

Footage taken whilst en route back to the TOLS

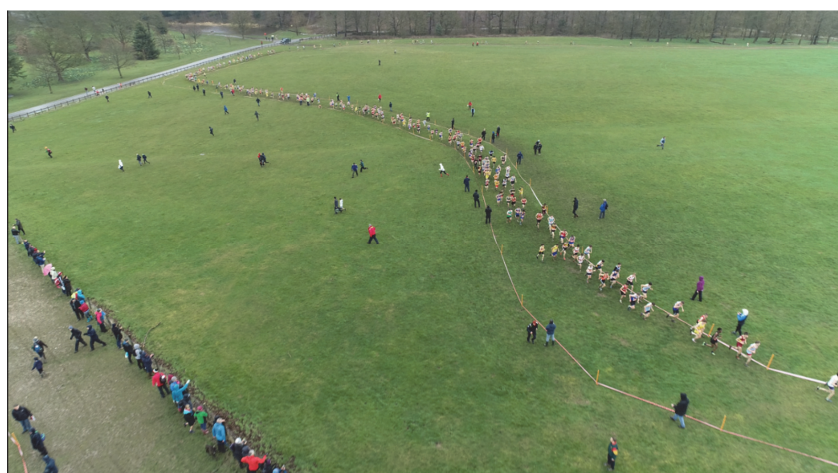
**Figure 3**

Footage captured one minute before the accident

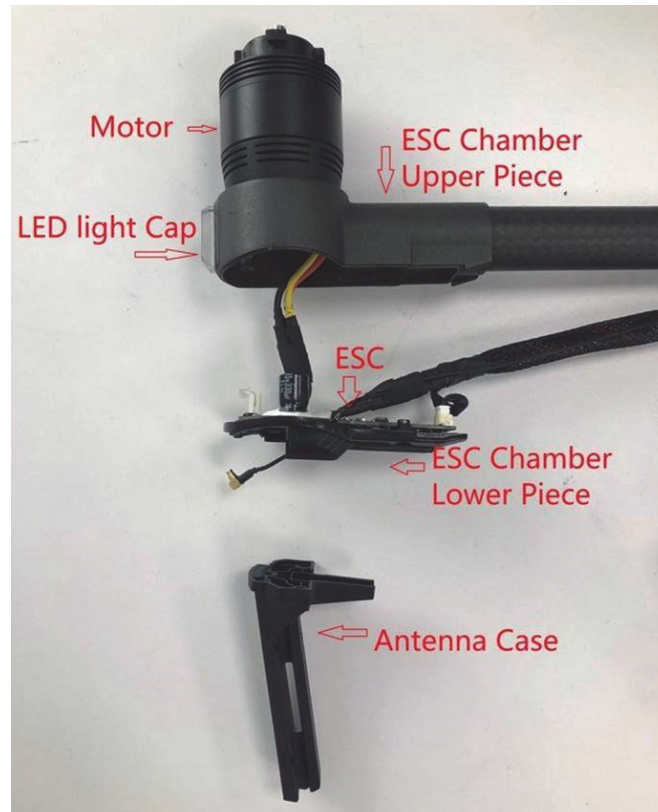
**Figure 5**

Each of the four propeller motors was controlled by an associated electronic speed controller (ESC) that was fitted in a chamber located below each motor (Figure 5). The ESC consisted of electronic components soldered to a circuit board that was connected to the motor and main body of the aircraft using a push-fit connector and soldered connections. Fitted to each ESC was a label (Figure 6) that changed colour if it was exposed to moisture or liquids. Moisture can result in erroneous operation or failure of electronic components and/or electrical connections.

To prevent moisture and dust<sup>6</sup> ingress into the ESC chamber the UAS manufacturer advised that most of the chamber was sealed using adhesive and gaskets, but the attachment holes and seam between the antenna case and lower chamber were not sealed. The

Motor, ESC, chamber and antenna

The lower section of the ESC chambers adjacent to the antennas were not sealed and this could have provided an entry path for rainwater. The IP 43 accreditation testing was also not performed with the propellers installed and so it is possible that these tests did not fully reflect in-service operation in rain. It is also possible that rainwater entered the unit due to rainfall exceeding the manufacturer's limitation of 10 mm/h or that the IP 43 protection had degraded over time.

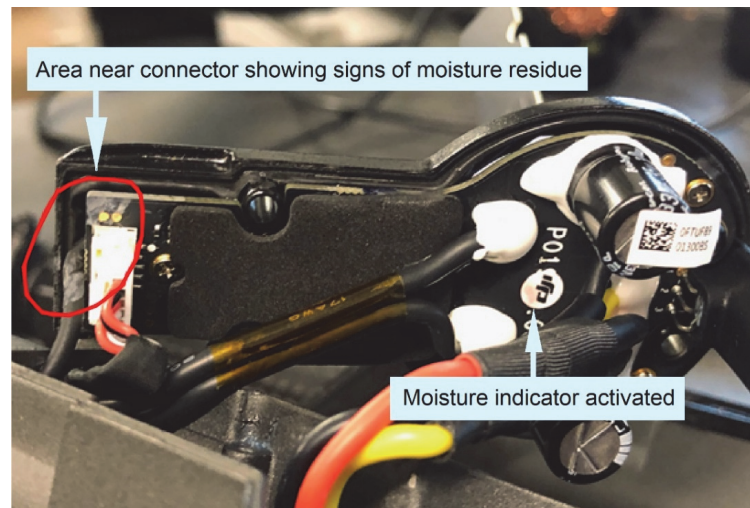
**Figure 7**

The pilot sent the aircraft to an Enterprise dealer in the UK for examination. It was found that the No 3 motor ESC moisture indicator had been activated and evidence of liquid residue was found on the ESC circuit board (Figure 7).

The No 3 motor arm had remained intact following the accident and the pilot stated that the arms had never been folded since the aircraft had been purchased from new in August 2018. The remaining ESC's were inspected, but no evidence of moisture ingress was found.

The onboard recorded data contained fault messages that coincided with the loss of control of the aircraft. These messages referred to a No 3 motor ESC '*link down*' and a fault with the No 4 motor ESC. The manufacturer reviewed this data and advised its Enterprise dealer that the accident had been caused by a fault with the No 4 ESC. The aircraft was subsequently

No 3 ESC from accident aircraft

Subsequent inspection of the aircraft found that moisture had entered the No 3 ESC chamber and residue was present on the ESC circuit board. No evidence of moisture was found on the other ESC's. Since owning the aircraft from new, the pilot had followed the manufacturer's guidelines to prevent moisture entering the aircraft and during the accident the No 3 motor arm had remained intact. It is therefore more likely that the moisture entered the No 3 ESC chamber during the last three minutes of the accident flight when the rainfall increased rather than during previous operation or following the accident.

It is recommended that the Civil Aviation Authority notify users of the DJI Matrice 200 series of the possibility of moisture entering the aircraft when operating in rain and that this could result in a sudden loss of control of the aircraft.
