**ACCIDENT**

<b>Aircraft Type and Registration:</b>	Snowbird Mk IV, G-MVOJ	
<b>No &amp; Type of Engines:</b>	1 Rotax 582/48-2V piston engine	
<b>Year of Manufacture:</b>	1989 (Serial no: SB-019)	
<b>Date &amp; Time (UTC):</b>	22 June 2019 at 0925 hrs	
<b>Location:</b>	Bedlands Gate, Newby, Cumbria	
<b>Type of Flight:</b>	Private	
<b>Persons on Board:</b>	Crew - 1	Passengers - None
<b>Injuries:</b>	Crew - 1 (Serious)	Passengers - N/A
<b>Nature of Damage:</b>	Nose structure and engine displaced, right wing leading edge misshapen and front spar bent	
<b>Commander's Licence:</b>	National Private Pilot's Licence	
<b>Commander's Age:</b>	87 years	
<b>Commander's Flying Experience:</b>	363 hours (of which 289 were on type) Last 90 days - 0 hours Last 28 days - 0 hours	
<b>Information Source:</b>	AAIB Field Investigation

**Synopsis**

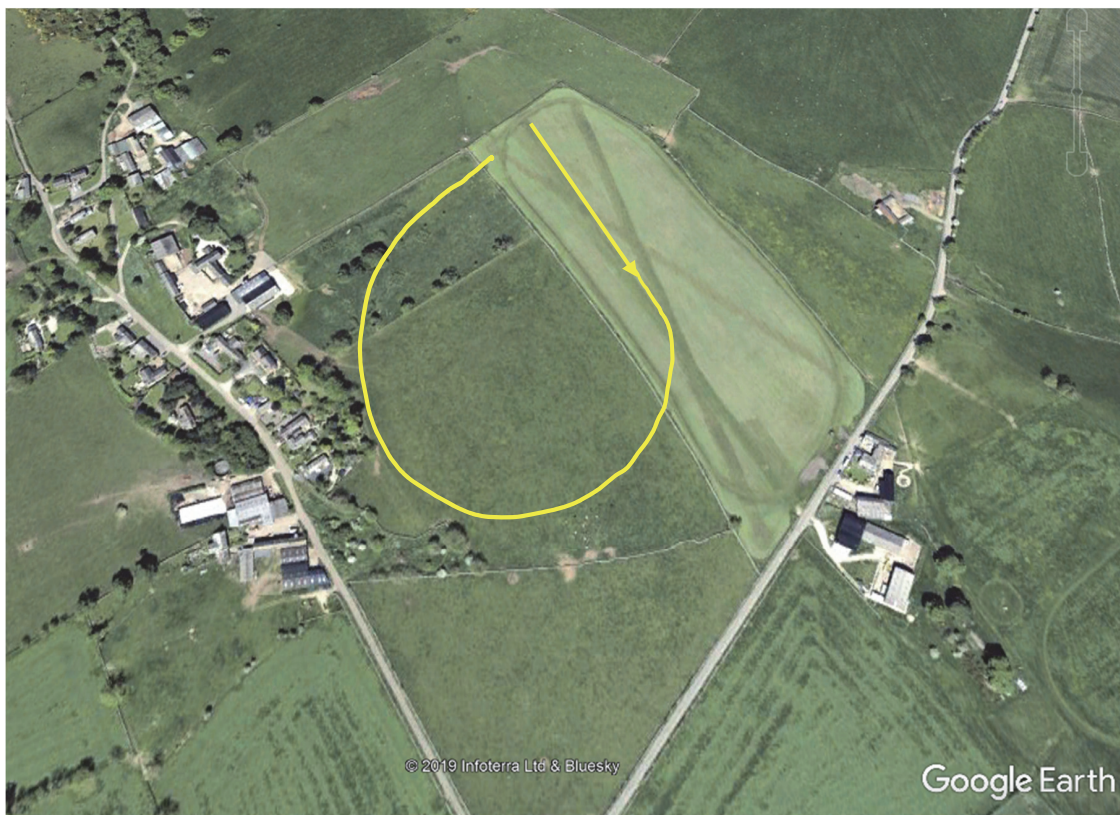
**Figure 1**

Estimated flight path of G-MVOJ

The aircraft had flown a large right arc and was heading back towards the airfield on a track perpendicular to the runway. Whilst airborne and outside the airfield boundary the aircraft hit the top of a poplar tree at a height of approximately 30 ft. A 6 ft long branch was found at the base of the tree, and leaves and twigs had been caught between the aircraft radiator and its fairing.

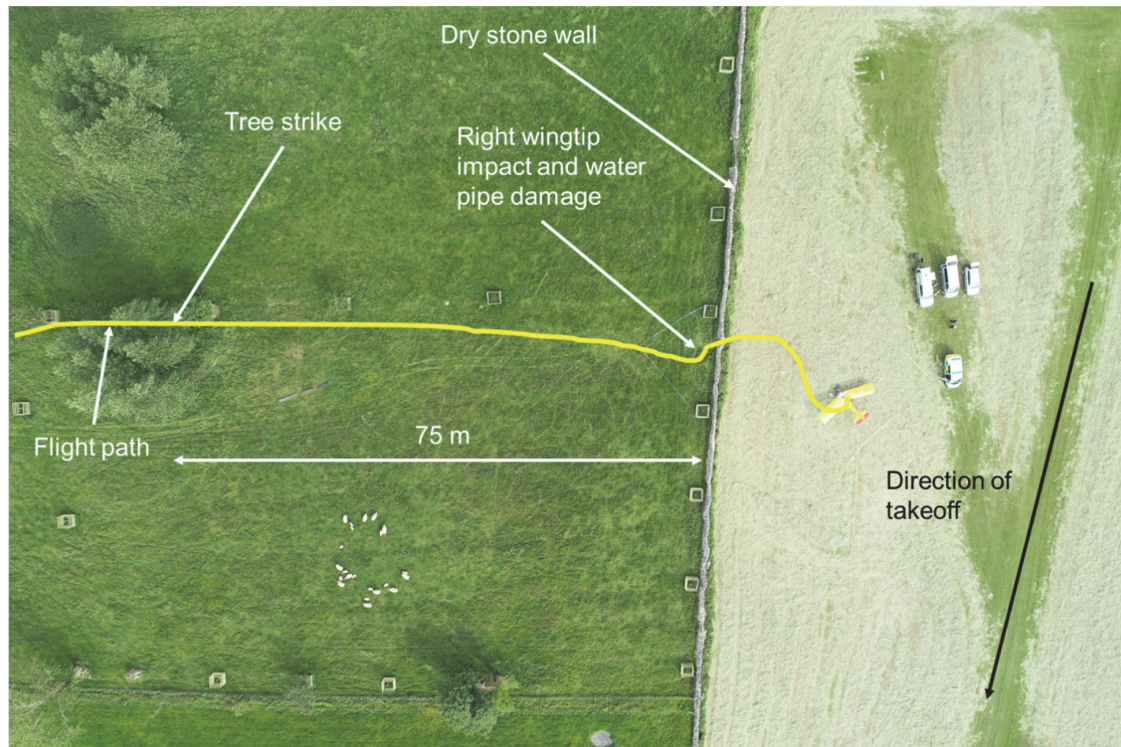
**Figure 2**

The aircraft then descended, striking the ground and a dry-stone wall next to the airfield. The aircraft came to rest, on the airfield side of the wall (Figure 2). The pilot was seriously injured.

Final aircraft flight path and impact points<sup>1</sup>

The aircraft continued to descend, and its right wingtip contacted the ground just in front of the dry-stone wall which forms the airfield boundary. By chance, as the wingtip dug into the soil, part of the tubular wingtip frame broke away and passed through a one-inch diameter polypropylene water pipe buried in the ground alongside the base of the wall. The wingtip digging in caused the aircraft to 'pole-vault' over the wall during which it became entangled

in a single strand barbed wire fence, dragging it and its posts over the wall. Marks on the leading edge of the right wing and stones that dislodged as it hit the wall, suggest that the aircraft was at a 45° angle of right bank.

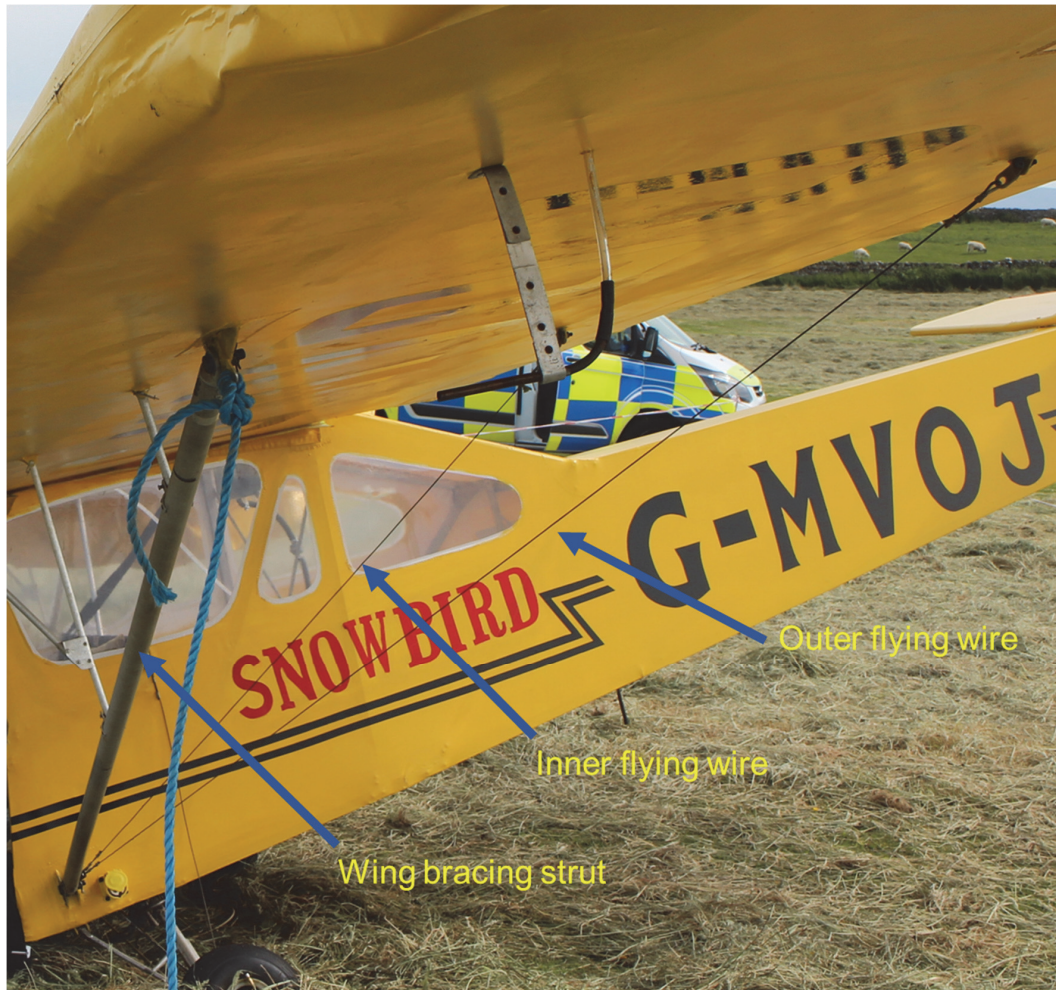
**Figure 4**

Flying wires and the bracing strut under the left wing  
(The blue rope was attached after the accident to stabilise the aircraft)

At the accident site, both wing struts had been disconnected from the fuselage by removing the attachment bolt, along with the smaller strut braces, and allowed to settle down against the wing for transport. It was noted that the left lower bracing strut joint bolt was more difficult to remove than expected, considering the lightness in construction of the aircraft.

Subsequent examination of the left strut also found that it had a slight permanent curvature along its length whilst the right strut was straight.

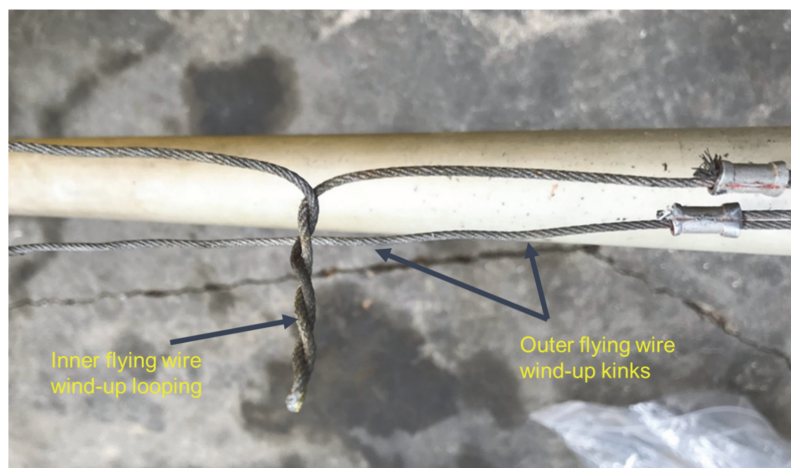
**Figure 8**

The flying wires were not disconnected from the struts or their spar attachments at the accident site. On later examination, it was noted that the right wing flying wires, in their relaxed state, were slack and in good condition. However, the two left wing flying wires were very different in their relaxed condition. They both had multiple tight loop twists and kinks indicating that they had been 'wound up' at some point during assembly. In the absence of tension, the wind-up had released and, because they are restrained at each end, twist loops were formed. The eye plates on which the cables were fitted had not been undone and were still attached correctly. It was also noted that the left pair of cables were made from galvanised steel and the right pair of cables were made from stainless steel. Figures 7 and 8 shows the wind-up twisting and kinks on the left flying wires, compared the right flying wires shown in Figure 9.

Close up of the distortion to the left inner and outer flying wires. In addition to the kinks, the outer wire also showed identical wind-up looping further along the cable (out of shot)

Anecdotal evidence also suggests that this is done by twisting the flying wires in the same direction as the lay (twist) of the strands, this increases the pitch of the helix created by the lay of strands, thus shortening the wires to increase their tension. This method is used in the absence of turnbuckle assemblies. However, this is not an ideal practice and may compromise any factor of safety inherent in a multi-strand wire by introducing bends or kinks as seen in Figures 7 and 8.
