ACCIDENT

Aircraft Type and Registration:	Reims Cessna F152, G-OLEE	
No & Type of Engines:	1 Lycoming O-235-L2C piston engine	
Year of Manufacture:	1980 (Serial no: 1797)	
Date & Time (UTC):	22 January 2019 at 1129 hrs	
Location:	Fairoaks Airport, Surrey	
Type of Flight:	Private	
Persons on Board:	Crew - 1	Passengers - None
Injuries:	Crew - 1 (Minor)	Passengers - N/A
Nature of Damage:	Tailfin, rudder, engine, propeller, nose landing gear, and right wingtip damaged	
Commander's Licence:	Private Pilot's Licence	
Commander's Age:	63 years	
Commander's Flying Experience:	136 hours (of which 118 were on type) Last 90 days - 3 hours Last 28 days - 1 hour	
Information Source:	Aircraft Accident Report Form submitted by the pilot and subsequent enquiries

Synopsis

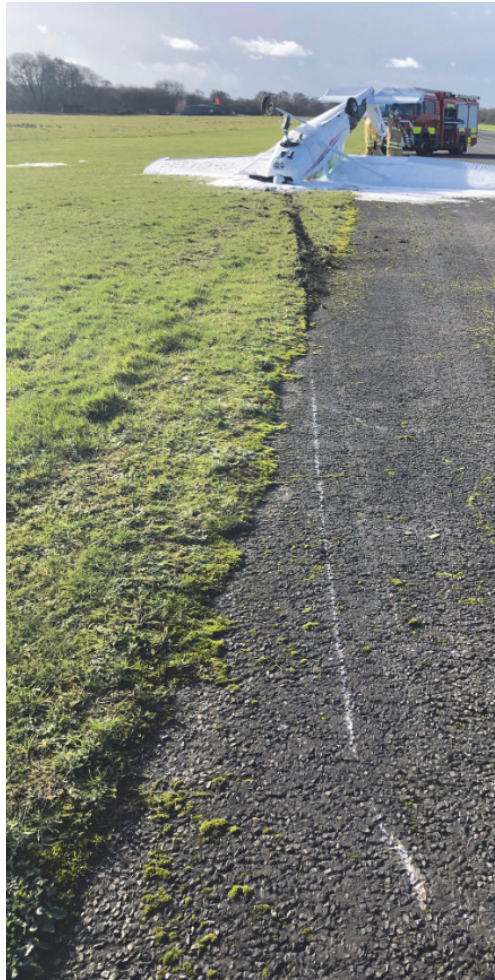
Figure 1

Witness marks on the runway from G-OLEE's nose gear
