**SERIOUS INCIDENT**

| <b>Aircraft Type and Registration:</b> | Piper PA-34-200T Seneca II, G-IFLP | |
| <b>Date &amp; Time (UTC):</b> | 16 December 2018 at 1820 hrs | |
| <b>Location:</b> | Approx 30 miles west of Leeds | |

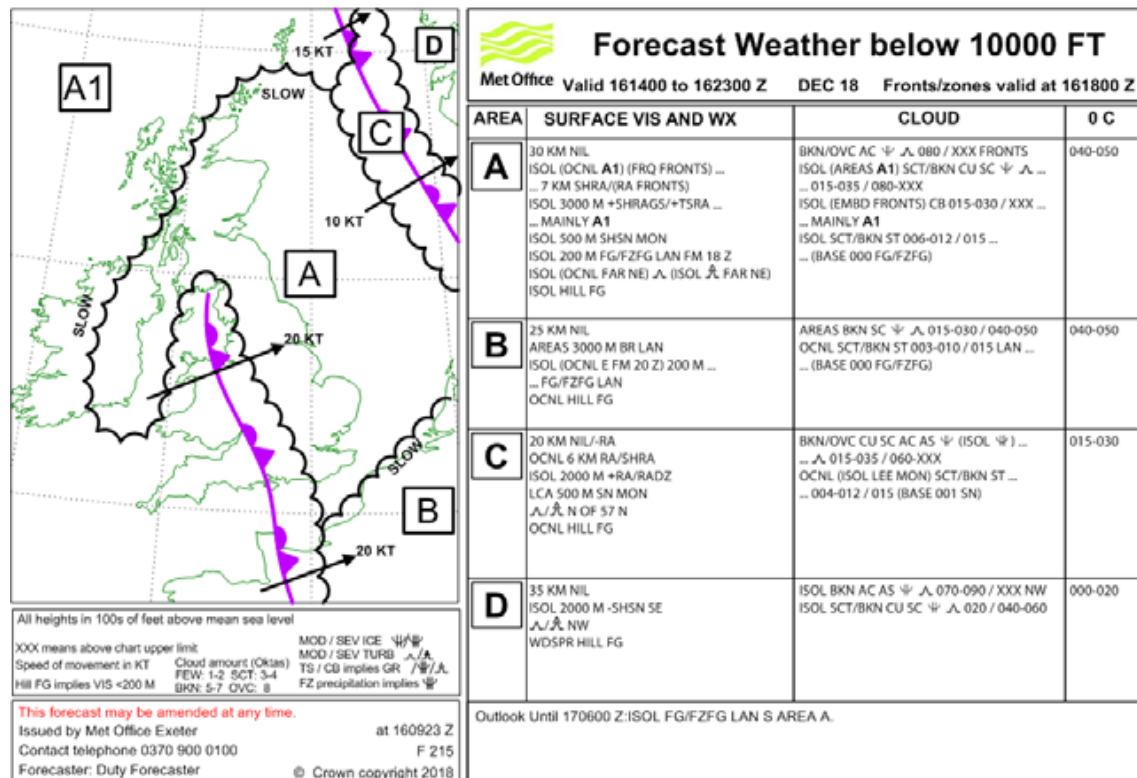
Figure 1

The Met Office forecast for the date and time of the incident is shown in Figure 1. Moderate icing was forecast from between 4,000 ft and 5,000 ft to the upper limit of the chart (10,000 ft). Severe icing was forecast within isolated cumulonimbus cloud embedded within the occluded front.

Met Office forecasts will predict moderate icing in high humidity environments (ie in cloud, where the air temperature is between 0°C and -20°C) and severe icing within cumulonimbus, alto cumulus castellanus or nimbostratus clouds. However, this does not relate directly to the amount of ice accumulation an aircraft may experience in flight. Ice accumulation is dependent on aircraft type, length of time in the icing environment and the aircraft ice protection systems.

Met Office forecast for 16 December 2018
