ACCIDENT

Aircraft Type and Registration:	Slingsby T61F Venture T Mk 2, G-BUGT	
No & Type of Engines:	1 Rollason RS MK 2 piston engine	
Year of Manufacture:	1977 (Serial no: 1871)	
Date & Time (UTC):	9 December 2018 at 1335 hrs	
Location:	Field near Rufforth Airfield, York	
Type of Flight:	Private	
Persons on Board:	Crew - 1	Passengers - None
Injuries:	Crew - None	Passengers - N/A
Nature of Damage:	Wings twisted and broken. One propeller blade damaged, minor damage to rear fuselage	
Commander's Licence:	National Private Pilot's Licence	
Commander's Age:	44 years	
Commander's Flying Experience:	106 hours (of which 80 were on type) Last 90 days - 10 hours Last 28 days - 2 hours	
Information Source:	Aircraft Accident Report Form submitted by the pilot and aircraft inspection report

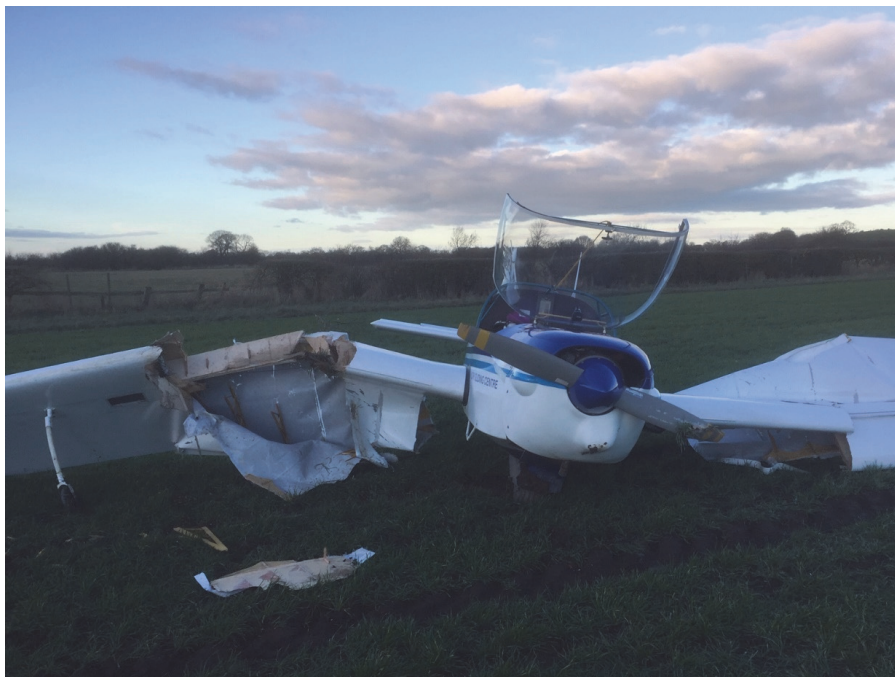
**Figure 2**

G-BUGT's departure from Runway 35 was delayed because the runway was occupied, and the pilot applied carburettor heat while waiting. When the runway was clear, the pilot lined up and applied full throttle without stopping. At approximately 150 to 200 ft, the pilot felt a complete loss of power and executed a forced landing. The aircraft touched down close to the field boundary (Figure 1). The pilot "attempted a hop" through a gap but the wings struck bushes (Figure 2). After stopping, the pilot noticed that the carburettor heat was still selected ON.

G-BUGT after the accident
