**SERIOUS INCIDENT**

| <b>Aircraft Type and Registration:</b> | Bell 429, M-YMCM | |
| <b>Location:</b> | On approach to Edinburgh Airport | |

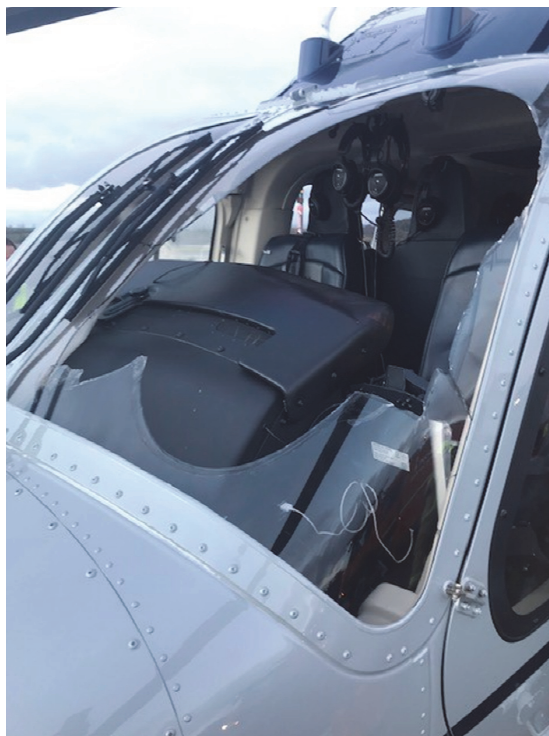
**Figure 1**

The left windscreen had shattered and remnants of the acrylic material were found throughout the cockpit and passenger area (Figure 1).

Left windscreen damage

The bird was killed in the impact and was found inside the passenger area. It was identified as a wood pigeon, weighing approximately 640g.

The helicopter manufacturer reviewed photographs of the damaged windscreen and its broken fragments. They concluded: *‘that the outcome, based on the size of bird and airspeed, is what was expected and in line with previous events’*.

M-YMCM was equipped with the stretched acrylic windscreens, which the manufacturer indicates offers additional protection over standard acrylic windscreens. Stronger, Polycarbonate windscreens are available as an option.
