## ACCIDENT

<b>Aircraft Type and Registration:</b>	Piper PA-28-181 Cherokee Archer III, G-BXTW	
<b>No &amp; Type of Engines:</b>	1 Lycoming O-360-A4M piston engine	
<b>Year of Manufacture:</b>	1998 (Serial no: 2843137)	
<b>Date &amp; Time (UTC):</b>	22 November 2018 at 1250 hrs	
<b>Location:</b>	Compton Abbas Airfield, Dorset	
<b>Type of Flight:</b>	Private	
<b>Persons on Board:</b>	Crew - 1	Passengers - None
<b>Injuries:</b>	Crew - None	Passengers - N/A
<b>Nature of Damage:</b>	Damage to right wing and tailplane	
<b>Commander's Licence:</b>	Private Pilot's Licence	
<b>Commander's Age:</b>	81 years	
<b>Commander's Flying Experience:</b>	3,165 hours (of which 3,100 were on type) Last 90 days - 5 hours Last 28 days - 2 hours	
<b>Information Source:</b>	Aircraft Accident Report Form submitted by the pilot and further enquires by the AAIB

## Synopsis

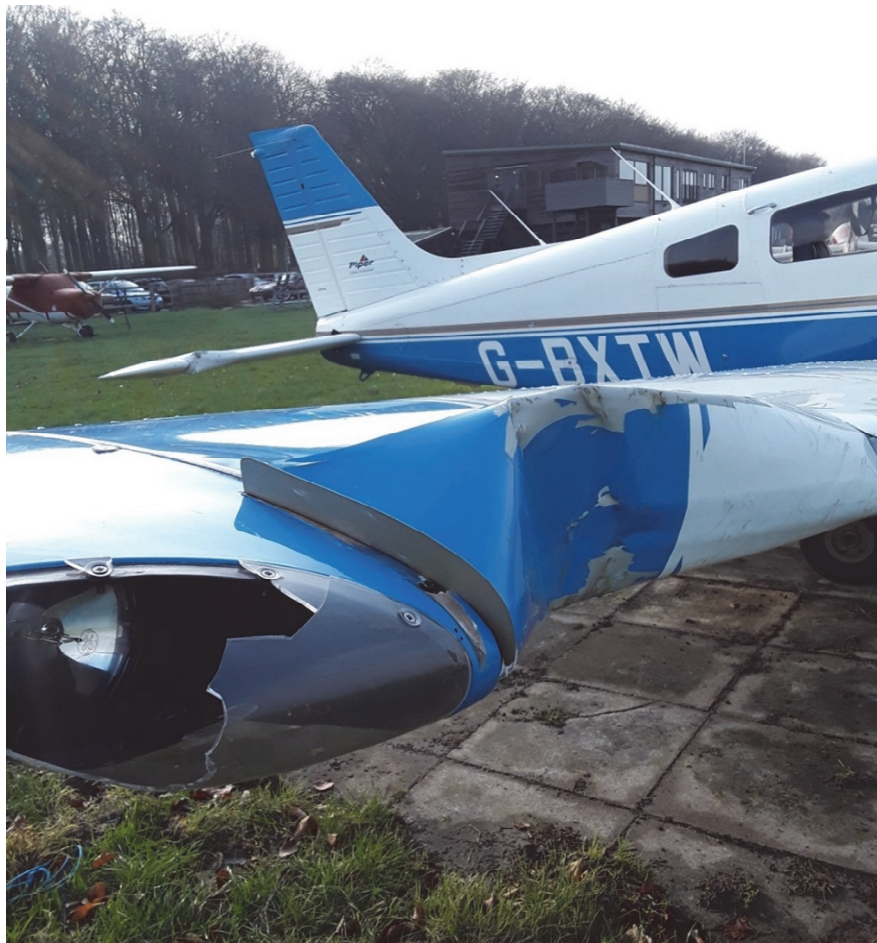
**Figure 1**

The pilot reported that he thought the approach was "normal" until he heard a bang and realised he had hit the top of trees located to the right and below the approach path. He applied power and left bank to return to the correct path. The aircraft landed normally. Damage was found to the leading edge and tip of the right wing, and to the tailplane (Figure 1).

G-BXTW after the accident showing damage to right wing and tailplane

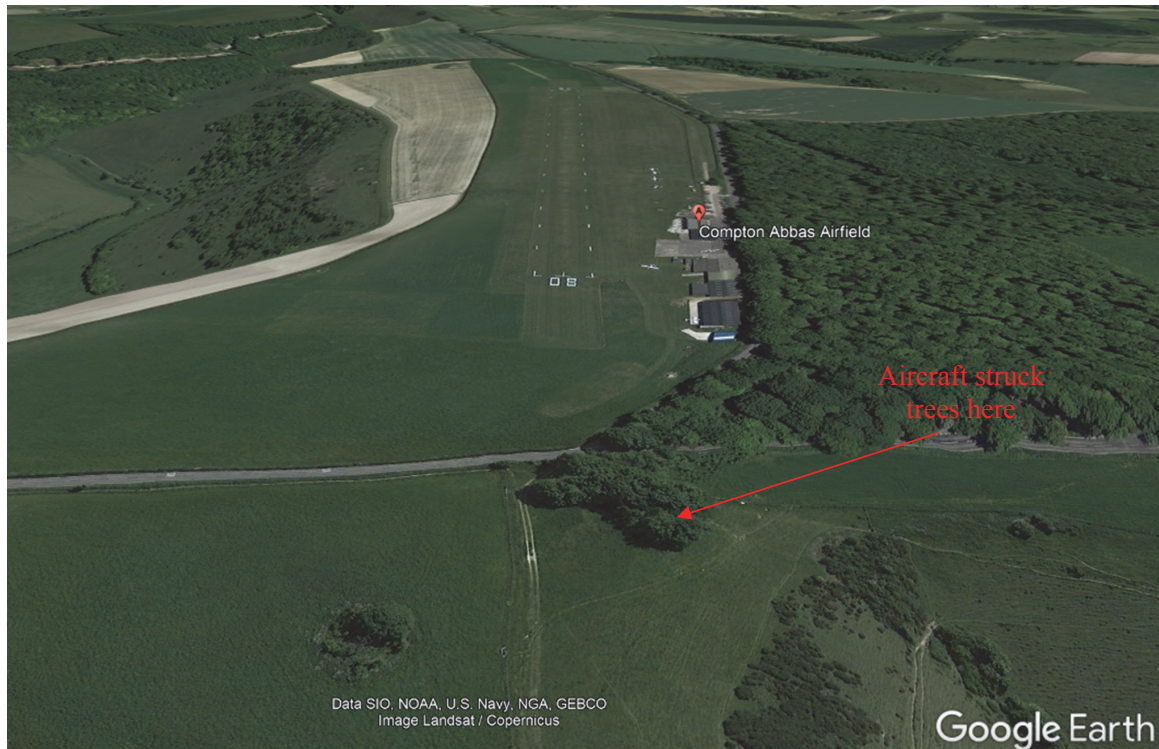
**Figure 2**

The trees the aircraft struck are located to the right of the approach path (Figure 2). The airfield operator reported that aircraft normally clear these trees by approximately 100 ft to 150 ft and that they are located approximately 100 m to the right of the straight-in approach to Runway 08.

Compton Abbas Airfield (viewed from the east)

The aerodrome operator has asked the land owner to prune these trees to reduce the chance of a similar accident occurring again.
