SERIOUS INCIDENT

Aircraft Type and Registration:	DHC-8-402 Dash 8 Q400, G-JECR	
No & Type of Engines:	2 Pratt & Whitney Canada PW150A turboprop engines	
Year of Manufacture:	2006 (Serial no: 4139)	
Date & Time (UTC):	15 November 2018 at 0807 hrs	
Location:	Exeter Airport	
Type of Flight:	Commercial Air Transport (Passenger)	
Persons on Board:	Crew - 4	Passengers - 35
Injuries:	Crew - None	Passengers - None
Nature of Damage:	None	
Commander's Licence:	Airline Transport Pilot's Licence	
Commander's Age:	39 years	
Commander's Flying Experience:	7,200 hours (of which 5,800 were on type) Last 90 days - 156 hours Last 28 days - 49 hours	
Information Source:	AAIB Field Investigation

Synopsis

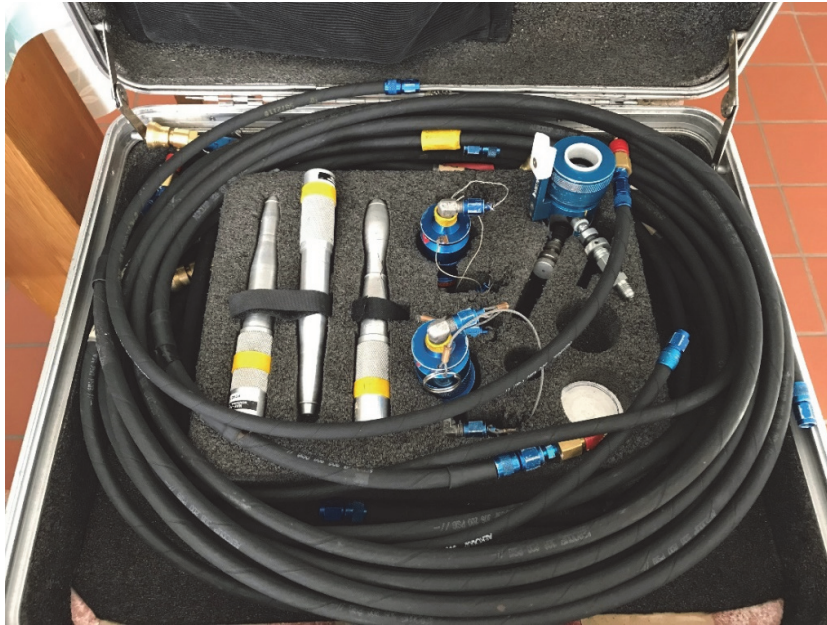
Figure 5

Air data accessory kit

The air data test kit used during the preceding maintenance period was checked and verified to be within calibration limits. The air data accessory kit used on the incident aircraft during maintenance prior to the incident flight was subjected to a visual and microscopic inspection which revealed the probe adaptors seals to be in good condition with no significant amounts of residue inside. However, a trace amount of material was recovered from the first seal

of each adaptor and the FT-IR results showed that it was a type of petroleum product, with the SEM-EX results showing elevated levels of silicone that were not consistent throughout the sample. There was evidence of damage to the knurled finish on the locking sleeves of all the adaptors.

It is recommended that Nav-Aids Ltd amend the manual supplied with air data accessory kits to include more specific installation instructions, and to include warnings against using non-approved materials to aid sealing.

The maintenance organisation has purchased new air data accessory kits and implemented tighter tool control of the kits to ensure all the components are always available.

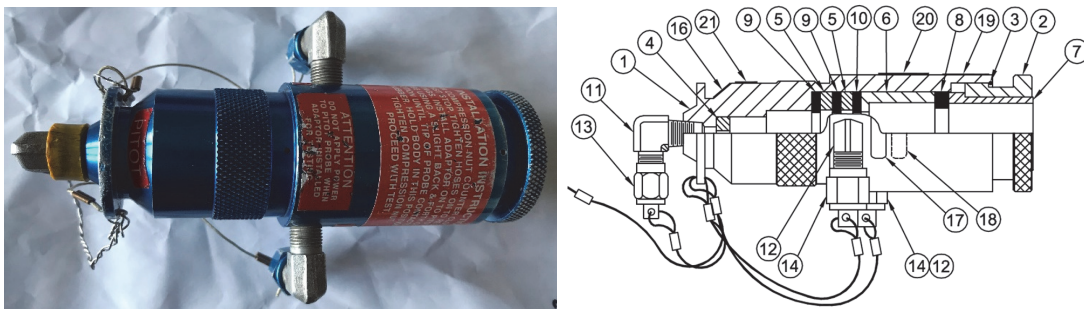
Figure 6

Primary pitot static probe adaptor

Although not a problem for all users, the avionics technicians noted that occasionally it can be difficult to establish a good seal between the pitot static probe and the adaptor resulting in incorrect air pressures being applied to the ADUs. Various remedial actions

were described: repeatedly removing and reinstalling the adaptors until a seal was achieved, using a set of adaptors from a different accessory kit, applying various products to achieve a seal or replacing with new seals. There was no consensus on a single solution which was successful every time and several products were mentioned, other than the approved lubricant, to achieve a seal but no evidence could be provided of specific occasions when they were used.

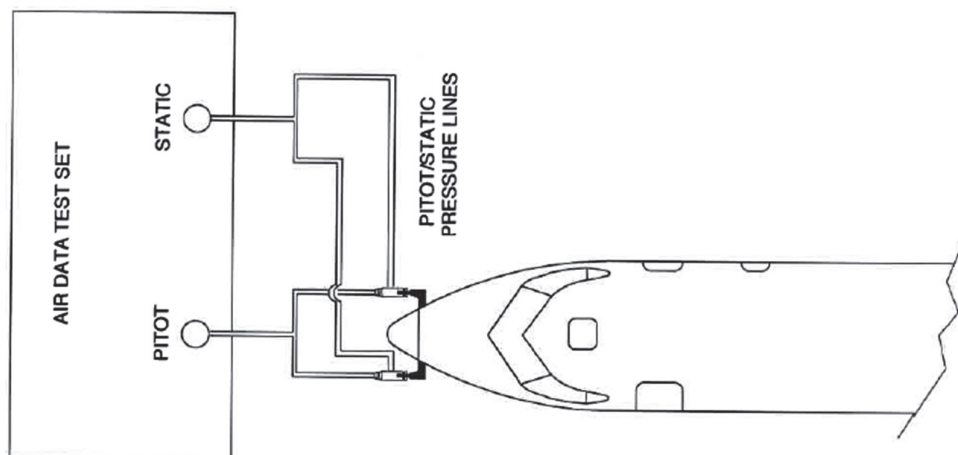
Figure 7

AMM diagram showing pitot static connections for testing

No further instructions are given, for example detailed instructions for connecting the air data accessory kit to the pitot static probes. To remove the kit, part (7) applies:

The kit manufacturer stated that the instructions for use of the air data accessory kit should be described in the relevant section of the AMM. The work orders issued by the maintenance organisation state that to accomplish a task it is to be done in accordance with the specific AMM task. However, the AMM does not provide any details on how to install the adaptors, which products should be used, or any additional information to aid the technicians to achieve a good seal between the probe and the adaptor.

It is recommended that De Havilland Aircraft of Canada Ltd amend the instructions in the Aircraft Maintenance Manual for the DHC-8-402 for testing pitot static probes to include more specific installation instructions, and to include warnings against using non-approved materials to aid sealing.
