ACCIDENT

Aircraft Type and Registration:	Piper PA-28-161 Cherokee Warrior II, G-BSZT	
No & Type of Engines:	1 Lycoming O-320-D3G piston engine	
Year of Manufacture:	1981 (Serial no: 28-8116027)	
Date & Time (UTC):	26 October 2018 at 1004 hrs	
Location:	Shoreham Airport, West Sussex	
Type of Flight:	Private	
Persons on Board:	Crew - 1	Passengers - 3
Injuries:	Crew - None	Passengers - None
Nature of Damage:	Damage to engine cowlings, exhaust and broken nose leg	
Commander's Licence:	Private Pilot's Licence	
Commander's Age:	47 years	
Commander's Flying Experience:	141 hours (of which 66 were on type) Last 90 days - 5 hours Last 28 days - 2 hours	
Information Source:	Aircraft Accident Report Form submitted by the pilot

Synopsis

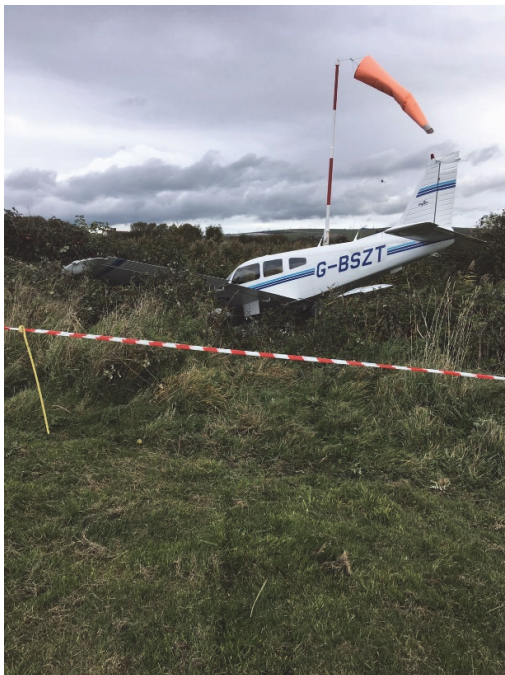
Figure 1

to yaw to the left. The pilot attempted to put the nosewheel back onto the runway by pushing on the control column, but the aircraft departed the runway to the left. Witnesses reported seeing the aircraft bounce across the grass, possibly becoming airborne momentarily due to the rough surface. They also noted that the aircraft seemed to continue at high speed for some time with no apparent reduction in power. Eventually the aircraft was seen to slow but the pilot found it difficult to stop the aircraft before it struck undergrowth. The aircraft then ran into a ditch at slow speed as shown in Figures 1 and 2.

G-BSZT came to rest in a ditch

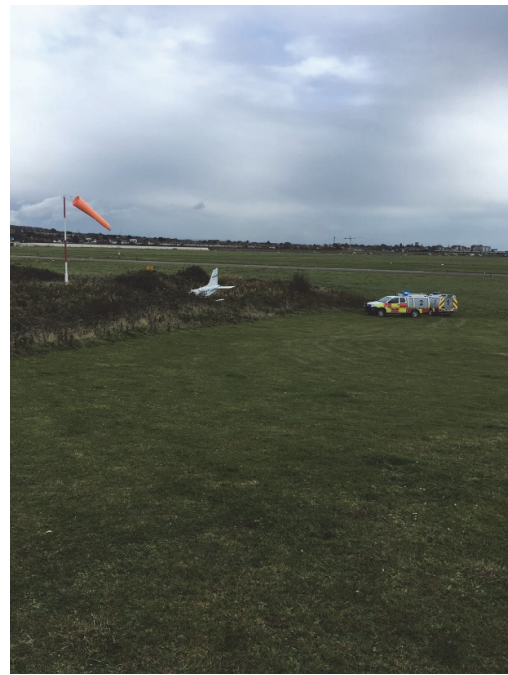
Figure 2

G-BSZT with the takeoff runway visible behind
