ACCIDENT

Aircraft Type and Registration:	Pitts S-1S Pitts Special, G-MAVK	
No & Type of Engines:	1 Lycoming IO-360-A1A piston engine	
Year of Manufacture:	1991 (Serial no: 4010)	
Date & Time (UTC):	21 October 2018 at 1130 hrs	
Location:	Near Towcester, Northamptonshire	
Type of Flight:	Private	
Persons on Board:	Crew - 1	Passengers - None
Injuries:	Crew - None	Passengers - N/A
Nature of Damage:	Wings damaged	
Commander's Licence:	Private Pilot's Licence	
Commander's Age:	47 years	
Commander's Flying Experience:	268 hours (of which 12 were on type) Last 90 days - 6 hours Last 28 days - 5 hours	
Information Source:	Aircraft Accident Report Form submitted by the pilot

Synopsis

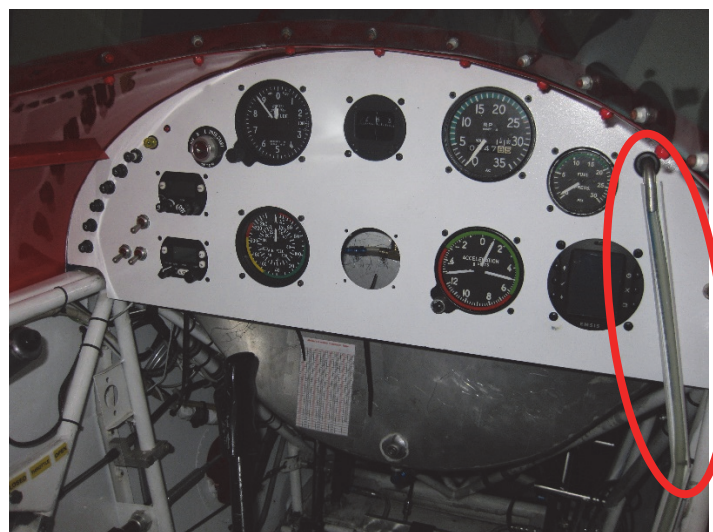
Figure 2

The fuel tank capacity was 72 litres (20 gal US) and was fitted with a sight-level fuel gauge. The pilot had recently fitted a new instrument panel and at the time of the accident there were no quantity markings on the fuel gauge (Figure 2).

Cockpit of G-MAVK with the unmarked fuel gauge highlighted

On a tailwheel aircraft such as the Pitts Special, the aircraft pitch attitude will affect the level of fuel shown in the sight gauge between level flight and the attitude on the ground. To mitigate this effect, sight gauges are usually dual-calibrated with on-ground and in-flight markings. At the time of the accident there were no markings to indicate the fuel quantity on G-MAVK and so the pilot could not accurately manage the onboard fuel quantity. This led to the engine stopping in flight due to fuel exhaustion. Although it has subsequently been discovered that a fuel union on the carburettor was loose, it is not possible to determine whether this was due to the accident or was a pre-existing defect.

Lack of fuel level markings on the fuel gauge made it difficult for the pilot to accurately manage the fuel quantity on-board, which resulted in the engine stopping due to fuel exhaustion. It has not been possible to determine whether there was a pre-existing fuel leak. The forced landing was only partially successful; although the pilot escaped with no injuries, both wings were damaged when the aircraft struck a hedge.

It is opinion of the LAA that a lack of structured conversion training resulted in the pilot not performing an effective forced landing. The LAA has recently issued a Technical Leaflet '*Converting to a New Type*' as part of a mitigation to prevent similar accidents and has given advice in their magazine '*Light Aviation*' about the importance of proper fuel gauge markings.
