**ACCIDENT**

<b>Aircraft Type and Registration:</b>	Piper PA-28-140 Cherokee, G-AYIG	
<b>No &amp; Type of Engines:</b>	1 Lycoming O-320-E2A piston engine	
<b>Year of Manufacture:</b>	1970 (Serial no: 28-26878)	
<b>Date &amp; Time (UTC):</b>	18 October 2018 at 1322 hrs	
<b>Location:</b>	West Wales Airport	
<b>Type of Flight:</b>	Private	
<b>Persons on Board:</b>	Crew - 2	Passengers - None
<b>Injuries:</b>	Crew - None	Passengers - N/A
<b>Nature of Damage:</b>	Damage to propeller and nosewheel; multiple scrapes on both wings	
<b>Commander's Licence:</b>	Private Pilot's Licence	
<b>Commander's Age:</b>	77 years	
<b>Commander's Flying Experience:</b>	1,065 hours (of which 547 were on type) Last 90 days - 8 hours Last 28 days - 4 hours	
<b>Information Source:</b>	Aircraft Accident Report Form submitted by the pilot

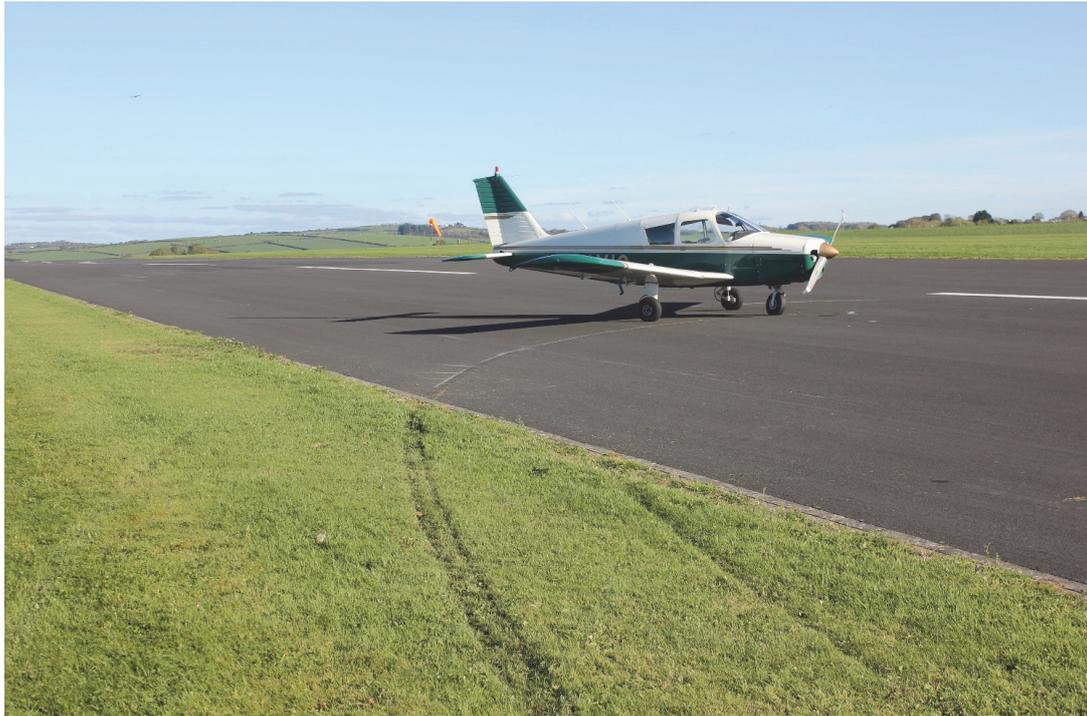
**Figure 1**

The pilot was completing his third circuit and planned to execute a practice forced landing (PFL) on Runway 07 from mid-way along the downwind leg. There was some right drift on short final on the previous landings, so he offset the PFL approach to the left of the runway extended centreline. The expected right drift did not occur, so the pilot rolled the aircraft to the right to regain the centreline. The aircraft's response was greater than expected, possibly due to the northerly crosswind lifting the left wing, causing the right wing, and the propeller to contact the runway surface. The aircraft slewed across the runway, departing the left side. It skidded left as it rotated to the right, returning to the runway as it did so. The left wing then contacted the runway surface before the aircraft came to rest (Figure 1).

The pilot commented that he had overestimated the effect of the crosswind and his attempt to re-align with the runway centreline caused the aircraft to roll excessively. He suggested a number of factors which may have contributed to the event. Most significantly, he identified that he was overly confident that he could recover the situation once it had diverged from the initial plan, so continued to attempt to land the aircraft rather than going around.

G-AYIG once it had come to rest (note the ground marks showing the path of travel)
