SERIOUS INCIDENT

Aircraft Type and Registration:	Boeing 737-8AS, EI-GJT	
No & Type of Engines:	2 CFM56-7B26E turbofan engines	
Year of Manufacture:	2018 (Serial no: 44837)	
Date & Time (UTC):	9 October 2018 at 2205 hrs	
Location:	En route from Porto Airport, Portugal to Edinburgh Airport	
Type of Flight:	Commercial Air Transport (Passenger)	
Persons on Board:	Crew - 6	Passengers - 177
Injuries:	Crew - None	Passengers - None
Nature of Damage:	None reported	
Commander's Licence:	Air Transport Pilot's Licence	
Commander's Age:	61 years	
Commander's Flying Experience:	19,500 hours (of which 350 were on type) Last 90 days - 170 hours Last 28 days - 60 hours	
Information Source:	AAIB Field Investigation

Synopsis

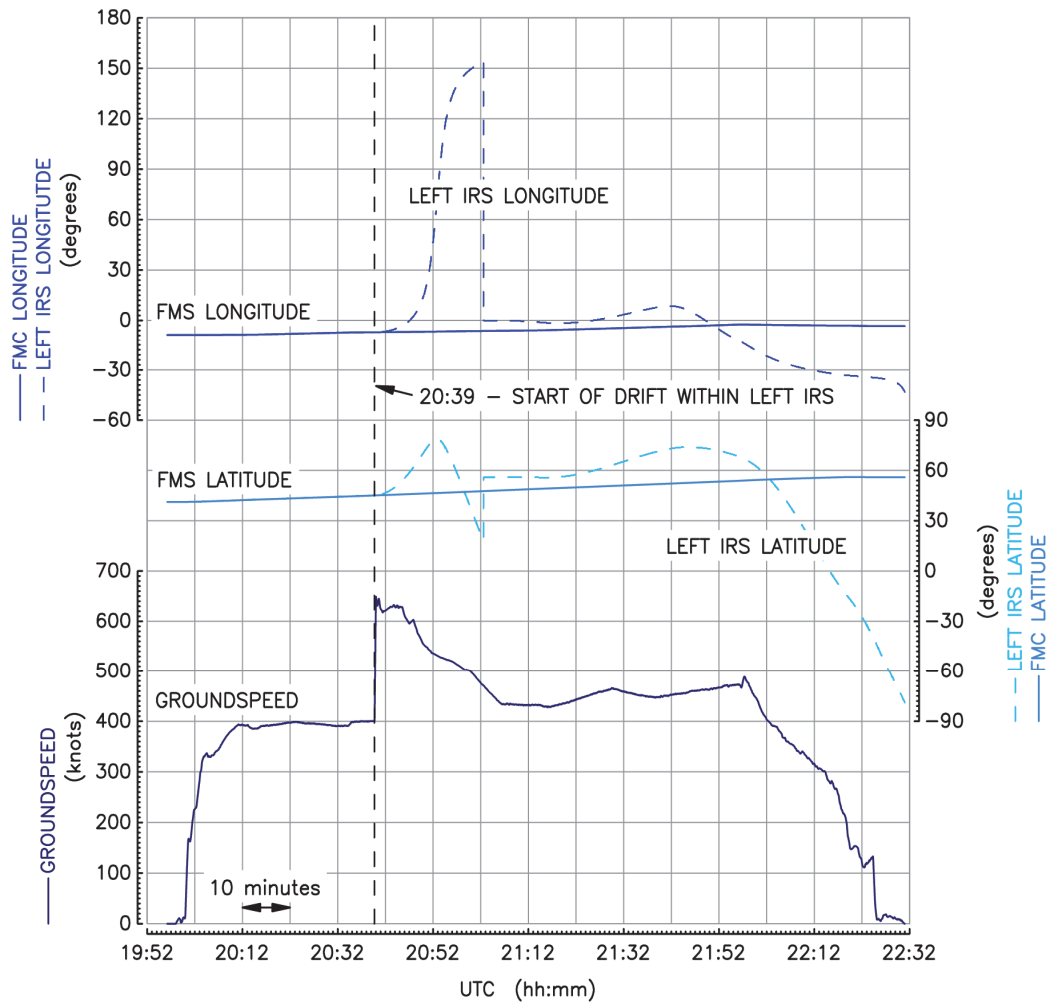
Figure 1
Left IRS latitude and longitude drift during the flight

Figure 1 is a plot of the aircraft's latitude and longitude, recorded from the Flight Management Computer (FMC) and the left IRS, together with the groundspeed indicated on the commander's PFD. The figure shows that at 2039 hrs the latitude and longitude in the left IRS began to drift with a corresponding 250 kt jump in the indicated groundspeed.

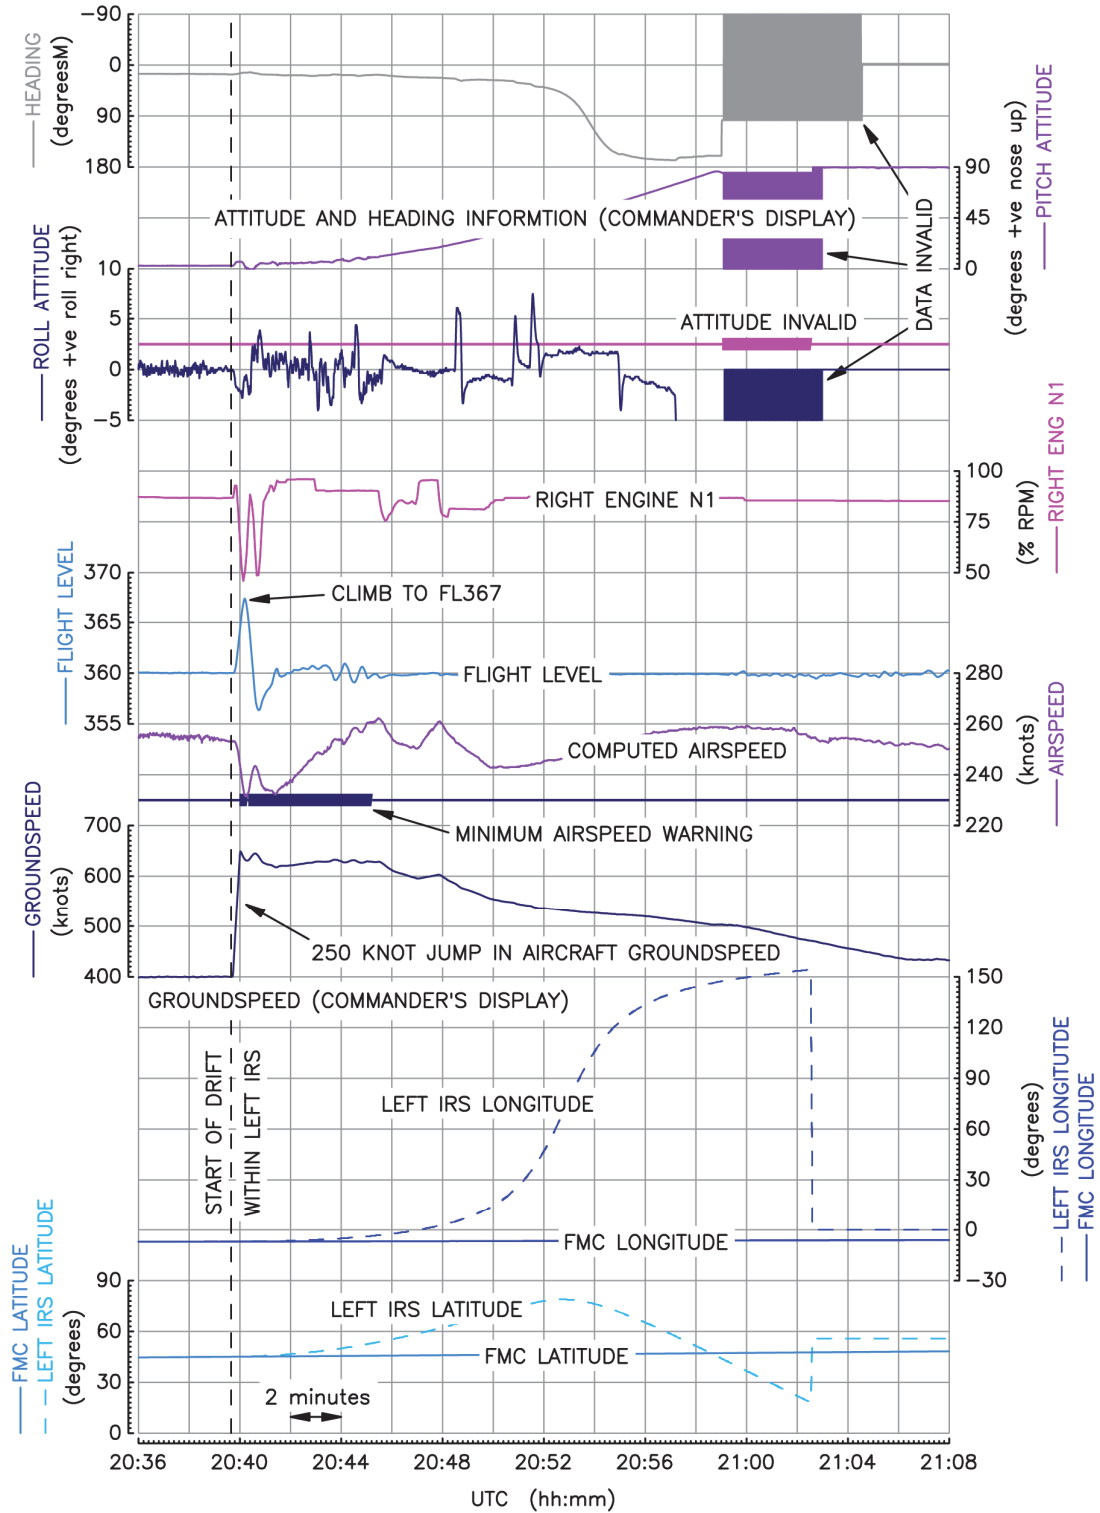
Figure 2
Salient FDR data during left IRS drift event

Figure 2 is a closeup of salient parameters recorded on the FDR from when the left IRS started to drift until just after the failed attitude indication was given. Highlighted in the figure shortly after the drift started are the climb to FL367 from FL360, the increase in N_1 to 95%, the pitch up, and the decrease in airspeed from about 250 kt to below 232 kt when a minimum airspeed warning was triggered. The erroneous attitude, heading and groundspeed information presented to the commander are also plotted and show the pitch attitude increasing to 90° and the heading changing by nearly 180° over a period of about 20 minutes, after which the aircraft issued an indication of invalid attitude information.

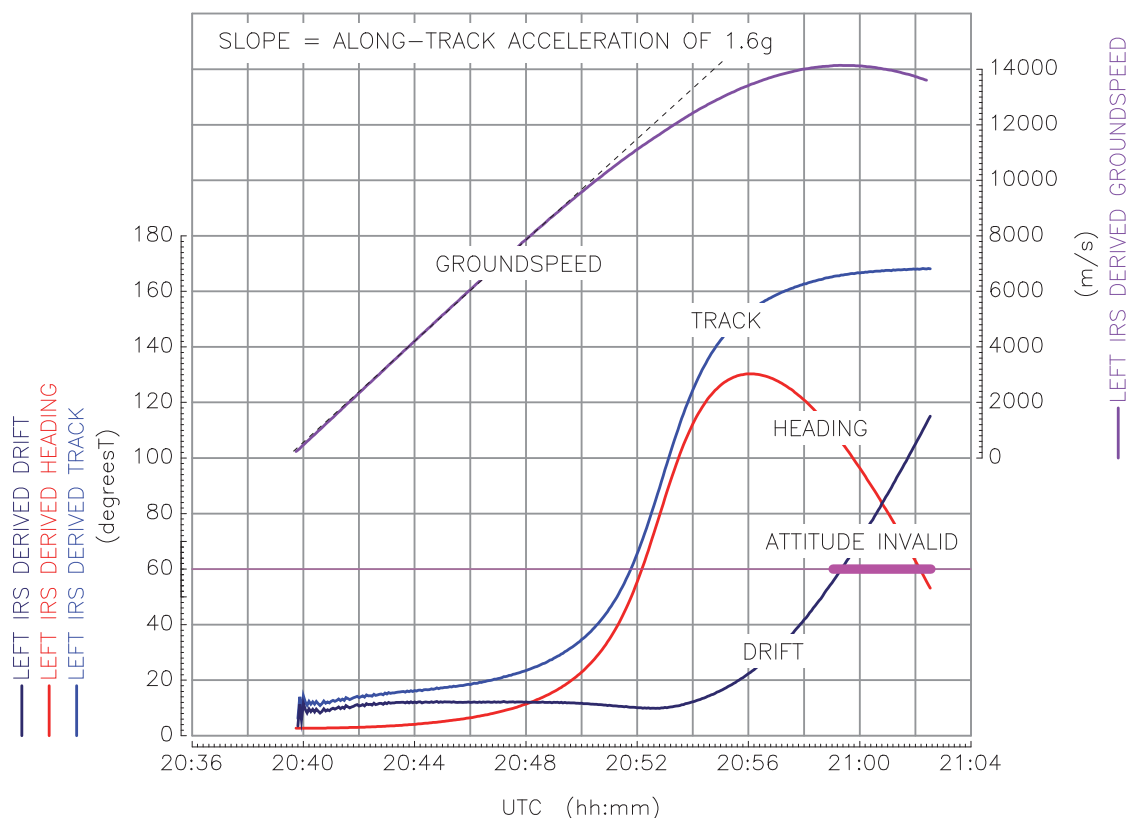
parameters are reproduced in Figure 3 and show that the drift in latitude and longitude was initially driven by an along-track acceleration of about 1.6 g. The figure also shows that when the aircraft issued an indication that the attitude information was invalid, the left IRS drift had just reached 60°.

Left IRS derived data based on its recorded latitude and longitude

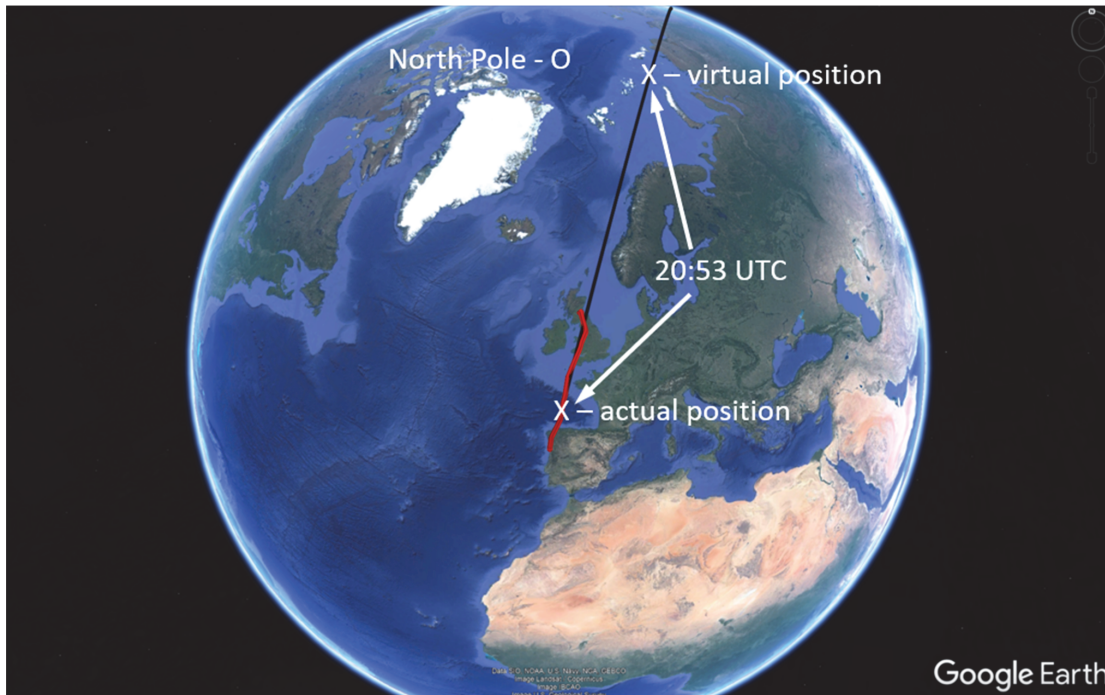
Figure 4

The data downloaded from the left ADIRU showed the unit experienced a drift angle test fault whilst in inertial reference navigation mode. The QAR data showed that this was caused by a longitudinal acceleration offset, which manifested itself as a 1.6 g acceleration in the along-track sense. This, and the resultant groundspeed error, induced an ADIRU positional error along the aircraft track, which led to a left IRS position that passed east of the north pole (Figure 4). As the flight progressed, the positional error increased leading to the spurious attitude indication on the PFD experienced by the crew.

FMC ground track (red) and left IRS ground track (black)
