## ACCIDENT

<b>Aircraft Type and Registration:</b>	Czech Sport Aircraft Sportcruiser, G-CGEO	
<b>No &amp; Type of Engines:</b>	1 Rotax 912 ULS piston engine	
<b>Year of Manufacture:</b>	2009 (Serial no: 09SC303)	
<b>Date &amp; Time (UTC):</b>	7 October 2018 at 1445 hrs	
<b>Location:</b>	Fowlmere Aerodrome, Cambridgeshire	
<b>Type of Flight:</b>	Private	
<b>Persons on Board:</b>	Crew - 1	Passengers - 1
<b>Injuries:</b>	Crew - None	Passengers - None
<b>Nature of Damage:</b>	Right main landing gear leg damaged	
<b>Commander's Licence:</b>	Light Aircraft Pilot's Licence	
<b>Commander's Age:</b>	75 years	
<b>Commander's Flying Experience:</b>	1,048 hours (of which 350 were on type) Last 90 days - 8 hours Last 28 days - 3 hours	
<b>Information Source:</b>	Aircraft Accident Report Form submitted by the pilot and further enquiries by the AAIB

## Synopsis

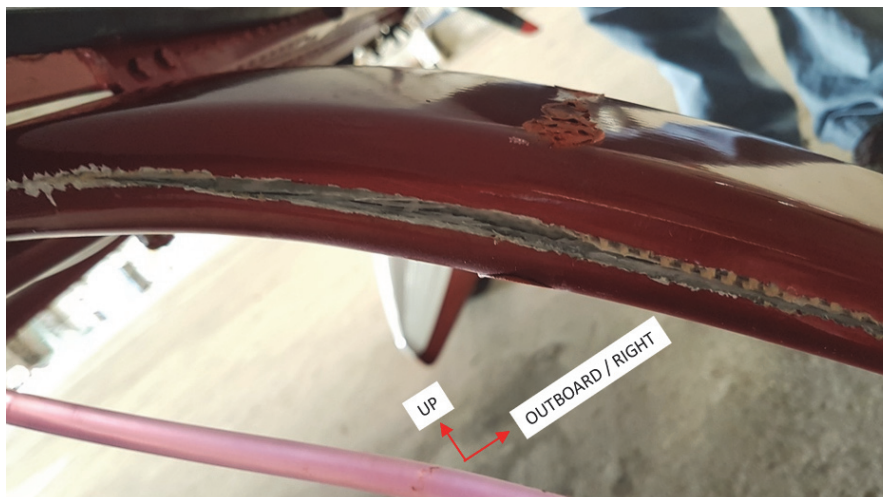
**Figure 1**  
Damage to right MLG leg

The pilot, accompanied by one passenger, flew the aircraft on a 20-minute flight from Graveley Airstrip, Hertfordshire, to Fowlmere Aerodrome. The pilot stated that the landing at Fowlmere was smooth and that the taxi to the parking area was uneventful. After vacating the aircraft, the pilot noticed that a large crack was present in the rear face of the right MLG leg (Figure 1). The leg retained sufficient residual strength to support the aircraft when parked.

The calculated landing weight for the landing at Fowlmere was 592 kg, below the MTOM of 600 kg. The pilot stated that no cracks were visible in either MLG leg during the pre-flight inspection of the aircraft. A second member of the aircraft's owner group stated that the aircraft, when parked in a hangar, had been sitting 10 cm right wing low during the month preceding the accident with the tyres correctly inflated.

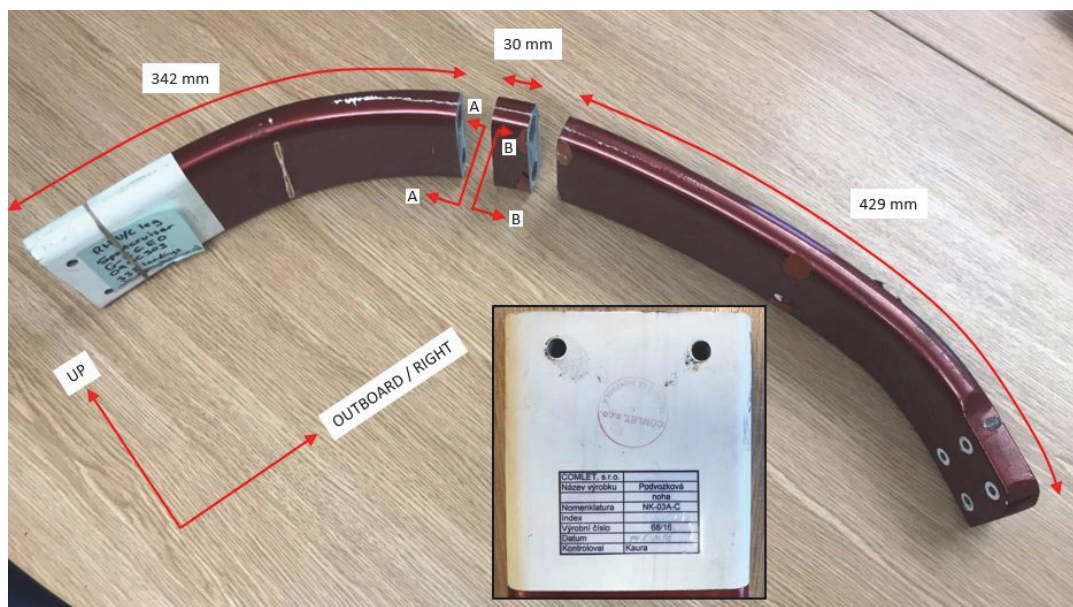
**Figure 2**

The damaged right MLG leg was examined by the AAIB to determine the cause of the failure. The visible crack in the rear face of the leg was 239 mm long. The leg was cut into three sections (Figure 2).

Sectioning of right MLG leg (leg dataplate image inset)

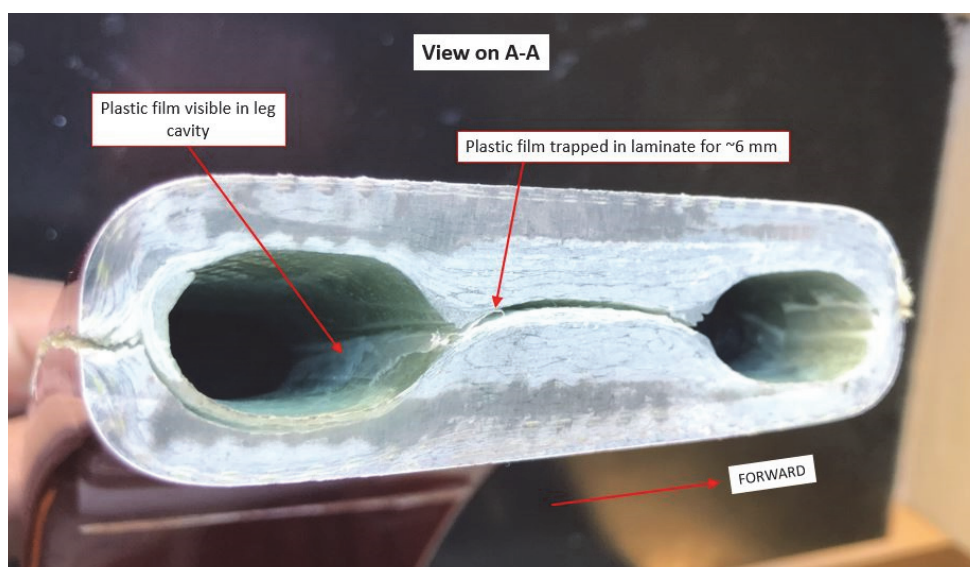
**Figure 3**

When the leg was cut open, plastic film was visible within the rear hole (Figure 3). Approximately 6 mm of the plastic film was trapped within the laminate between the rear and forward holes at section A-A.

View on section A-A

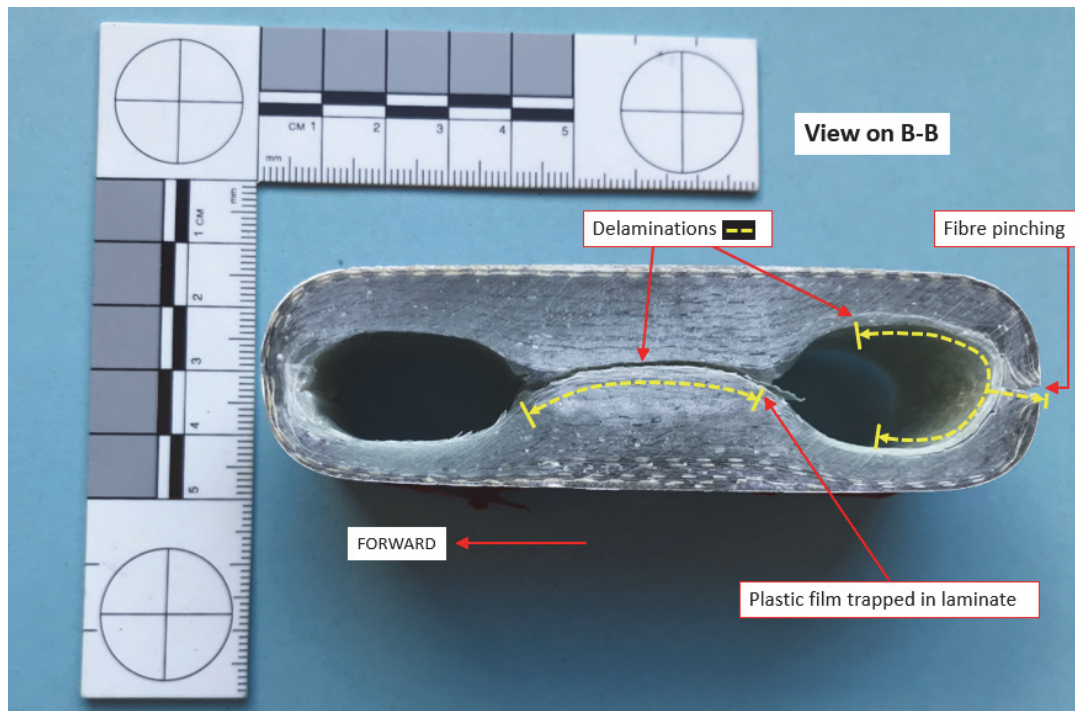
**Figure 4**  
View on section B-B

The leg's composite structure had delaminated between the forward and rear holes (Figure 4). Additional delaminations were observed around the rear half of the rear hole, and between the rear hole and the aft face of the leg section. A small area of fibre pinching was also present at the rear of the leg section.

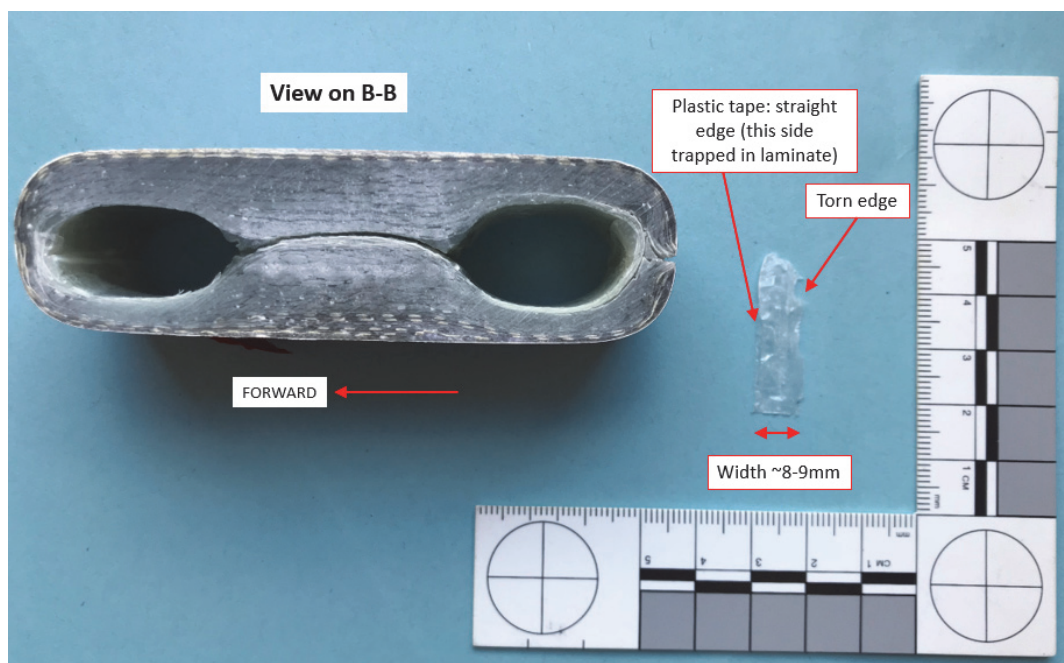
**Figure 5**

A sample of the plastic film, measuring approximately 29 mm long by 8 mm wide, was recovered from the leg for laboratory analysis (Figure 5). Additional internal inspection of the leg revealed that the trapped plastic film was present within the rear leg hole over a length of approximately 260 mm, aligned with the external crack in the leg's aft face.

The plastic film sample recovered from the leg, shown in Figures 4 and 5, was analysed using FTIR<sup>3</sup> spectroscopy along with a sample of the stretch film used in the production process of the leg, supplied by the aircraft manufacturer. This analysis showed that the sample was the same material as that used in production of the leg.

Plastic film sample recovered at section B-B

The stretch film material was used during the manufacturing process of the leg and it did not form part of the leg's intended structural design. Pressure loads applied to the rear inflatable tube during the lamination process pushed the stretch film into the forward corner void of the rear section hole and the film became permanently trapped once the epoxy resin had cured. The torn edge of the rear length of the trapped stretch film material was created when the bulk of the stretch film was pulled from the rear section hole after the epoxy resin had cured, leaving the trapped portion behind.

The aircraft manufacturer is currently certifying a reinforced MLG leg, part number SG0160L/P, intended to increase the durability of the legs in service. This new MLG will be available for retrofit to all models of Sportcruiser and PS-28 Cruiser aircraft. In addition to slightly enlarging the MLG leg cross-section, the inflatable tubes and stretch film material used during leg manufacture are now surrounded by a woven glass fibre 'sock', to prevent radial migration of the stretch film into the leg's composite structure.
