**ACCIDENT**

| <b>Aircraft Type and Registration:</b> | Grob G115E Tutor, G-BYUU | |
| <b>Date &amp; Time (UTC):</b> | 2 October 2018 at 1115 hrs | |
| <b>Location:</b> | RAF Wittering, Cambridgeshire | |

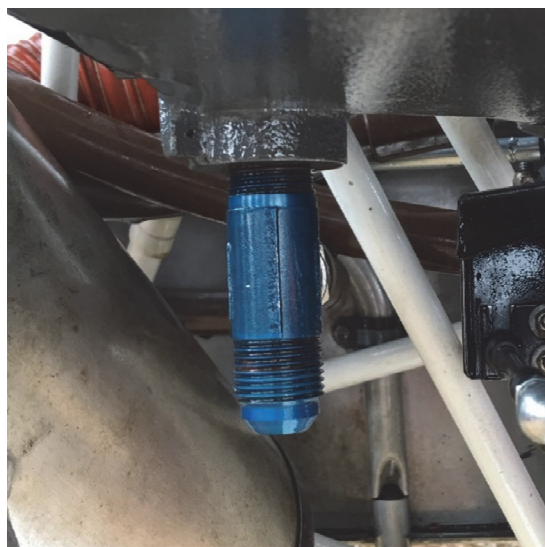
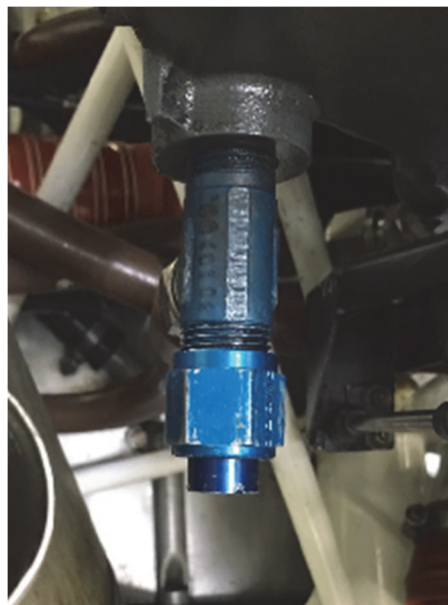
**Figure 1**

Examination found that the engine oil sump drain cap was missing (Figure 1). Loss of the cap resulted in an oil leak and engine seizure.

There is no requirement for the oil cap to be wire locked on the Grob 115E, which is equipped with a modified (inverted) engine oil system to cater for aerobatic manoeuvres. The maintenance organisation considered that the most likely scenario is that the drain cap was not correctly secured after the engine was installed.

Grob 115E engine oil sump drain  
(Left image shows cap missing; right image shows cap installed)

The maintenance organisation is reviewing their procedures and, as part of their continuous airworthiness management, is liaising with the manufacturer about an alternative cap that can be wire locked. In the interim, they have introduced an independent check to ensure that the cap is correctly refitted.
