ACCIDENT

Aircraft Type and Registration:	Flight Design CTSW, G-KEVK	
No & Type of Engines:	1 Rotax 912 ULS piston engine	
Year of Manufacture:	2009 (Serial no: 8483)	
Date & Time (UTC):	15 September 2018 at 1742 hrs	
Location:	4.5 miles north of Sywell Aerodrome	
Type of Flight:	Private	
Persons on Board:	Crew - 2	Passengers - None
Injuries:	Crew - None	Passengers - N/A
Nature of Damage:	Aircraft damaged beyond repair	
Commander's Licence:	National Private Pilot's Licence	
Commander's Age:	46 years	
Commander's Flying Experience:	541 hours (of which 345 were on type) Last 90 days - 14 hours Last 28 days - 1 hour	
Information Source:	Aircraft Accident Report Form submitted by the pilot

Synopsis

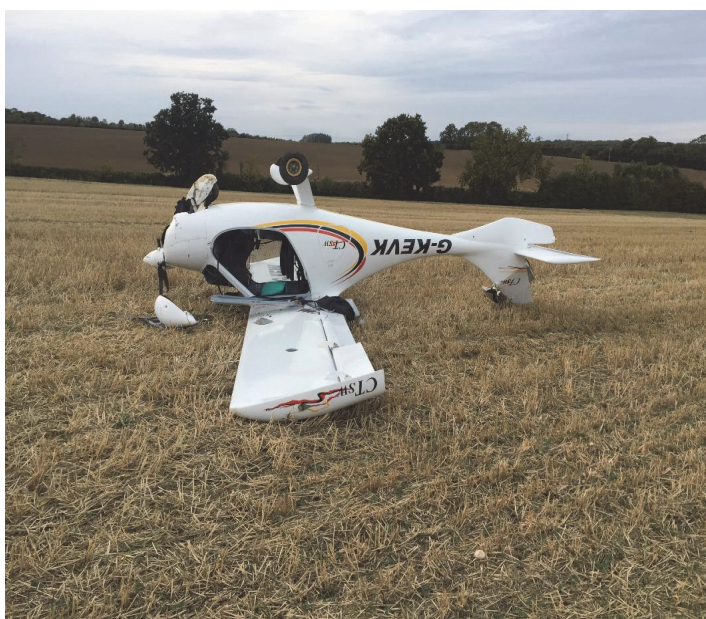
Figure 1

As they approached approximately 5 nm from the airfield, the pilots heard the engine 'cough' and then stop. The pilot who was flying the aircraft at the time began to scan for a suitable field. He observed that most of the fields appeared newly ploughed but that there was a long field that looked to have a stubble surface although it was not into wind. The pilot considered that there was little or no other choice than to accept a downwind landing into this field as he did not have the height to position the aircraft for an into-wind landing. As a result, the touchdown was at a higher groundspeed than the pilot would have liked. The aircraft type is not fitted with suspension and has disc brakes on its main wheels. The pilot was beginning to apply the brakes gently to avoid locking the wheels when the nose dropped suddenly and the aircraft lurched forward, coming to rest upside down as show in Figure 1.

The final position of the aircraft

The aircraft landed in a field of stubble which contained numerous tractor furrows. The CTSW undercarriage is not constructed for rough terrain and photographs of the accident site suggested that the nosewheel struck a tractor furrow before the aircraft speed had been reduced significantly. This caused the collapse of the nose landing gear and pitched the aircraft onto its roof. Both occupants were able to vacate the aircraft unaided and neither suffered any injuries.

The flying pilot positioned the aircraft for a forced landing in a suitable field but was not at a height at which he could manoeuvre to approach the landing into wind. The extra speed of the downwind landing combined with the nose striking a tractor furrow before the speed had decreased pitched the aircraft onto its roof. Neither occupant was injured.
