**ACCIDENT**

<b>Aircraft Type and Registration:</b>	RAF 2000 GTX-SE, G-BXDE	
<b>No &amp; Type of Engines:</b>	1 Subaru EJ22 piston engine	
<b>Year of Manufacture:</b>	2000 (Serial no: PFA G/13-1280)	
<b>Date &amp; Time (UTC):</b>	14 September 2018 at 0955 hrs	
<b>Location:</b>	North Weald Airfield, Essex	
<b>Type of Flight:</b>	Private	
<b>Persons on Board:</b>	Crew - 2	Passengers - None
<b>Injuries:</b>	Crew - 1 (Serious) 1 (Minor)	Passengers - N/A
<b>Nature of Damage:</b>	Extensive	
<b>Commander's Licence:</b>	Private Pilot's Licence	
<b>Commander's Age:</b>	62 years	
<b>Commander's Flying Experience:</b>	904 hours (of which 100 were on type) Last 90 days - 16 hours Last 28 days - 5 hours	
<b>Information Source:</b>	Aircraft Accident Report Form submitted by the pilot and further enquires by the AAIB

**Synopsis**

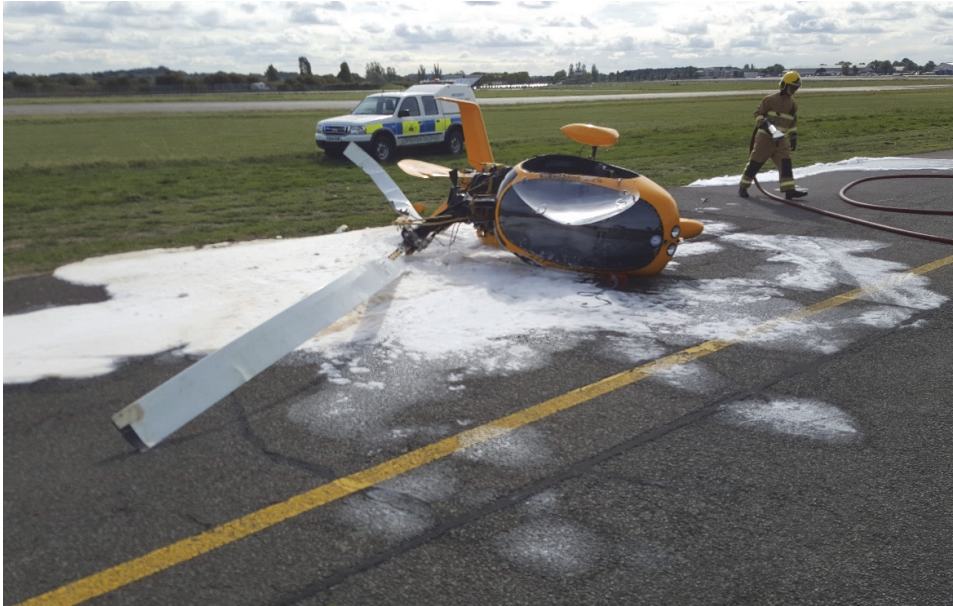
The gyroplane initially struck the ground on its right side, on the grass to the right of Runway 20. It stopped on the parallel taxiway (Figure 2). The pilot was able to exit the gyroplane unaided and helped the examiner out. The examiner suffered three broken vertebrae and multiple cuts and bruises. The pilot suffered minor injuries.

**Figure 2**  
G-BXDE after the accident

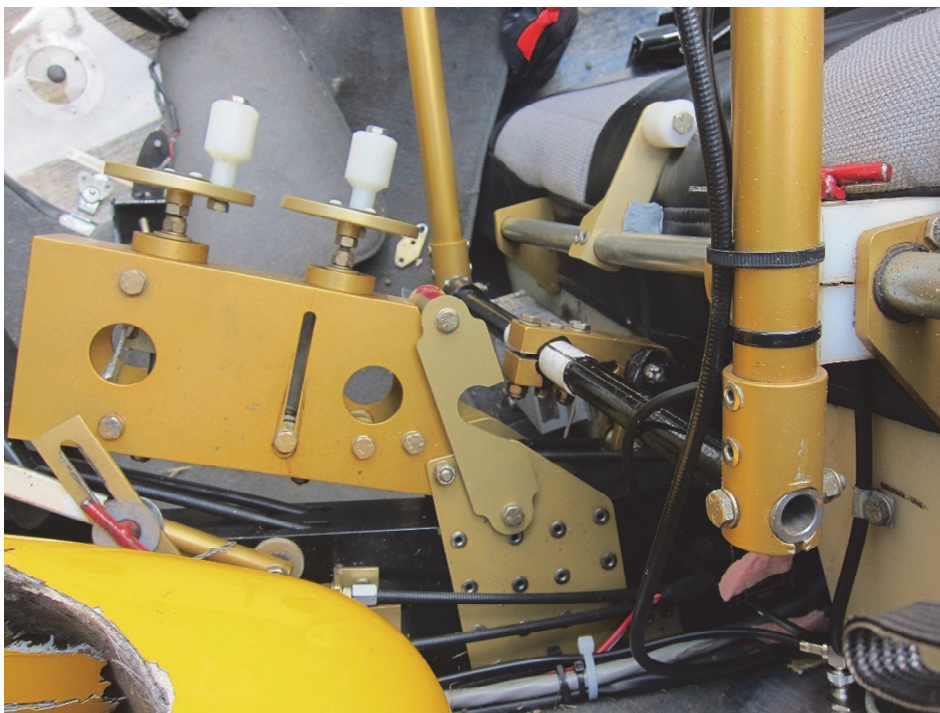
The pilot examined the gyroplane after the accident and found the gust lock was not engaged (Figure 3). However, it could not be determined if the gust lock had disengaged during the accident sequence.

**Figure 3**  
Photo taken after the accident showing the gust lock disengaged

The examiner believes that the gust lock was left engaged which is why the rotor disc was not tipped fully back during the takeoff roll. After the accident the gust lock was found disengaged but it is possible that this happened during the accident sequence. The pilot recalls disengaging the gust lock when he boarded the gyroplane. However, he may have reapplied the lock whilst trying to release the rotor brake. It is possible this distraction and change of routine meant that the gust lock was left engaged. The flight controls were not checked for full and free motion prior to commencing the takeoff. If the gust lock had been left engaged, a full and free check is likely to have uncovered this omission.
