ACCIDENT

Aircraft Type and Registration:	Pulsar, G-LUED	
No & Type of Engines:	1 Rotax 582 piston engine	
Year of Manufacture:	1996 (Serial no: PFA 202-12122)	
Date & Time (UTC):	31 August 2018 at 1800 hrs	
Location:	Sturgate Airfield, Lincolnshire	
Type of Flight:	Private	
Persons on Board:	Crew - 1	Passengers - 1
Injuries:	Crew - 1 (Minor)	Passengers - None
Nature of Damage:	Broken canopy, nose and propeller	
Commander's Licence:	Private Pilot's Licence	
Commander's Age:	76 years	
Commander's Flying Experience:	475 hours (of which 375 were on type) Last 90 days - 4 hours Last 28 days - 2 hours	
Information Source:	Aircraft Accident Report Form submitted by the pilot and further AAIB enquiries

Synopsis

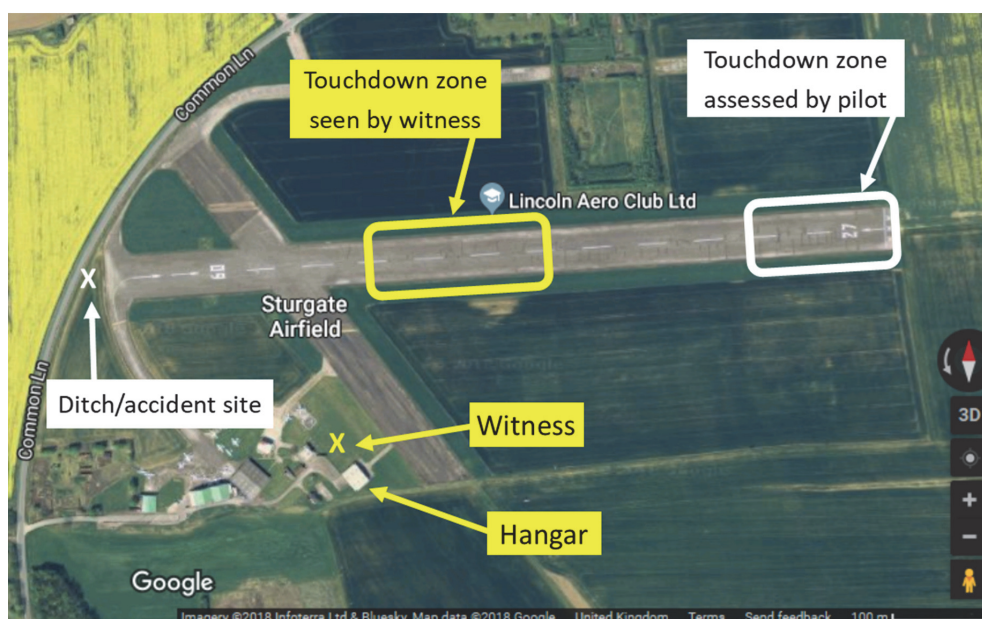
Figure 2

G-LUED's approach and landing was witnessed by a second pilot who had recently landed and was standing to the south of the main runway. He judged that the touchdown point was significantly inset into the runway (Figure 2) and he heard G-LUED's engine note rise as if the pilot was attempting an aborted-landing go-around. He did not see the aircraft enter the ditch but ran over to it as soon as he realised there had been an accident. On arriving at the scene, he found two passers-by, who had been driving on Common Lane, helping the occupants of G-LUED.

Overview of Sturgate Airfield
