## ACCIDENT

<b>Aircraft Type and Registration:</b>	Rotorsport UK Cavalon, G-CKYV	
<b>No &amp; Type of Engines:</b>	1 Rotax 914-UL piston engine	
<b>Year of Manufacture:</b>	2018 (Serial no: RSUK/CVLN/026)	
<b>Date &amp; Time (UTC):</b>	9 August 2018 at 1306 hrs	
<b>Location:</b>	Wolverhampton Halfpenny Green Airport	
<b>Type of Flight:</b>	Private	
<b>Persons on Board:</b>	Crew - 1	Passengers - None
<b>Injuries:</b>	Crew - None	Passengers - N/A
<b>Nature of Damage:</b>	Damaged beyond economic repair	
<b>Commander's Licence:</b>	Private Pilot's Licence	
<b>Commander's Age:</b>	67 years	
<b>Commander's Flying Experience:</b>	701 hours (of which 13 were on type) Last 90 days - 95 hours Last 28 days - 24 hours	
<b>Information Source:</b>	Aircraft Accident Report Form submitted by the pilot

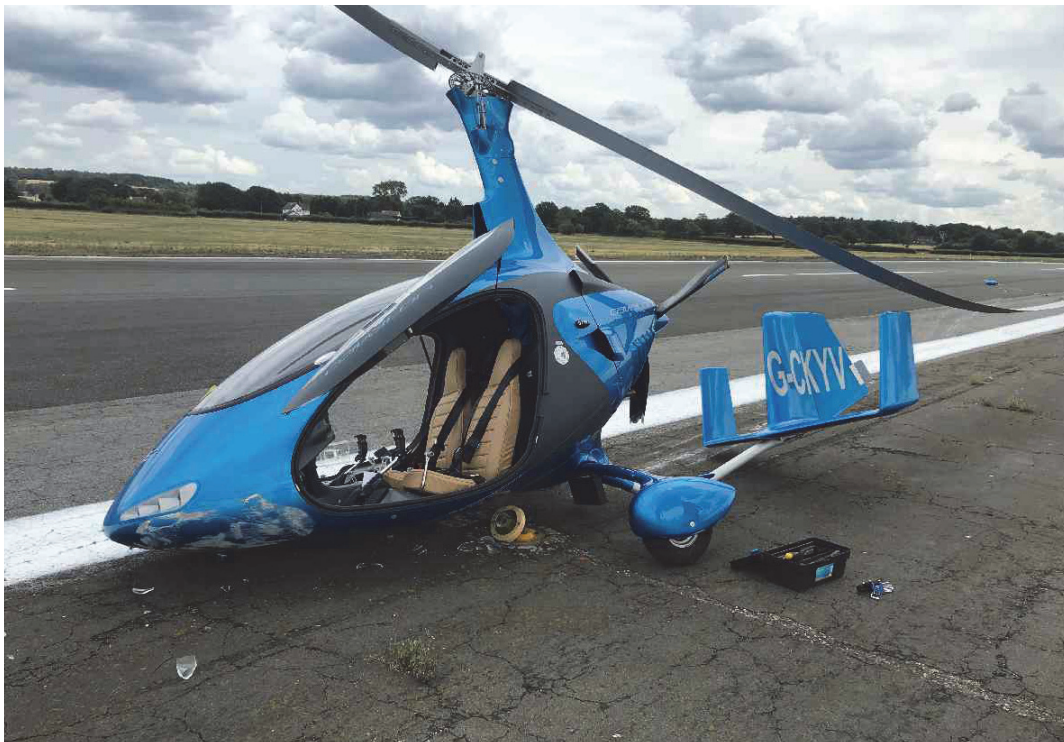
The rotor was being pre-rotated in preparation for departure. The pilot recalled seeing 200 rpm but shortly thereafter noticed the rotor rpm indication had dropped to zero. Concerned that the rotors might now be rotating below 200 rpm he decided to attempt to increase the rotor rpm by commencing a takeoff roll. At approximately 30 kt the cyclic control moved violently and was wrenched from the pilot's grasp. The aircraft pitched up, yawed left and rolled left before falling upright and sliding along the runway.

**Figure 1**  
Aircraft on the runway

At low rotor rpm, blade sailing can cause the rotor disc to move violently. It is probable that G-CKYV encountered a blade sailing event as the airspeed increased and the rapid movement of the rotor disc forced the controls from the pilots grasp. Though he reduced power, he was unable to effectively counter the motion of the aircraft.
