**ACCIDENT**

<b>Aircraft Type and Registration:</b>	Skystar Kitfox Mk 7, G-FBCY	
<b>No &amp; Type of Engines:</b>	1 Rotax 912ULS piston engine	
<b>Year of Manufacture:</b>	2015 (Serial no: PFA 172D-14696)	
<b>Date &amp; Time (UTC):</b>	5 August 2018 at 1730 hrs	
<b>Location:</b>	Field near Rugby, Warwickshire	
<b>Type of Flight:</b>	Private	
<b>Persons on Board:</b>	Crew - 1	Passengers - 1
<b>Injuries:</b>	Crew - 1 (Minor)	Passengers - 1 (Minor)
<b>Nature of Damage:</b>	Propeller, engine, nosewheel strut and right wing	
<b>Commander's Licence:</b>	Private Pilot's Licence	
<b>Commander's Age:</b>	64 years	
<b>Commander's Flying Experience:</b>	246 hours (of which 49 were on type) Last 90 days - 4 hours Last 28 days - 1 hour	
<b>Information Source:</b>	Aircraft Accident Report Form submitted by the pilot and subsequent AAIB enquiries

**Synopsis**

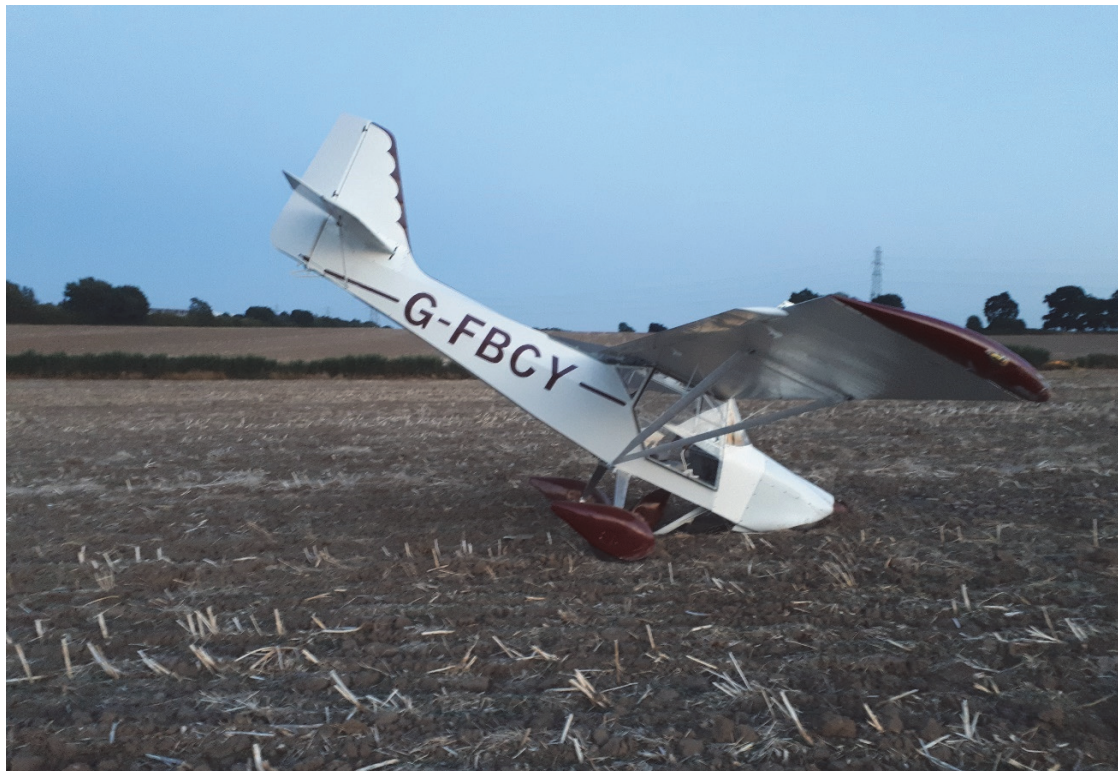
**Figure 1**  
G-FBCY after landing

and had a slight uphill gradient. After touching down, the nosewheel collapsed and the propeller struck the ground (Figure 1). The pilot and his passenger suffered only minor injuries and were able to exit the aircraft unaided.

Following the loss of thrust, presented with the unusual and confusing situation in which the engine seemed to be operating normally, albeit overspeeding, the pilot considered that he may have spent too much time trying to diagnose and manage the situation before making the decision to execute a forced landing. He subsequently estimated that the engine may have been running for more than one minute in excess of 7,000 rpm. The aircraft lost height and speed during this time and as a result the forced landing was more hurried than he would have liked, which may have contributed to the nosewheel collapse after touchdown.

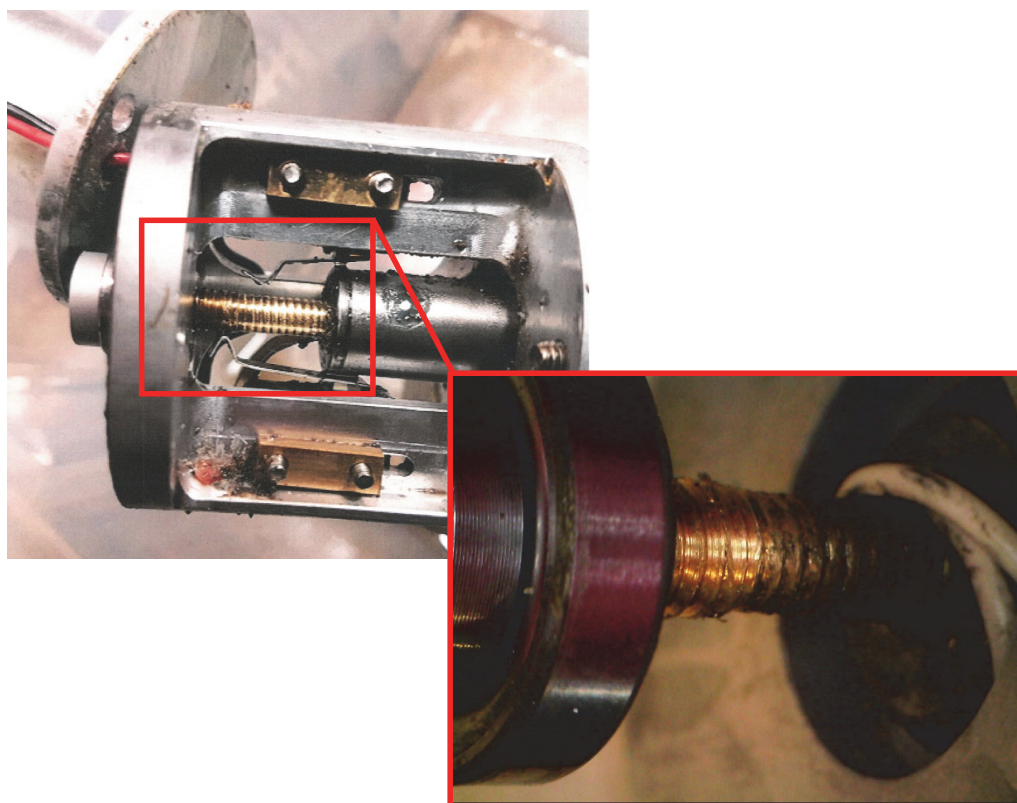
**Figure 2**

Further examination and disassembly of the propeller pitch-change mechanism identified that the screw thread was stripped on the lead screw within the motor, such that the blade pitch was free to move at will (Figure 2). It was considered that this had allowed the propeller blades to migrate beyond the electrical fine pitch limit microswitch, into a super-fine pitch regime, leading to a loss of thrust. Following a period running at excessive speed, the engine would have begun to fail. As the engine stopped developing power and the rpm dropped, it is likely that aerodynamic loading on the propeller blades caused them to move back towards a coarse pitch setting.

Motor from G-FBCY's propeller pitch-change mechanism showing the stripped thread on the lead screw (*Photographs courtesy of pilot / LAA*)

The propeller manufacturer’s service instructions required the lead screw to be removed, cleaned, inspected and lubricated every 50 hours, but these service instructions had not been correctly followed, leading to a lack of adequate lubrication. As a result of that incident, on 6 February 2008 the LAA published Airworthiness Information Leaflet (AIL) MOD/PROP/08-007 titled ‘*Arplast – variable pitch propeller essential in-service inspection*’, requiring inspection and lubrication of the propeller lead screw on the Arplast PV50 propeller. The inspection was to be accomplished at installation, after the first 25 hours and then each subsequent 50 hours. In addition, the AIL required checking and, where necessary, adjustment of the mechanical fine pitch stops on the propeller in accordance with instructions produced by the then UK sales agent for the propeller.

The LAA also intends to reissue the AIL originally issued in 2008 for the Arplast PV50 propeller and is currently identifying all LAA aircraft to which this propeller is fitted. Owners of projects still under construction who may have this propeller but who have not yet identified the propeller type to the LAA, will be identified when an application for an initial permit to fly or modification is made.
