ACCIDENT

Aircraft Type and Registration:	Robinson R22 Beta, G-OODX	
No & Type of Engines:	1 Lycoming O-320-B2C piston engine	
Year of Manufacture:	1987 (Serial no: 720)	
Date & Time (UTC):	1 August 2018 at 1248 hrs	
Location:	Near Naunton Beauchamp, Worcestershire	
Type of Flight:	Private	
Persons on Board:	Crew - 1	Passengers - 1
Injuries:	Crew - None	Passengers - 1 (Minor)
Nature of Damage:	Extensive	
Commander's Licence:	Private Pilot's Licence	
Commander's Age:	46 years	
Commander's Flying Experience:	220 hours (of which 100 were on type) Last 90 days - 18 hours Last 28 days - 4 hours	
Information Source:	AAIB Field Investigation

Synopsis

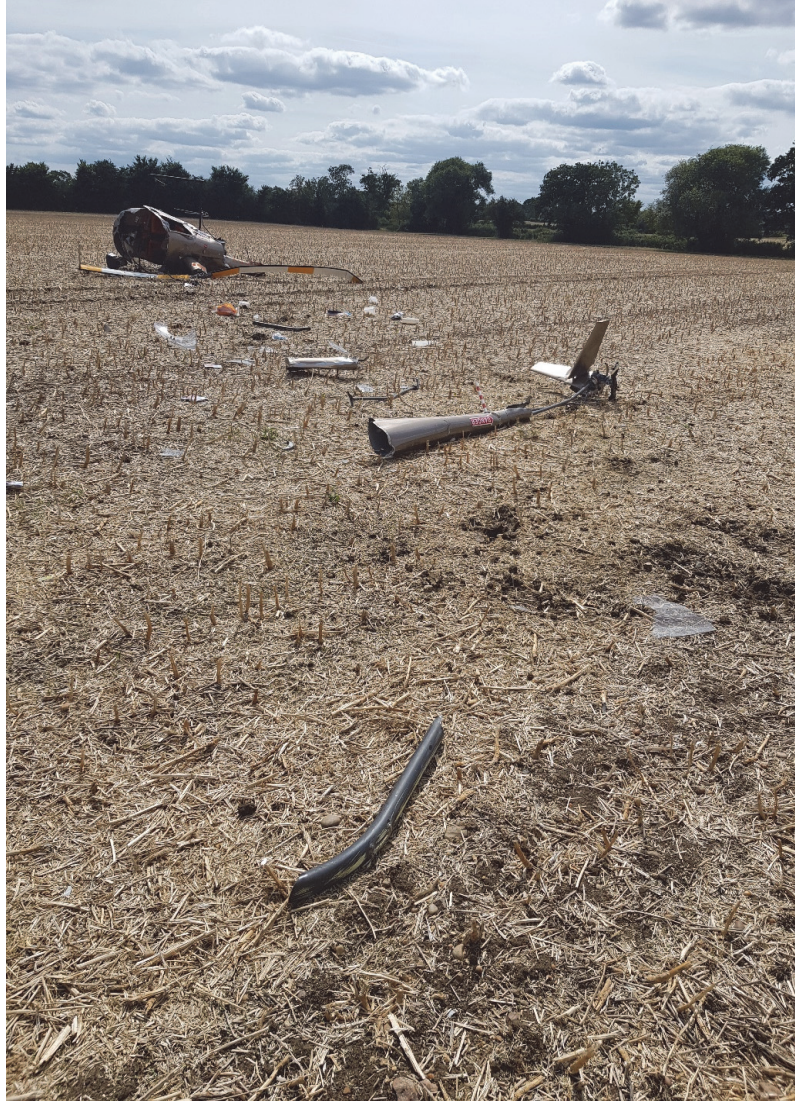
Figure 2

G-OODX after the accident (provided by the operator)

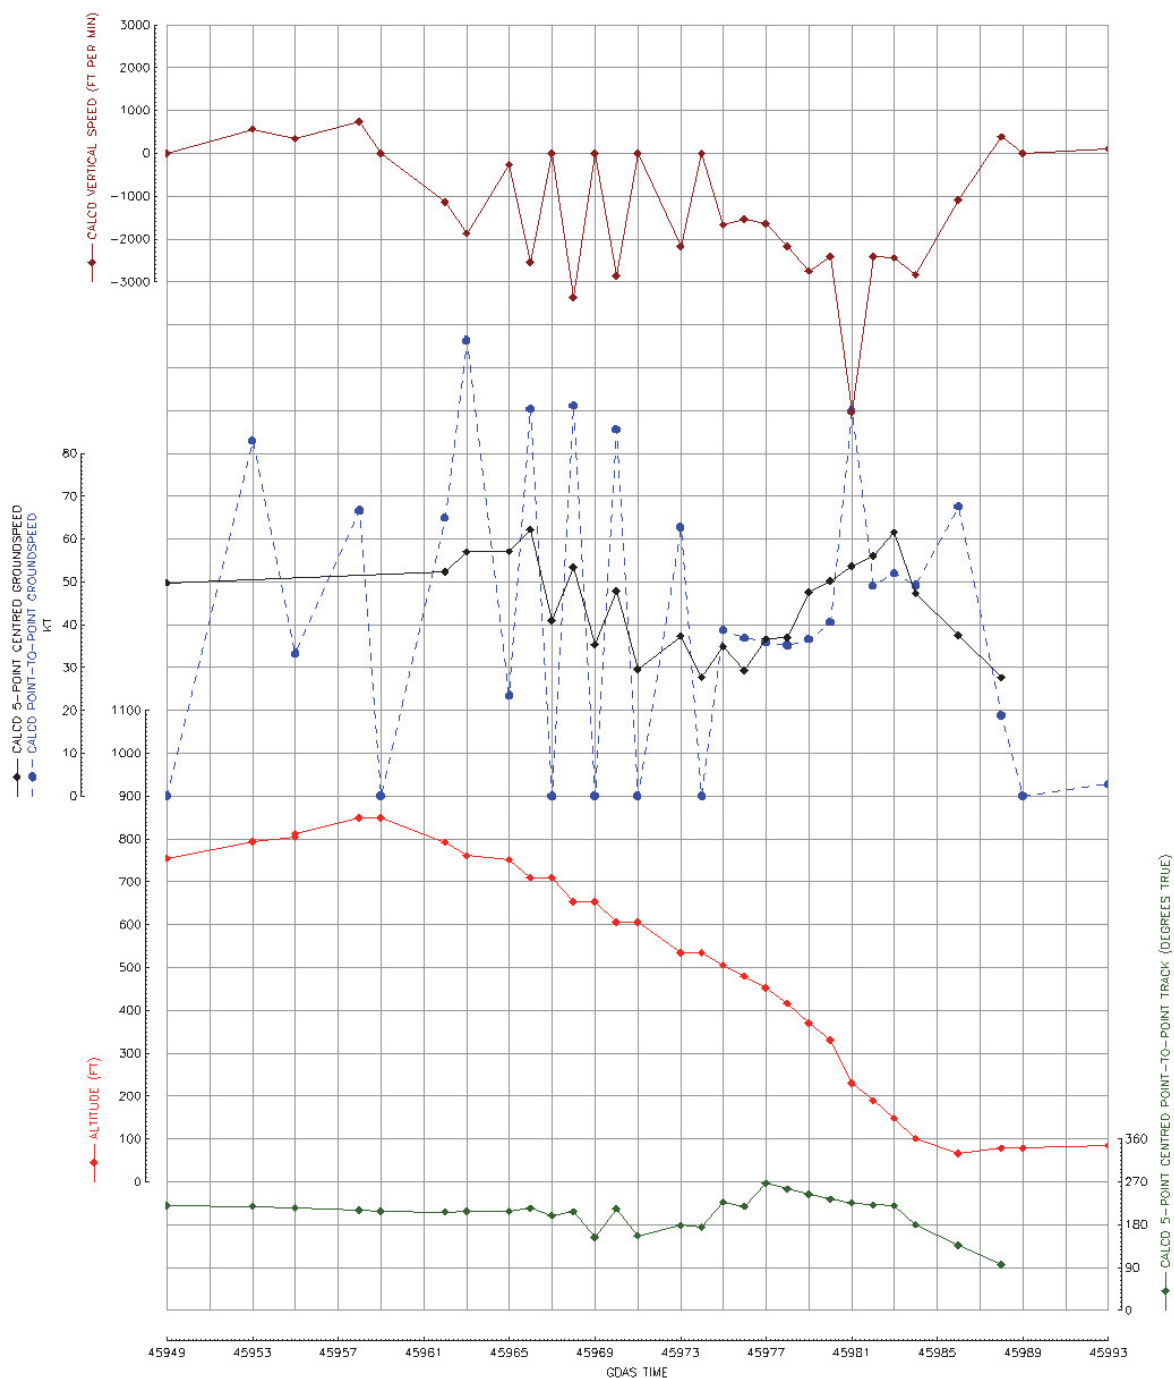
Figure 5 shows the helicopter's groundspeed, altitude, vertical speed and track recorded by the app. As the autorotation was flown into wind the groundspeed shown is approximately 10 kt less than the indicated airspeed seen by the pilot. Figure 5 shows the groundspeed initially stable at 50 kt. Once the descent was established the groundspeed reduced to approximately 30 kt then increased back to 60 kt. At approximately 60 ft above the ground the groundspeed was 60 kt. The groundspeed and rate of descent then reduced as the pilot flared the helicopter.

Helicopter Vertical Speed, Groundspeed, Altitude and Track during the autorotation, derived from navigation app

The pilot recognised the loss of drive to the rotor and established the helicopter in autorotation. During the descent he reduced airspeed to shorten the glide range to land in a suitable field. Rotor rpm during the descent is not known but the pilot reported that the low rpm horn was on throughout the descent. At approximately 60 ft the recorded data showed the helicopter was back at the correct airspeed to flare for landing. The pilot reported that he flared the helicopter, but the tail struck the ground. It is not known if the pilot misjudged the flare or if the rotor rpm was insufficient to arrest the rate of descent sufficiently before landing.
