SERIOUS INCIDENT

Aircraft Type and Registration:	1) Cessna 182T Skylane, G-ORDM 2) Hercules C130J C Mk 4, ZH878
No & Type of Engines:	1) 1 Lycoming IO-540-AB1A5 piston engine 2) 4 AE2100D3 Turboprop
Year of Manufacture:	1) 2003 (Serial no: 18281206) 2) Not known
Date & Time (UTC):	20 July 2018 at 1215 hrs
Location:	RAF Brize Norton, Oxfordshire
Type of Flight:	1) Private 2) Military
Persons on Board:	1) Crew - 1 Passengers - None 2) Crew - 3 Passengers - None
Injuries:	1) Crew - None Passengers - N/A 2) Crew - None Passengers - N/A
Nature of Damage:	1) Airframe and engine damage 2) No damage
Commander's Licence:	1) Airline Transport Pilot's Licence 2) Airline Transport Pilot's Licence
Commander's Age:	1) 39 years 2) 48 years
Commander's Flying Experience:	1) 3,567 hours (of which 3 were on type) Last 90 days - 63 hours Last 28 days - 39 hours 2) 6,057 hours (of which 679 were on type) Last 90 days - 55 hours Last 28 days - 22 hours

Synopsis

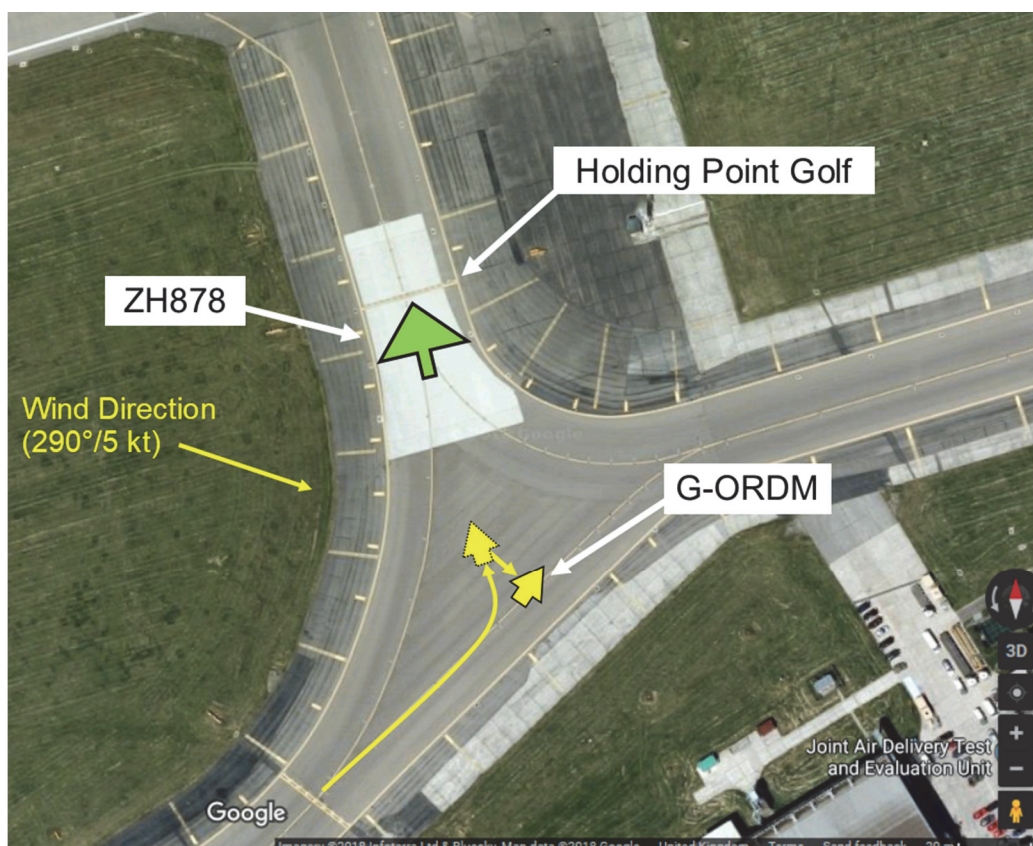
Figure 1

Relative positions of the aircraft at Golf and approximate ground track of G-ORDM

G-ORDM's pilot had used visual cues, based on the size of the C-130J ahead, to assess his taxi spacing. He believed that he had consistently maintained 50 to 100 m behind the other aircraft en route to the holding point. Analysis of the relative positions of the aircraft after the accident, supported by eye-witness testimony, suggested that the actual separation at the time of the propwash encounter was approximately 25 m. The pilot stated that while taxiing he did not experience any thrust effects from the preceding C-130J and, consequently, the separation distance achieved became his 'safe-norm' for the situation. Even though he was qualified on the C-130J, the pilot was surprised by the intensity and extent of the propwash hazard area. He further observed that Flight Idle thrust was significantly higher than the breakaway thrust requirement for even a fully-laden C-130J.

Unless backed up by known distance markers, the assessment of taxi separation is subjective. On this occasion the pilot's perception of aircraft separation distance at the holding point appears to have been at least double that achieved.
