## ACCIDENT

<b>Aircraft Type and Registration:</b>	Piper J5A Cub Cruiser, G-BSXT	
<b>No &amp; Type of Engines:</b>	Rolls Royce O-200A	
<b>Year of Manufacture:</b>	1940 (Serial no: 5-498)	
<b>Date &amp; Time (UTC):</b>	20 July 2018 at 1310 hrs	
<b>Location:</b>	Felthorpe Airfield, Norwich	
<b>Type of Flight:</b>	Private	
<b>Persons on Board:</b>	Crew - 1	Passengers - None
<b>Injuries:</b>	Crew - None	Passengers - N/A
<b>Nature of Damage:</b>	Right wing and left rear fuselage damaged	
<b>Commander's Licence:</b>	FAA Private Pilot's Licence	
<b>Commander's Age:</b>	73 years	
<b>Commander's Flying Experience:</b>	876 hours (of which 0 were on type) Last 90 days - 4 hours Last 28 days - 2 hours	
<b>Information Source:</b>	Aircraft Accident Report Form submitted by the pilot and enquiries made by AAIB

## Synopsis

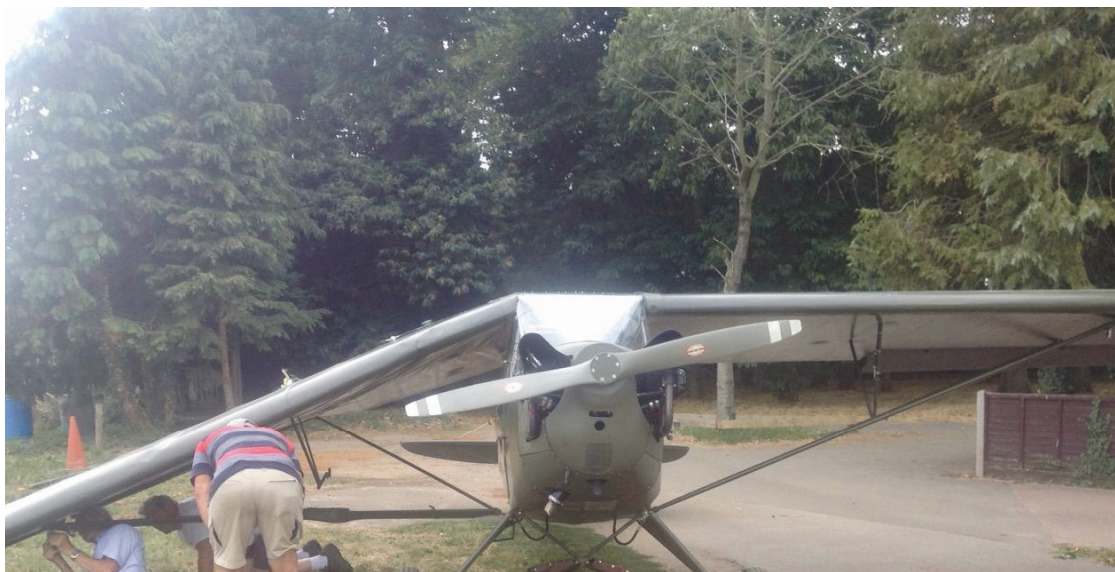
The aircraft struck a gate with the right fore and aft wing struts causing it to swing to the right and its left wing tip hit a tree. The right wing and left rear fuselage were damaged (Figures 1 and 2).

**Figure 1**  
G-BSXT after the accident

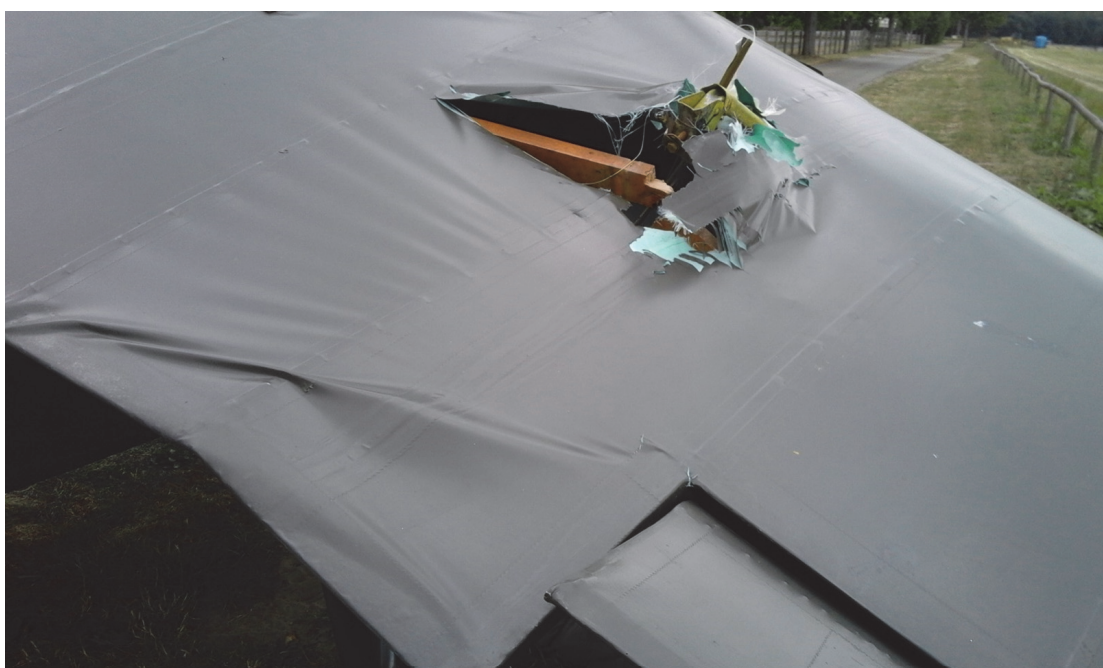
**Figure 2**  
Damage to the right wing

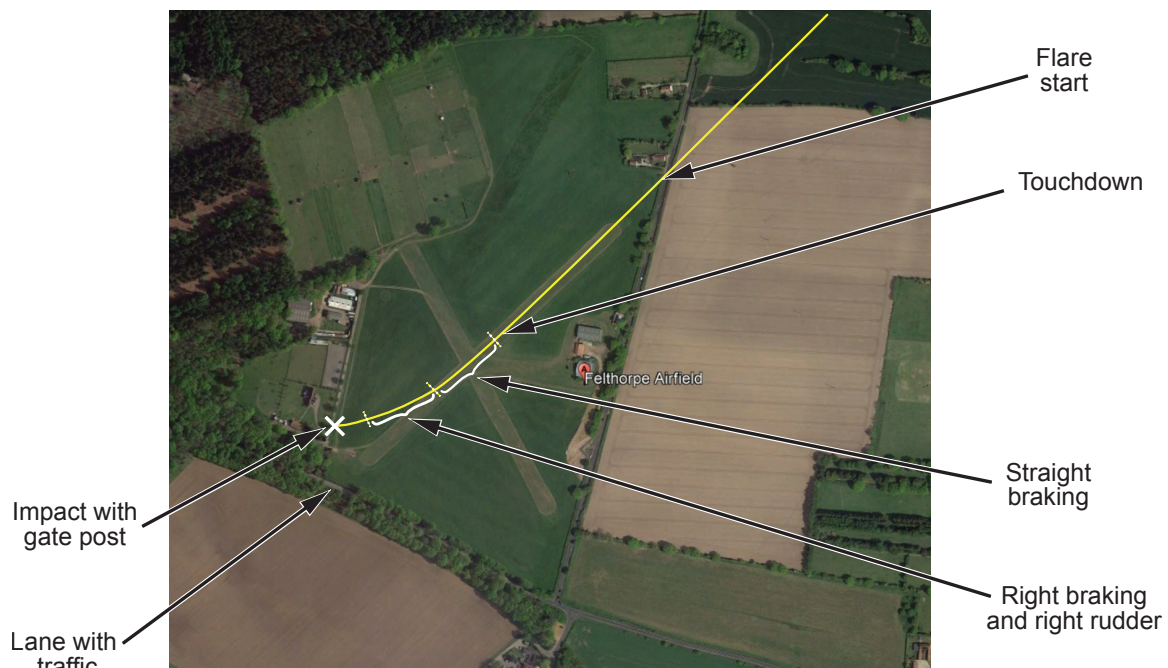
**Figure 3**

After flaring, the aircraft floated for some distance before making a three-point touch down. The aircraft was still moving at speed and the pilot applied full brake but was already over half way along the 487 m runway.

At the end of the runway there was a hedge with a public road behind. The pilot decided to turn to increase the landing distance. He turned the aircraft gradually to the right using braking and rudder. There was a fence ahead so he “attempted to ground loop” to the right. Full depression of the brake was not enough to turn the aircraft in time.

Figure 3 shows significant locations in the accident sequence.

Sequence of the accident and accident site (edited image from Google Earth)
