ACCIDENT

| Aircraft Type and Registration: | Flight Design CTSW, G-KUPP | |

Synopsis

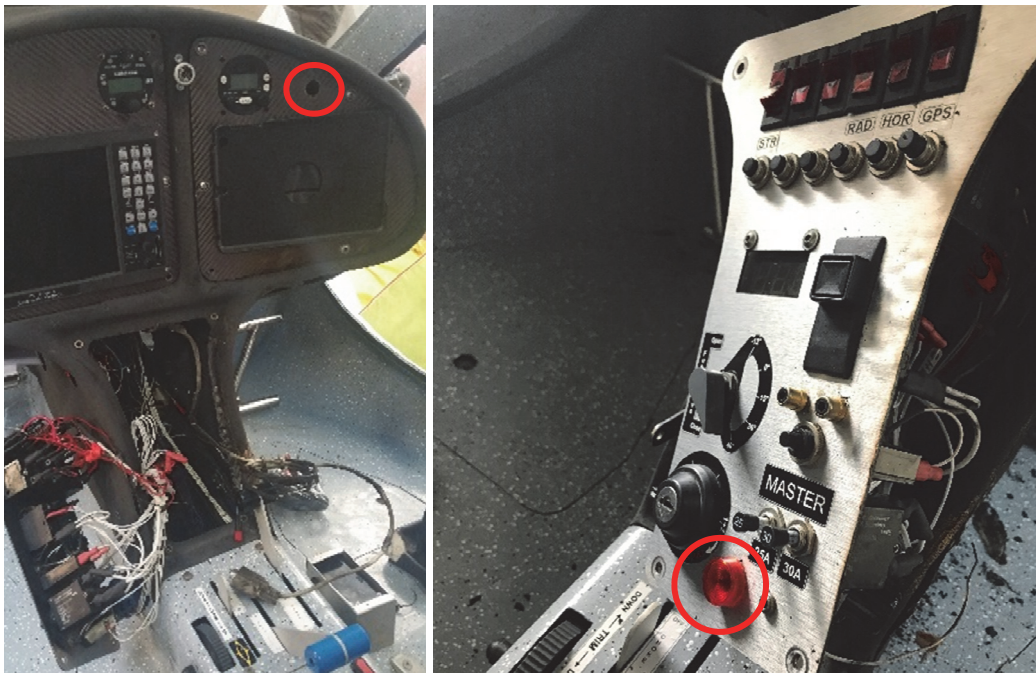
Figure 1

The aircraft was recovered to a repair organisation for examination and the instrument console was disassembled. There was evidence that the console had been modified previously to fit new avionics equipment and the charge indicator lamp had been moved. The original location was the upper right of the panel, but it had been moved to the lower central section (Figure 1). The repair organisation's assessment was that the standard of wiring was very poor. Wires were over length, had insufficient support, there was a risk of entrapment or chafing and improper terminals had been used.

Instrument console

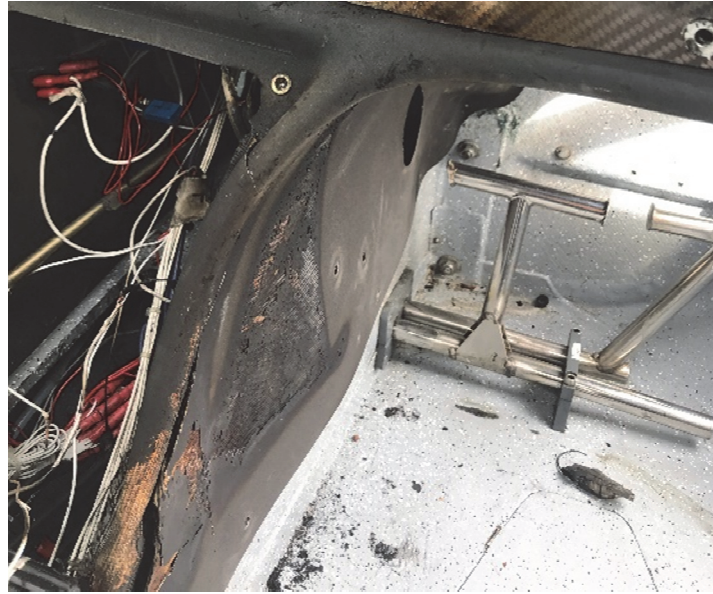
Figure 2

The charge indicator lamp is connected to the voltage regulator through a 22AWG (0.64 mm) wire which is nominally sized for current up to 3 amps. Should the lamp supply wire short to earth, the current could be up to 50 amps; the full regulator output of 20 amps and up to 30 amps from the battery. The wire to this lamp had burned through and several adjacent wires showed evidence of heat damage. The structure of the instrument console is a woven carbon / resin composite which showed evidence of fire damage. The damage showed that in some places, the resin had been totally consumed and only the carbon mat remained (Figure 2).

Fire damage to the instrument console

The repair organisation assessed that the modification to the charge warning lamp, without shortening the wires, was a causal factor in initiating the fire. The length of wire for the modified position was significantly less compared to the original location. The insulation

on this excess wire was damaged and this resulted in a short circuit to the structure of the composite instrument console. The cause of the insulation damage could not be determined but could have been from chafing or pinching in a panel joint. The composite material is electrically resistive and the current of up to 50 amps generated sufficient heat for the resin to ignite and produce smoke as it burned.

The UK type approval holder (also the repair organisation) has subsequently issued Service Bulletin 150 for Flight Design CTSL, CTSW and CT2K aircraft. The Service Bulletin recommends a 1 amp fuse to be fitted to the charge warning lamp supply wire and to:

'ensure the wiring is tidy with tight connections and is well secured and protected. Be sure the wiring cannot be trapped in panel joints and has adequate strain relief. Ensure it cannot short against anything including control runs, at all extremes of movement.'

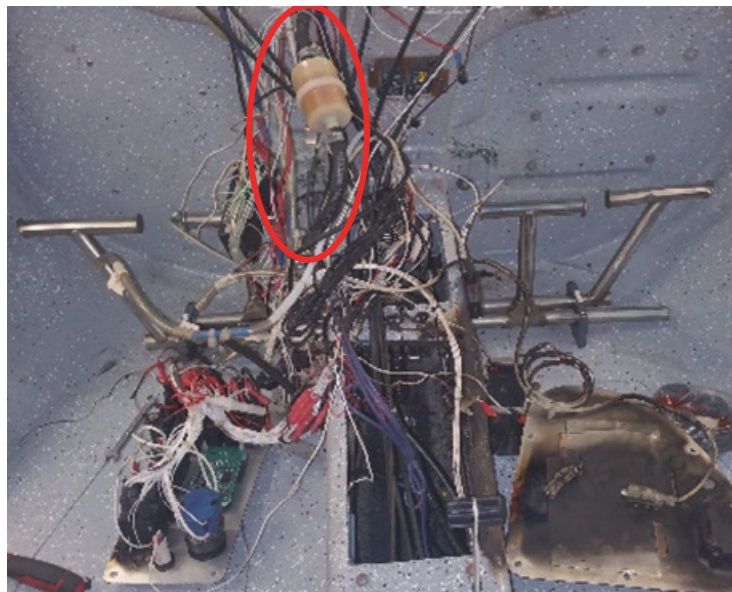
Figure 3

Located in the rear of the instrument console (Figure 3) was the engine fuel supply pipe, and the fuel filter, from the wing fuel tanks to the engine.

Fuel supply and filter location (Instrument console removed)

Further, it states that any fuel filter inside the instrument console must be of a fire-resistant type.
