ACCIDENT

Aircraft Type and Registration:	Ikarus C42 FB80 Ikarus, G-ULSY	
No & Type of Engines:	1 Rotax 912-UL piston engine	
Year of Manufacture:	2004 (Serial no: 0405-6603)	
Date & Time (UTC):	13 July 2018 at 1230 hrs	
Location:	Sandown Airfield, Isle of Wight	
Type of Flight:	Private	
Persons on Board:	Crew - 1	Passengers - 1
Injuries:	Crew - None	Passengers - None
Nature of Damage:	Left landing gear collapsed	
Commander's Licence:	National Private Pilot's Licence	
Commander's Age:	51 years	
Commander's Flying Experience:	183 hours (of which 101 were on type) Last 90 days - 50 hours Last 28 days - 24 hours	
Information Source:	Aircraft Accident Report Form submitted by the pilot and further enquiries by the AAIB

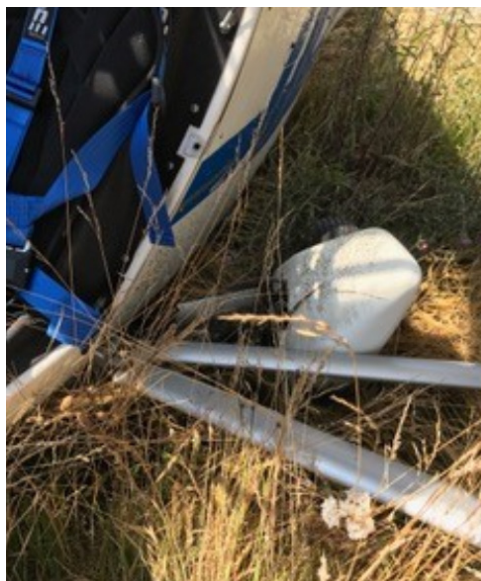
Figure 1

Shortly after touchdown, G-ULSY's left landing gear assembly failed, allowing the mainwheel to pivot rearwards and inwards towards the fuselage. The aircraft veered left uncontrollably, departed the prepared surface and came to rest in long grass adjacent to the runway (Figure 1). Neither occupant was injured and they vacated the aircraft unaided.

G-ULSY's left landing gear assembly after the accident

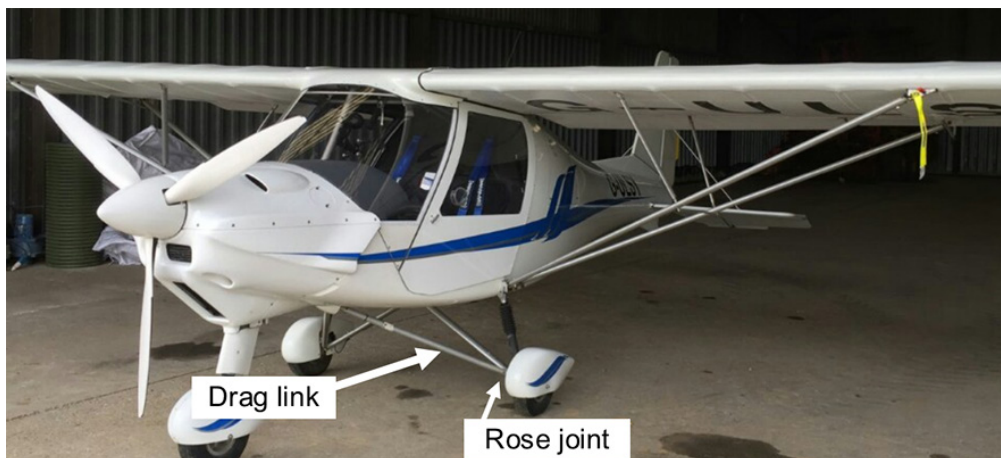
Figure 2

Investigation revealed that the rod end bolt connecting the drag link to the undercarriage assembly had sheared forward of the rose joint lock nut (Figures 2 and 3).

Diagram showing drag link and rose joint locations
