## ACCIDENT

<b>Aircraft Type and Registration:</b>	Extra 400, D-EXKG	
<b>No &amp; Type of Engines:</b>	1 Teledyne Continental TSIOL-550-C piston engine	
<b>Year of Manufacture:</b>	2003 (Serial no: 26)	
<b>Date &amp; Time (UTC):</b>	13 July 2018 at 1257 hrs	
<b>Location:</b>	Oban Airport, Argyll and Bute	
<b>Type of Flight:</b>	Private	
<b>Persons on Board:</b>	Crew - 1	Passengers - 2
<b>Injuries:</b>	Crew - None	Passengers - None
<b>Nature of Damage:</b>	Damage to propeller and front wheel, and shockloaded engine	
<b>Commander's Licence:</b>	Private Pilot's Licence	
<b>Commander's Age:</b>	53 years	
<b>Commander's Flying Experience:</b>	1,244 hours (of which 20 were on type) Last 90 days - 33 hours Last 28 days - 19 hours	
<b>Information Source:</b>	Aircraft Accident Report Form submitted by the pilot

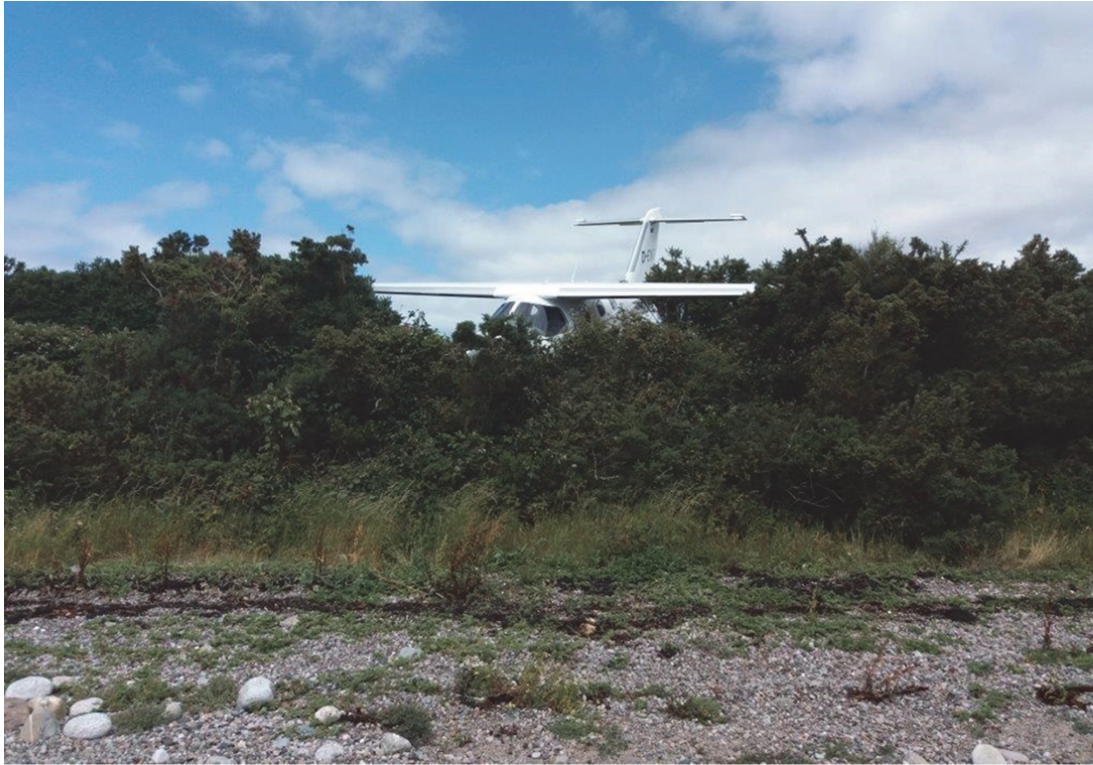
The pilot was cognisant of the fact that locking the wheels would radically reduce braking performance and tried to avoid this while still applying significant braking effort. However, the aircraft failed to stop by the end of the paved surface, overran the runway and struck the airfield boundary fence before coming to a stop in an area of bushes just prior to the shoreline (Figure 1).

**Figure 1**  
Aircraft on the Shoreline

The pilot reported that in the last 25 m of the runway the brakes became ineffective and he believed that they had become overheated. The aircraft struck the bushes and the perimeter fence at approximately 5 kt. All those on board exited the aircraft without assistance and were clear of the aircraft when the airport RFFS arrived on scene.
