## ACCIDENT

<b>Aircraft Type and Registration:</b>	Piper PA-34-200T Seneca II, G-FILE	
<b>No &amp; Type of Engines:</b>	2 Continental Motors Corp TSIO-360-EB piston engines	
<b>Year of Manufacture:</b>	1980 (Serial no: 34-8070108)	
<b>Date &amp; Time (UTC):</b>	11 July 2018 at 1003 hrs	
<b>Location:</b>	Cotswold (Kemble) Airport, Gloucestershire	
<b>Type of Flight:</b>	Private	
<b>Persons on Board:</b>	Crew - 1	Passengers - 2
<b>Injuries:</b>	Crew - None	Passengers - None
<b>Nature of Damage:</b>	Damage to left propeller, underside of left wing and aileron, rear fuselage	
<b>Commander's Licence:</b>	Private Pilot's Licence	
<b>Commander's Age:</b>	64 years	
<b>Commander's Flying Experience:</b>	922 hours (of which 127 were on type) Last 90 days - 11 hours Last 28 days - 8 hours	
<b>Information Source:</b>	Aircraft Accident Report Form submitted by the pilot

## Synopsis

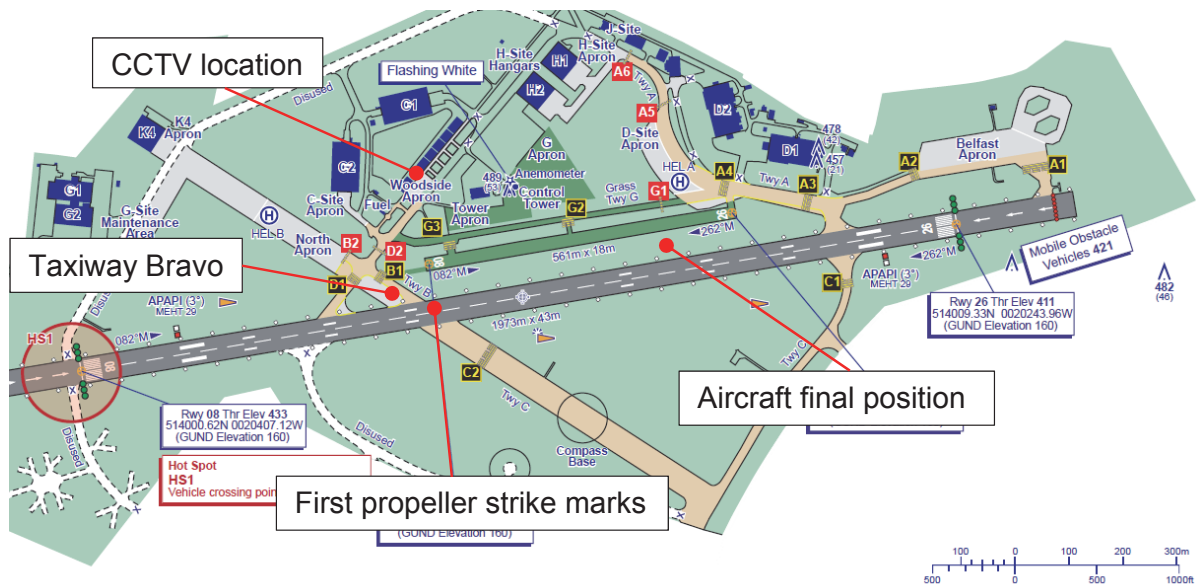
**Figure 1**  
Cotswold Airport

Examination of the runway showed impact marks from the left propeller after the aircraft had passed the intersection with Taxiway Bravo (Figure 1). There were 15 strike marks and the spacing was consistent with an aircraft speed of 70-80 kt. Further along the runway there were more strike marks along with scraping from the left wing and aileron and the aft fuselage. The aircraft halted facing north-west on the grass between the tarmac and grass runways.

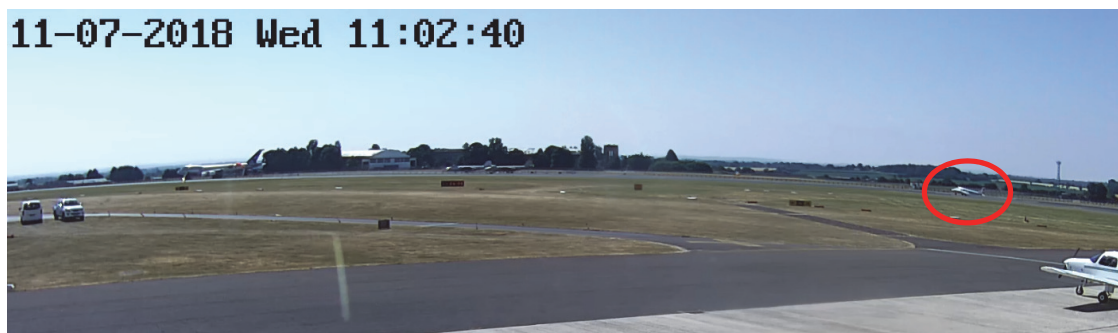
**Figure 3**  
Landing Sequence

A closed-circuit camera mounted on a hanger at the Woodside Apron captured the landing from Taxiway Delta until the aircraft veered off the runway (Figure 3). The footage is consistent with the left wing dropping with propeller contact, correcting and then contact further along the runway.
