ACCIDENT

Aircraft Type and Registration:	Rutan Long-Ez (Modified), G-BPWP	
No & Type of Engines:	1 Continental Motors Corp O-240-E piston engine	
Year of Manufacture:	1989 (Serial no: PFA 074A-11132)	
Date & Time (UTC):	7 July 2018 at 1131 hrs	
Location:	Dunkeswell Airfield, Devon	
Type of Flight:	Private	
Persons on Board:	Crew - 1	Passengers - 1
Injuries:	Crew - 1 (Serious)	Passengers - 1 (Minor)
Nature of Damage:	Aircraft destroyed	
Commander's Licence:	Private Pilot's Licence	
Commander's Age:	80 years	
Commander's Flying Experience:	641 hours (of which 465 were on type) Last 90 days - 5 hours Last 28 days - 2 hours	
Information Source:	AAIB Field Investigation

Synopsis

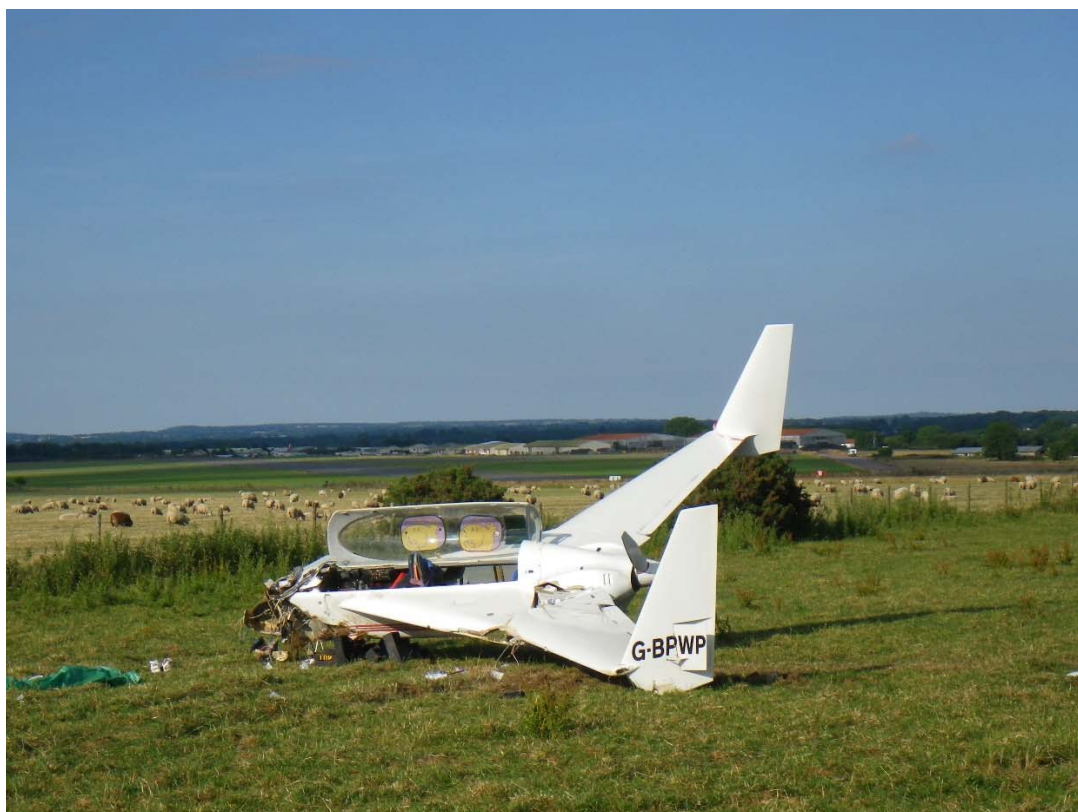
Figure 1
Accident site

G-BPWP came to rest in a field slightly to the left of the extended centreline, and approximately 550 m from the threshold of Runway 04, at Dunkeswell Airfield. The ground marks and damage to the aircraft indicated that the aircraft initially landed heavily on the left mainwheel and nosewheel. The left landing leg structural cross beam member failed at the centre of the fuselage, the nose landing leg detached, and the forward section of the fuselage was badly damaged when it struck the ground. The left fin and canard also contacted the ground with sufficient force to break the main spar in the left wing and damage the canard. Following the initial impact, the aircraft continued to travel across the ground for a further 54 m before stopping on a heading of 340°(M). The aircraft was 11 m from the fence which the pilot tried to avoid. See Figure 1.

The impact forces during the accident were mostly absorbed by the left wing and the nose section of the fuselage, which were extensively damaged. The nose landing gear leg, which was in the extended position, detached from the aircraft at the point of impact. The main landing gear structural cross member also failed. The cockpit area, seat harnesses and canopy remained intact. The speed brakes were found in the retracted position.

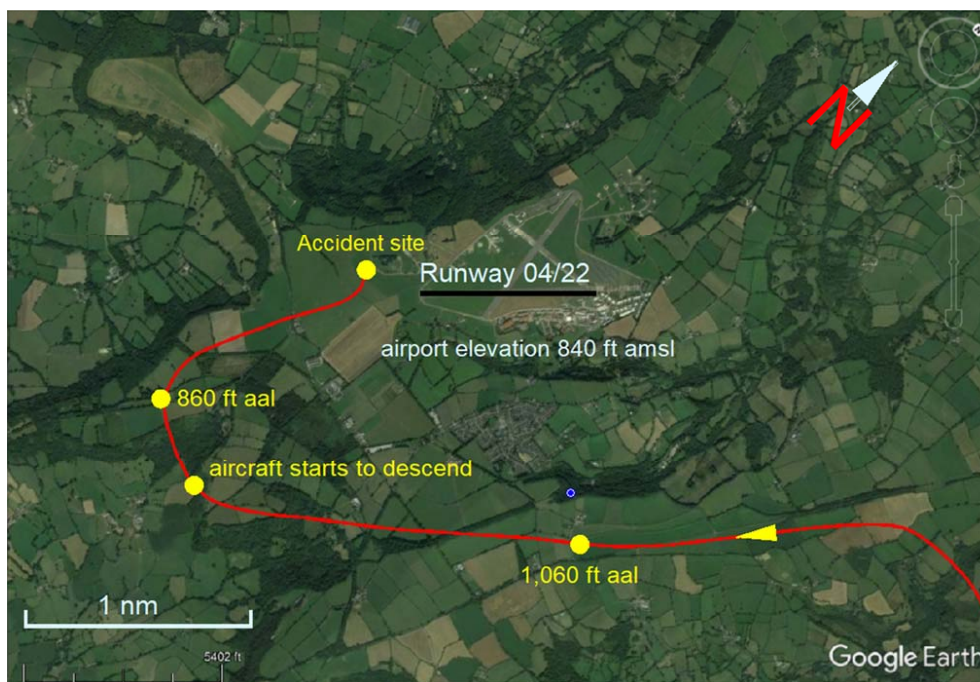
Figure 2

Ground track on approach to Runway 04

When the aircraft was about 800 m (0.4 nm) from the runway threshold it was at approximately 200 ft agl. The aircraft then started to alter track to the left, turning away from the extended runway centre line. Shortly after the aircraft touched down at a groundspeed of about 68 kt and at a calculated vertical descent rate of approximately 1,000 ft/min. The aircraft came to a stop five seconds later.

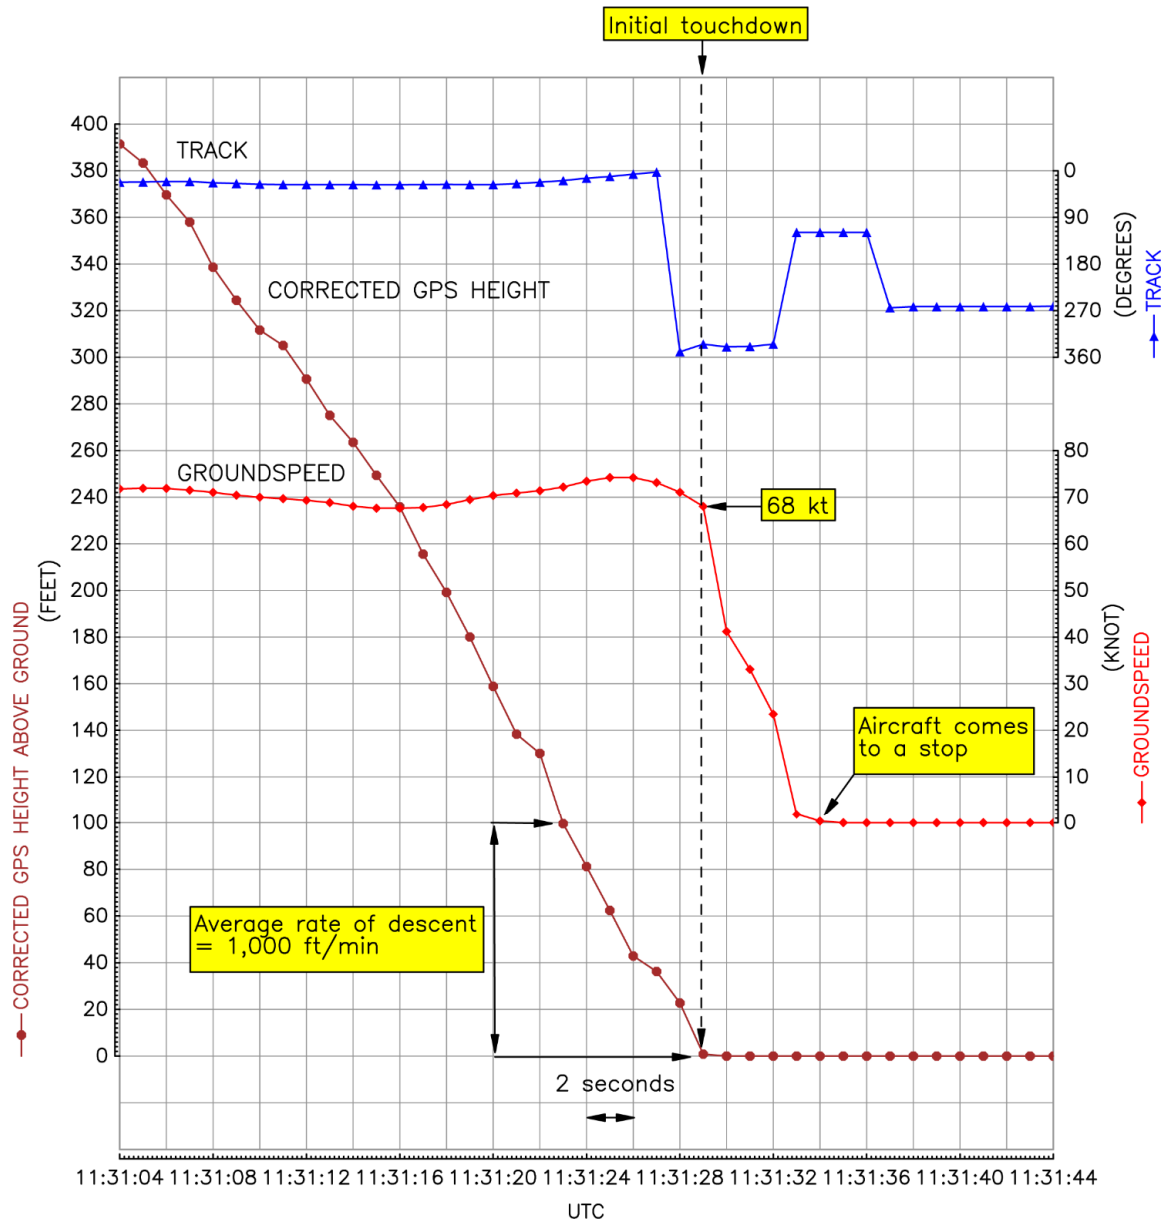
Figure 3
GPS data during final approach

As the aircraft descended on the final approach its average groundspeed was 70 kt. The recorded wind at Exeter airport, 10 nm to the south-west, was 3 kt and variable in direction. Based on this wind, the estimated true airspeed of G-BPWP would have been between 67 kt and 73 kt.

The aircraft's estimated airspeed during the final approach was about 70 kt, which was consistent with the recommended glide speed of 70 to 75 kt. The damage to the aircraft, ground marks and recorded data indicate that the pilot may not have arrested the aircraft's high rate of descent sufficiently to prevent it landing firmly.

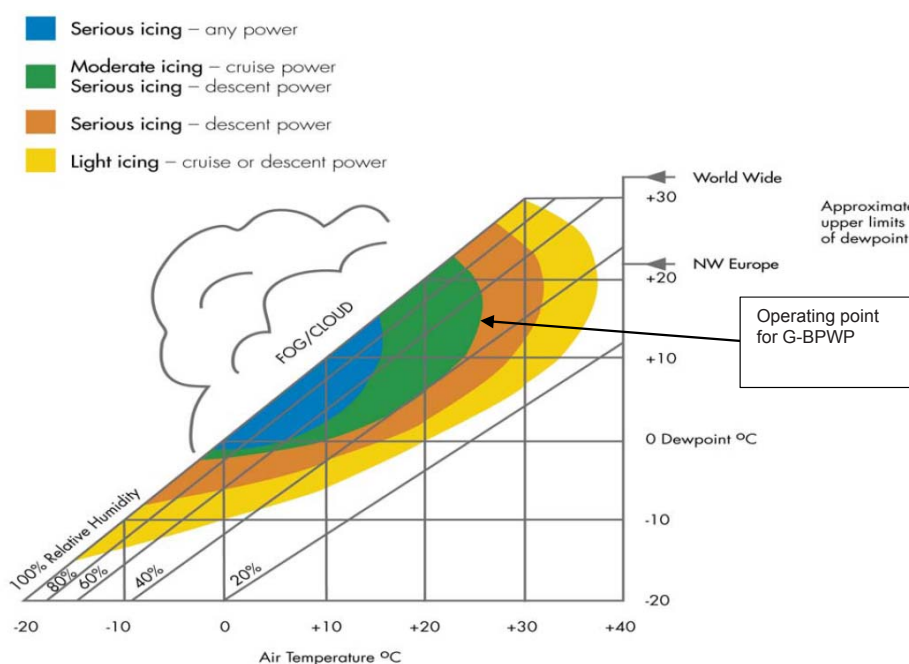
Figure 6

An aftercast from the Met Office reported that at the time of the accident the air temperature was 25°C and the dew point was 14°C. From the CAA graph on the probability of carburettor icing (Figure 6), at the time of the accident there would have been a moderate risk of carburettor icing during the cruise and a serious risk during the decent.

Probability of carburettor icing

The Owner's Manual advises that the engine is susceptible to carburettor icing and in moist conditions the carburettor heat should be selected ON (HOT) often, or left ON, during the cruise. The humidity at the time of the accident was approximately 50% and there would have been a moderate risk of carburettor icing at cruise power setting and a serious risk at descent power setting.

Prior to the engine stopping, the aircraft had been in the cruise and then descended to circuit height at a relatively low power setting. The pilot stated that during the flight he had adopted his usual technique of applying carburettor heat every 20 minutes and that during the downwind leg he initially selected HOT and then COLD. It is therefore possible that the frequency of application may have been insufficient. It is also possible that the temperature of the exhausts at the low engine power settings might have been insufficient to warm the air sufficiently to clear any build-up of ice.
