**SERIOUS INCIDENT**

<b>Aircraft Type and Registration:</b>	Britten-Norman BN-2B-21 Islander, VP-AEJ	
<b>No &amp; Type of Engines:</b>	2 Lycoming IO-540 piston engines	
<b>Year of Manufacture:</b>	1980	
<b>Date &amp; Time (UTC):</b>	4 July 2018 at 1940 hrs	
<b>Location:</b>	On approach to Robert L. Bradshaw Airport, Saint Kitts	
<b>Type of Flight:</b>	Commercial Air Transport (Passenger)	
<b>Persons on Board:</b>	Crew - 1	Passengers - 4
<b>Injuries:</b>	Crew - None	Passengers - None
<b>Nature of Damage:</b>	Broken aileron drive rod	
<b>Commander's Licence:</b>	FAA Commercial Pilot's License	
<b>Commander's Age:</b>	30 years	
<b>Commander's Flying Experience:</b>	875 hours (of which 700 were on type) Last 90 days - 95 hours Last 28 days - 33 hours	
<b>Information Source:</b>	Aircraft Accident Report Form submitted by the pilot

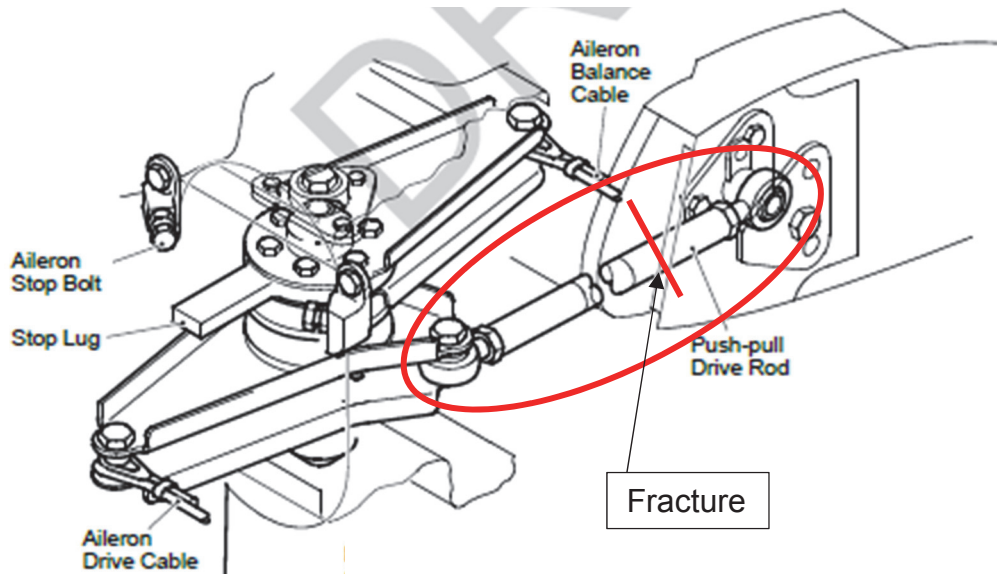
**Figure 1**

On the evening after the incident flight, the maintenance organisation attended the aircraft and replaced the broken aileron drive rod in the right wing (Figure 1).

Aileron drive mechanism

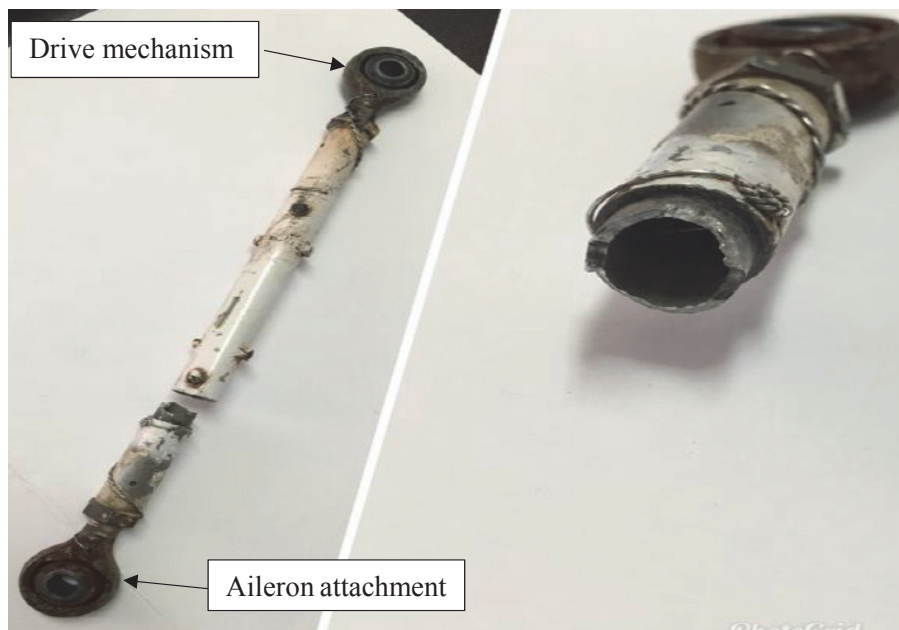
**Figure 2**

An examination of the drive rod found that the spherical bearing in the rod end that connected to the aileron was heavily corroded and had seized. The rod had suffered an overload fracture 70 mm from the rod end at an area where the rod end had been riveted (Figure 2).

Broken drive rod

It is the assessment of the aircraft manufacturer that the cause of the failure of the drive rod was initiated by the bearing corroding, which resulted in the seizure of the bearing. When normal operation loads were applied to the aileron drive mechanism they were sufficient to overload the rod and cause it to fracture. The aircraft manufacturer has published Service letter SL 127 '*Greasing of Aileron Rod End Bearings*' to remind operators of the greasing requirements and to request relevant feedback on bearing corrosion.

An aileron drive rod bearing had corroded and seized which resulted in the drive rod becoming overloaded and failing under normal operational loads. It is possible that the operating environment was more corrosive than the aircraft manufacturer expected when defining the lubrication tasks in the aircraft maintenance programme.

Service Letter SL127 published to remind operators of the greasing requirements and to provide relevant feedback.

A reduction in the lubrication task interval from 1,000 hours to 100 hours for the aileron drive rod bearings.

A fleet-wide corrosion inspection of all drive rod/bearing assemblies.
