ACCIDENT

Aircraft Type and Registration:	Rotorway Executive 90, G-BZES	
No & Type of Engines:	1 Rotorway RI 162 piston engine	
Year of Manufacture:	1994 (Serial no: 6191)	
Date & Time (UTC):	1 July 2018 at 1430 hrs	
Location:	Fenland Airfield, Lincolnshire	
Type of Flight:	Private	
Persons on Board:	Crew - 1	Passengers - None
Injuries:	Crew - None	Passengers - N/A
Nature of Damage:	Extensive	
Commander's Licence:	Private Pilot's Licence	
Commander's Age:	36 years	
Commander's Flying Experience:	71 hours (of which 18 were on type) Last 90 days - 11 hours Last 28 days - 0 hours	
Information Source:	Aircraft Accident Report Form submitted by the pilot and subsequent enquiries by the AAIB

Synopsis

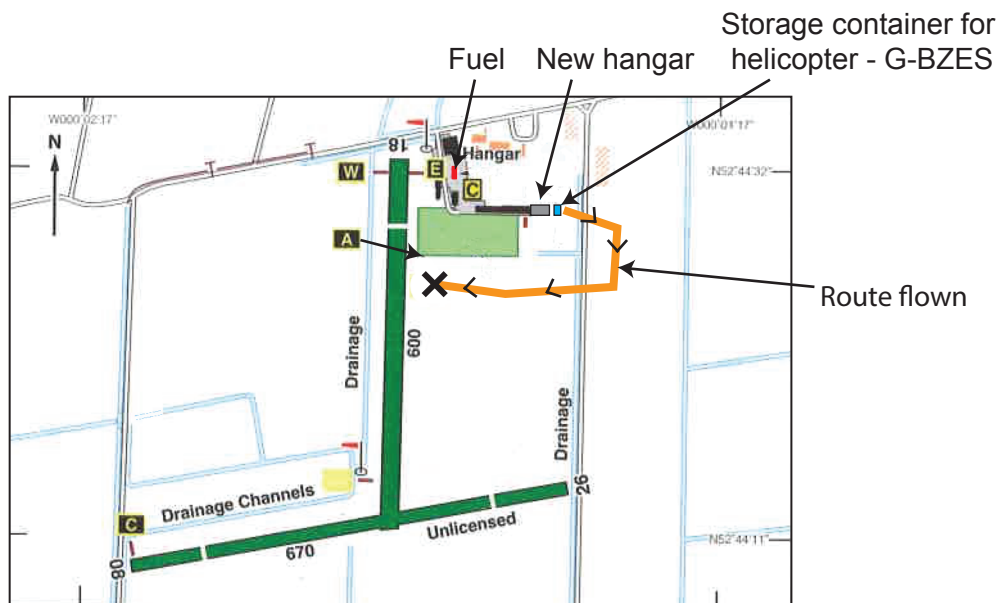
Figure 1

Diagram of accident flight path, as provided by the pilot, superimposed on amended plate from Pooleys Flight Guide

The pilot stated that he wished to refuel the helicopter which was stored at the eastern end of the hangars, within the roped-off area. The refuelling facility was to the north-west of the hangar complex (Figure 1). He arranged with an airfield steward to keep bystanders well away whilst he was starting up and preparing to lift.
