ACCIDENT

Aircraft Type and Registration:	Piper PA-28R-200-2 Cherokee Arrow II, G-EDVL	
No & Type of Engines:	1 Lycoming IO-360-C1C piston engine	
Year of Manufacture:	1972 (Serial no: 28R-7235245)	
Date & Time (UTC):	18 June 2018 at 1735 hrs	
Location:	Redhill Aerodrome, Surrey	
Type of Flight:	Training	
Persons on Board:	Crew - 2	Passengers - None
Injuries:	Crew - None	Passengers - N/A
Nature of Damage:	Right main landing gear trunnion failed, right wing skin damaged	
Commander's Licence:	Commercial Pilot's Licence	
Commander's Age:	69 years	
Commander's Flying Experience:	11,034 hours (of which 200 were on type) Last 90 days - 168 hours Last 28 days - 76 hours	
Information Source:	Aircraft Accident Report Form submitted by the pilot

Synopsis

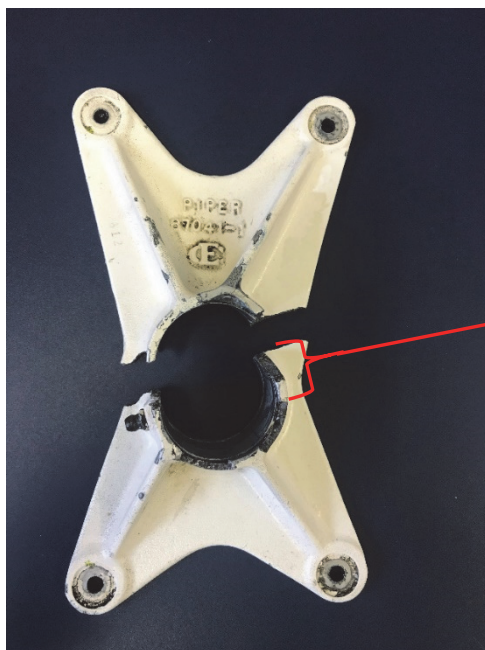
**Figure 2**

Examination of the aircraft showed that the forward trunnion of the right main landing gear leg had failed (Figure 2), which allowed the landing gear leg to rotate rearwards, which resulted in the right wing dropping and the top of the landing gear leg piercing the wing skin. A small section of material had separated from the trunnion and was not recovered. The remains of the trunnion were removed and examined by the AAIB.

Failed right main landing gear forward trunnion

The accident was caused by the failure of the right main landing gear forward trunnion while the aircraft was taxiing. The failure allowed the landing gear leg to pivot forwards piercing the right-wing skin and causing the right wing to drop.

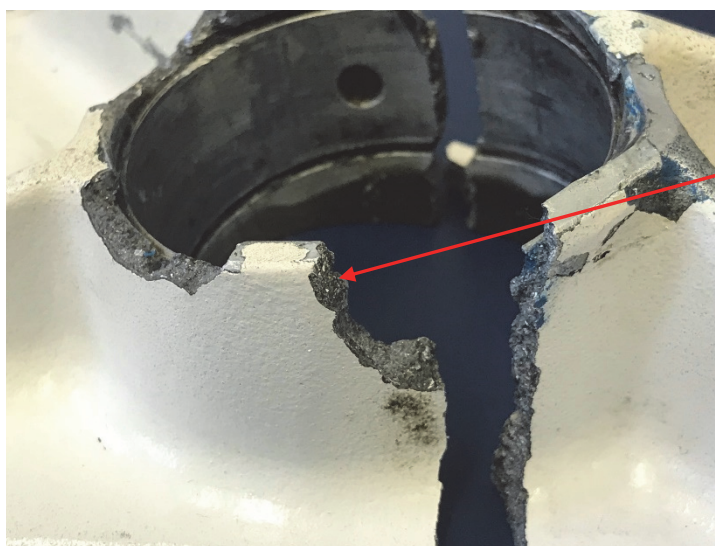
**Figure 3**

Examination of the fracture faces showed that most of the fracture surfaces had suffered from mechanical damage but appeared to show the characteristics of failure in overload. One area was identified which showed the characteristics of crack propagation in fatigue (Figure 3) although damage to the fracture face prevented the identification of the crack initiation site. This area was associated with the area of missing material.

Area of missing material from trunnion

The fracture faces of the failed trunnion showed evidence of failure in overload together with one area which showed the characteristics of crack progression in fatigue. The initiation of the fatigue crack could not be identified due to mechanical damage of the fracture surface.

It is likely that the crack then progressed through the parent material with the normal loads experienced during the aircraft's operation. When the crack had reached a sufficient length to compromise the overall strength of the trunnion, the remaining material failed in overload.

The PA-28R landing gear was designed to allow the type to operate from unpaved airfields. It is therefore probable that the initiation of the fatigue crack within the trunnion was the result of an unreported abnormal event, such as a heavy landing or rapid taxiing across uneven ground.
