**ACCIDENT**

<b>Aircraft Type and Registration:</b>	AS350B2 Ecureuil, G-PLMH	
<b>No &amp; Type of Engines:</b>	1 Turbomeca Arriel 1D1 turboshaft engine	
<b>Year of Manufacture:</b>	1989 (Serial no: 2156)	
<b>Date &amp; Time (UTC):</b>	13 June 2018 at 0911 hrs	
<b>Location:</b>	Loch Scadavay, North Uist, Western Isles	
<b>Type of Flight:</b>	Specialised Operation	
<b>Persons on Board:</b>	Crew - 1	Passengers - None
<b>Injuries:</b>	Crew - 1 (Fatal)	Passengers - N/A
<b>Nature of Damage:</b>	Helicopter destroyed	
<b>Commander's Licence:</b>	Airline Transport Pilot's Licence (Helicopters)	
<b>Commander's Age:</b>	59 years	
<b>Commander's Flying Experience:</b>	9,260 hours (of which 1,892 were on type) <sup>1</sup> Last 90 days - 127 hours Last 28 days - 37 hours	
<b>Information Source:</b>	AAIB Field Investigation

**Synopsis**

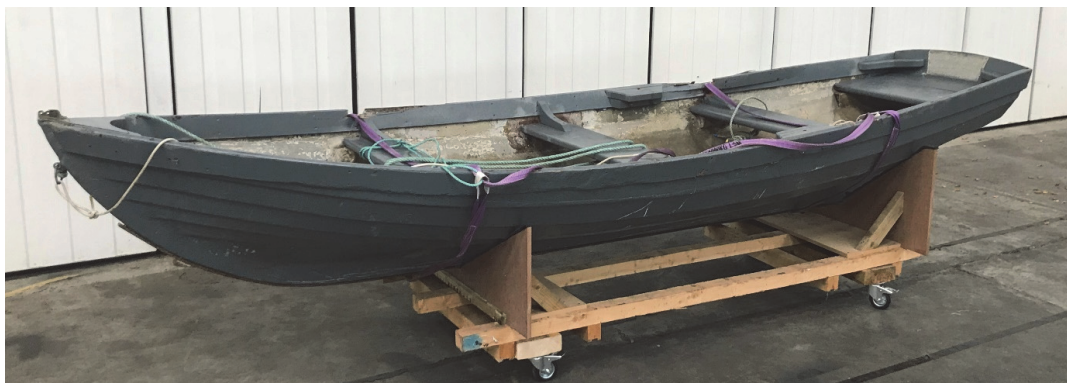
**Figure 9**

Boat 2 was approximately 4.4 m long, 1.4 m wide and weighed 192 kg. The mooring ring on the bow was not considered by the crew to be strong enough to lift the boat, so the lifting hook was connected to the boat using two strops, at approximately 1/3 of the length in from each end of the boat. These were secured in place by rope to stop them moving on the curved surfaces of the boat's hull (Figure 9). The strops were arranged such that the boat would be carried on its side.

Boat 2 showing arrangement of lifting strops  
(cradle added for storage purposes)

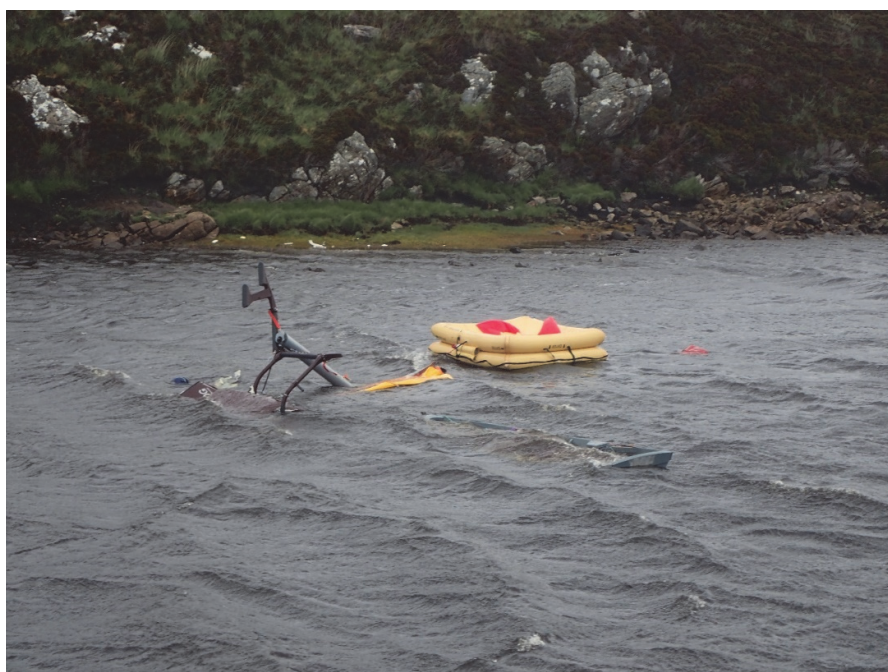
**Figure 10**

The helicopter came to rest in Loch Scadavay lying on its left side and mostly submerged (Figure 10). Its life raft had automatically inflated and remained tethered to the wreckage. The manually-operated flotation devices on the helicopter's skids had not been activated. Boat 2 remained connected to the wreckage by the lifting chain and after floating initially, it eventually sank.

General view of wreckage in Loch Scadavay

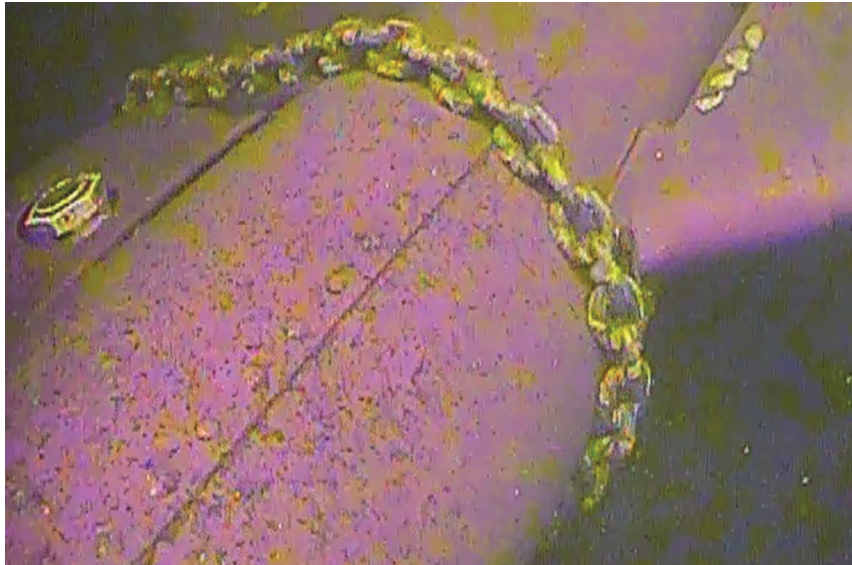
**Figure 11**

An evaluation of the wreckage in-situ was carried out by an expert recovery diver. Images from a helmet-mounted camera were available for viewing by shore-based personnel. The lifting chain was found to be wrapped around the tail boom and horizontal stabilisers (Figure 11). Its upper end had been released from the hook on the underside of the helicopter, and its lower end remained attached to the strops secured to Boat 2.

Diver's view of lifting chain wrapped around tail boom, as found

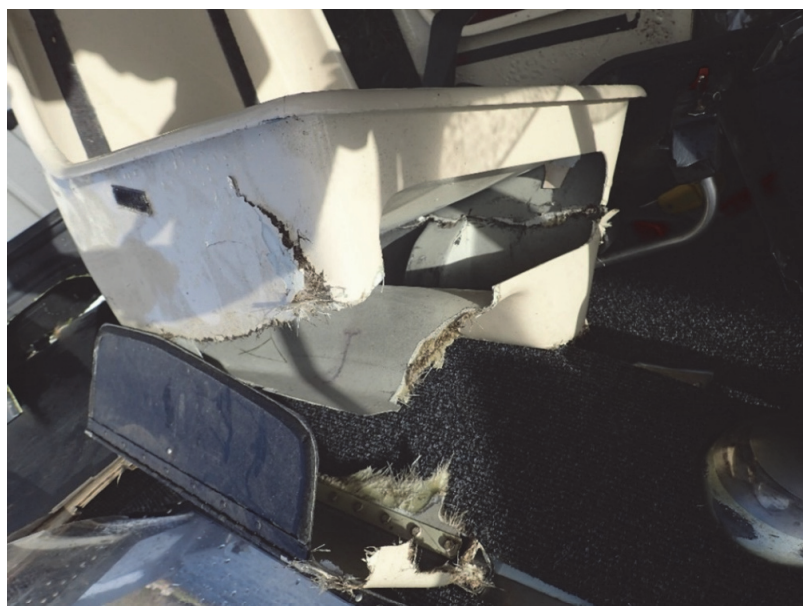
**Figure 12**

The cockpit area of the helicopter was severely disrupted. The pilot's seat composite structure was torn from the floor mountings on its right side (Figure 12).

Pilot's seat showing damaged mounting

The pilot's seat structure had failed, compromising the degree of restraint of the pilot in the accident. The seat met the standards required at the time of certification, but standards have improved over time. However, the new standards only apply to helicopters certified at the time they are in force and do not have to be retrospectively applied to previously certified helicopter designs. The manufacturer had made available an improved, stronger seat and its fitment was optional. It had not been fitted on this helicopter and nor was it required to be.

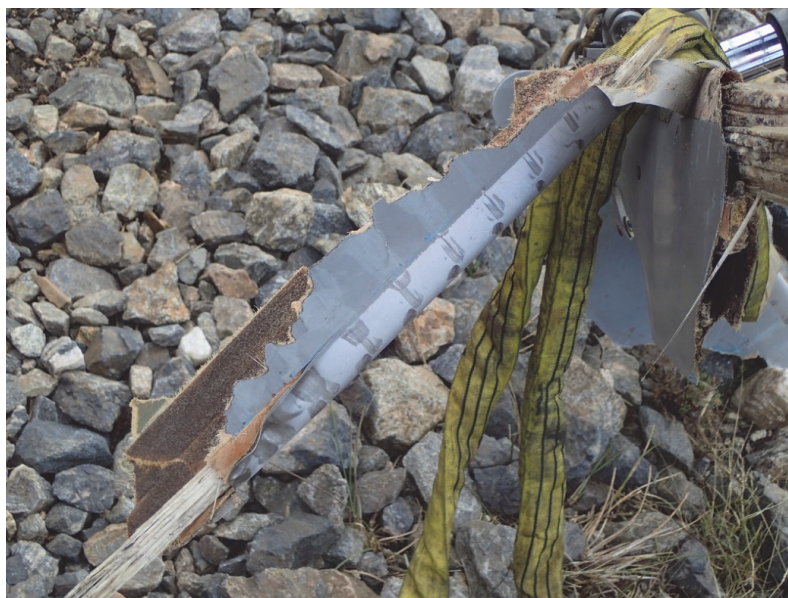
**Figure 13**

The tail rotor blades showed witness marks along the leading edges from contact with the lifting chain (Figure 13).

Remains of a tail rotor blade showing witness marks from contact with the lifting chain (yellow strop is from the recovery operation)

Analysis of the wreckage indicated that the lifting chain had contacted the tail rotor blades, severely damaging them. Because of this damage, the tail rotor would no longer be effective in controlling the torque of the main rotor and would most likely have caused severe vibration. The lifting chain became entangled around the tail boom and stabiliser surfaces despite it being released from the helicopter's lifting hook by the pilot.
