## ACCIDENT

<b>Aircraft Type and Registration:</b>	Just SuperSTOL XL, G-SSXL	
<b>No &amp; Type of Engines:</b>	1 ULPower UL520iS piston engine	
<b>Year of Manufacture:</b>	2016 (Serial no: LAA 397-15385)	
<b>Date &amp; Time (UTC):</b>	10 June 2018 at 1411 hrs (UTC)	
<b>Location:</b>	Near Barton Aerodrome, Manchester	
<b>Type of Flight:</b>	Private	
<b>Persons on Board:</b>	Crew - 2	Passengers - None
<b>Injuries:</b>	Crew - 1 (Minor)	Passengers - N/A
<b>Nature of Damage:</b>	Damaged beyond economical repair	
<b>Commander's Licence:</b>	Private Pilot's Licence	
<b>Commander's Age:</b>	76 years	
<b>Commander's Flying Experience:</b>	9,000 hours (of which 100 were on type) Last 90 days - 100 hours Last 28 days - 65 hours	
<b>Information Source:</b>	Aircraft Accident Report Form submitted by the pilot and further enquiries by the AAIB

## Synopsis

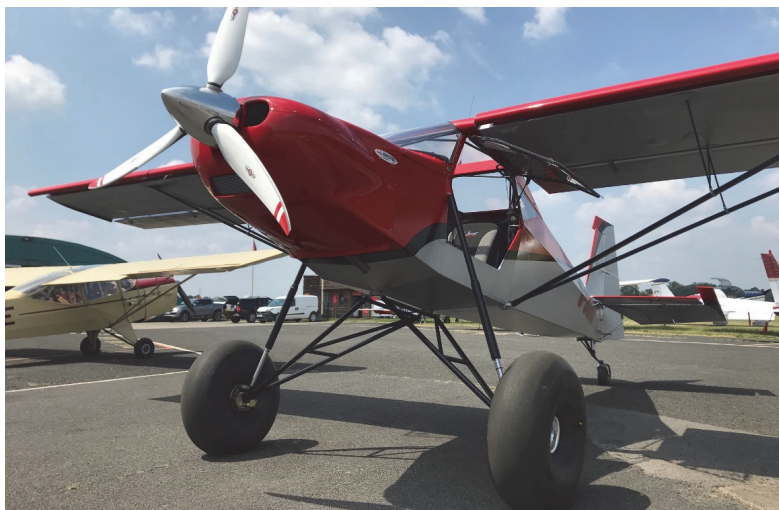
**Figure 1**

The aircraft landed heavily, with right bank applied, and no flaps extended, resulting in the aircraft's landing gear collapsing and the aircraft coming to rest on its underside. The testing pilot suffered serious injuries and the owner minor injuries, but they were able to extract themselves from the aircraft without assistance. The testing pilot was taken to hospital in an ambulance.

When the aircraft was removed from the field, the length of the underside was very oily and had some soil stuck to it. However, there was no sign of any external oil leaks from the engine despite the oil cooler being damaged. With the engine level, the oil dip stick indicated just below minimum.

Accident aircraft
