ACCIDENT

Aircraft Type and Registration:	Cirrus SR22, G-SRTT	
No & Type of Engines:	1 Teledyne Continental IO-550-N46 piston engine	
Year of Manufacture:	2007 (Serial no: 2421)	
Date & Time (UTC):	9 June 2018 at 1039 hrs	
Location:	Benington, Hertfordshire	
Type of Flight:	Private	
Persons on Board:	Crew - 1	Passengers - 1
Injuries:	Crew - None	Passengers - None
Nature of Damage:	Minor damage to fuselage at the lower left engine mount and where the CAPS cables pulled out of the structure; engine severely damaged	
Commander's Licence:	Private Pilot's Licence	
Commander's Age:	60 years	
Commander's Flying Experience:	284 hours (of which 4 were on type) Last 90 days - 18 hours Last 28 days - 4 hours	
Information Source:	Aircraft Accident Report Form submitted by the pilot, AAIB enquires and examination of the engine

Synopsis

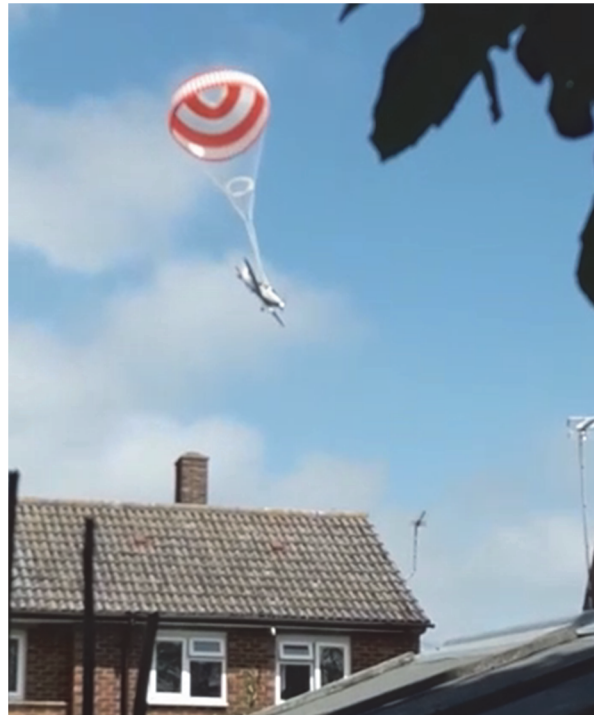
Figure 1

Approximately eight minutes into a cross-country flight there was a catastrophic engine failure. At a height of approximately 800 ft agl the pilot successfully operated the aircraft's parachute recovery system and the aircraft descended into a field near the village of Benington (Figure 1). The engine failure most probably occurred because of an insufficient quantity of oil.

G-SRTT descending under the parachute
(Photograph used with permission)

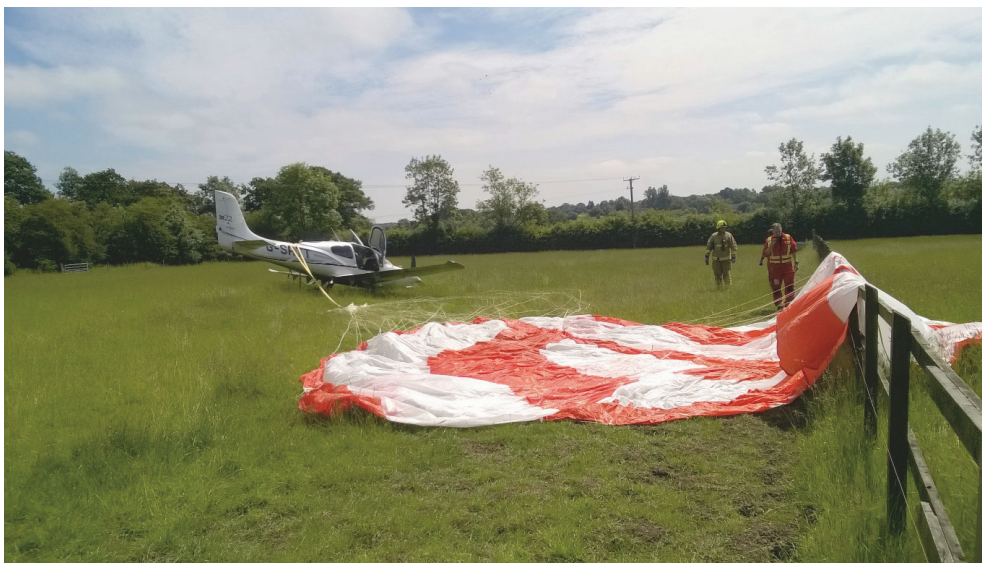
Figure 2
Accident site

The CAPS operated normally, and the aircraft descended into a field on the eastern edge of the village of Benington (Figure 2). The pilot and passenger were uninjured.

The engineering organisation who recovered the aircraft reported that the only significant damage to the aircraft was to the area of the fuselage adjacent to the lower left engine mount and the areas where the cables for the CAPS had been pulled out of the airframe. The CAPS had operated as designed.

Engine oil had leaked onto the ground from the sump, which had been punctured during the impact. There was a hole in the crankcase next to the No 4 cylinder through which the oil had leaked out of the engine in flight. There was no other evidence of an oil leak

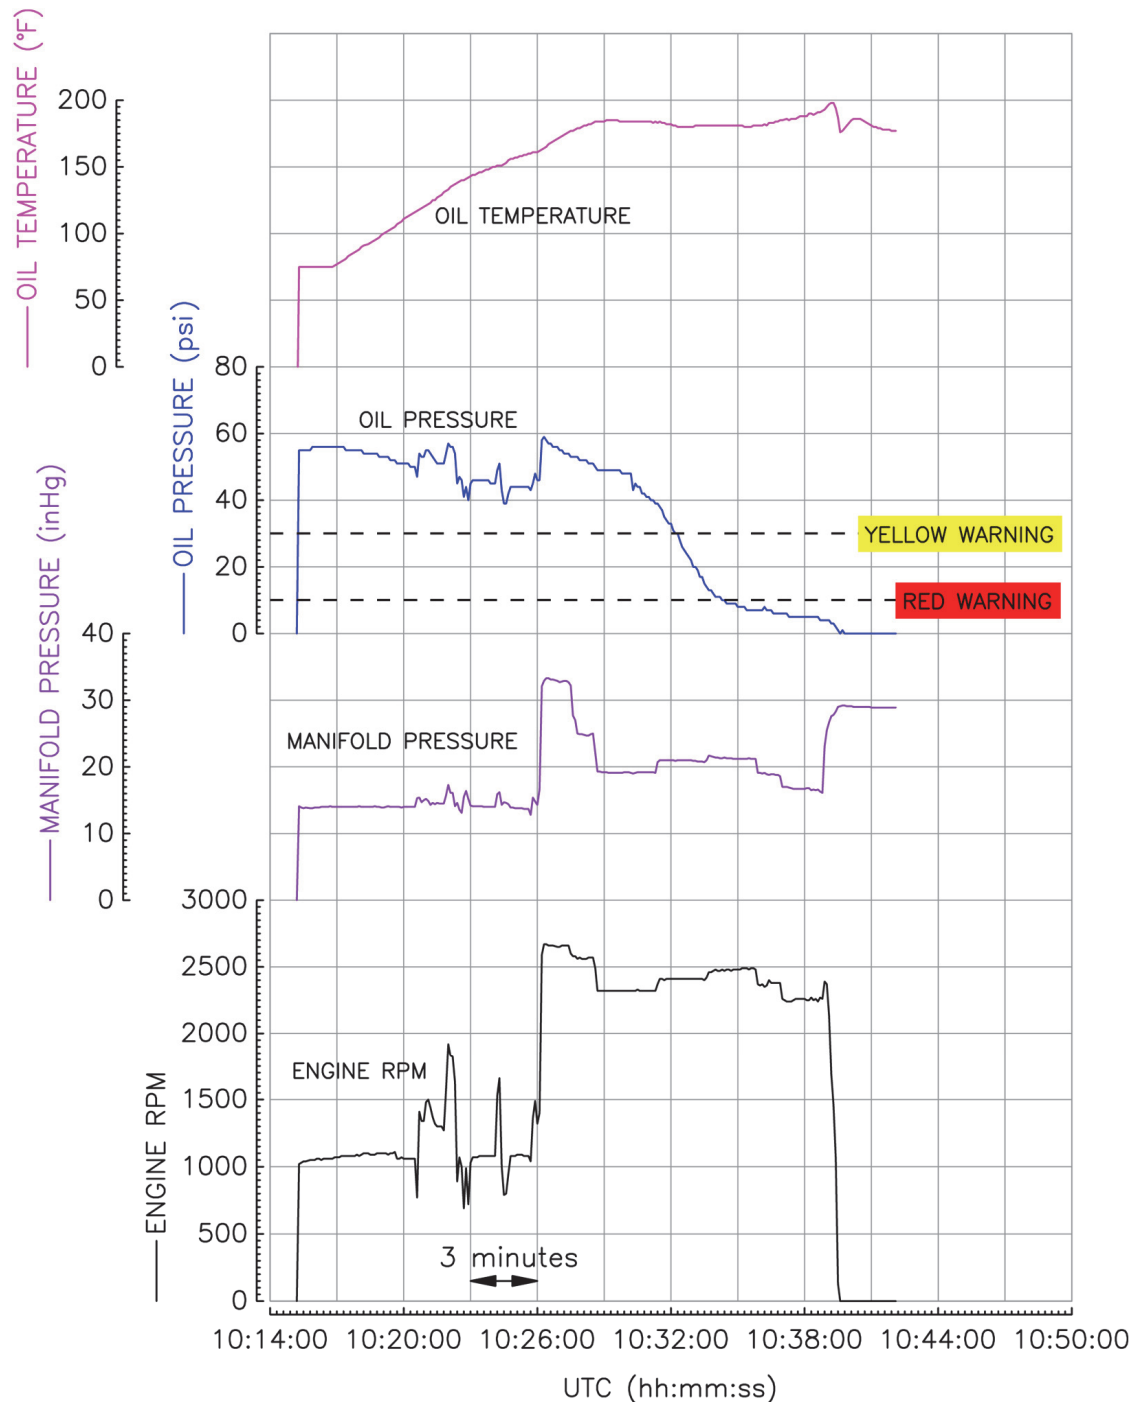
Figure 7
Engine data from accident flight

The engine data for the accident flight is plotted in Figure 7. The data shows that the engine had been running for 11 minutes before the rpm and MAP increased for takeoff. During this period the oil temperature rose progressively to 162°F and the oil pressure reduced to approximately 45 psi before peaking at 58 psi as the engine speed was increased to 2,670 rpm. Over the next 13 minutes, the oil temperature continued to increase, peaking at 198°F. Approximately 6 minutes after the start of the takeoff run, the oil pressure reduced to 30 psi (yellow warning) and 2 minutes later reduced to 10 psi (red warning). The engine stopped rotating approximately 13 minutes after the takeoff run commenced. During the flight the CHTs peaked at 346°F, and the EGTs at 1,436°F.

Apart from the reducing oil pressure, all the parameters indicate that the engine was operating normally until 30 seconds before the engine stopped, when the EGTs started to decrease. The engine data for the four flights prior to the accident flight appeared to be normal with the oil pressure remaining at around 50 psi during the cruise. The oil temperature during the previous flights peaked at between 184°F and 195°F; on the accident flight the oil temperature peaked at 198°F.

The engine data indicates that the rise in temperature at the connecting rod bearings, and subsequent failure of the cap bolts, occurred over a short period of time and before there was sufficient heat transfer from the crankshaft to affect the temperature of the oil in the engine sump where the temperature sensor is located.

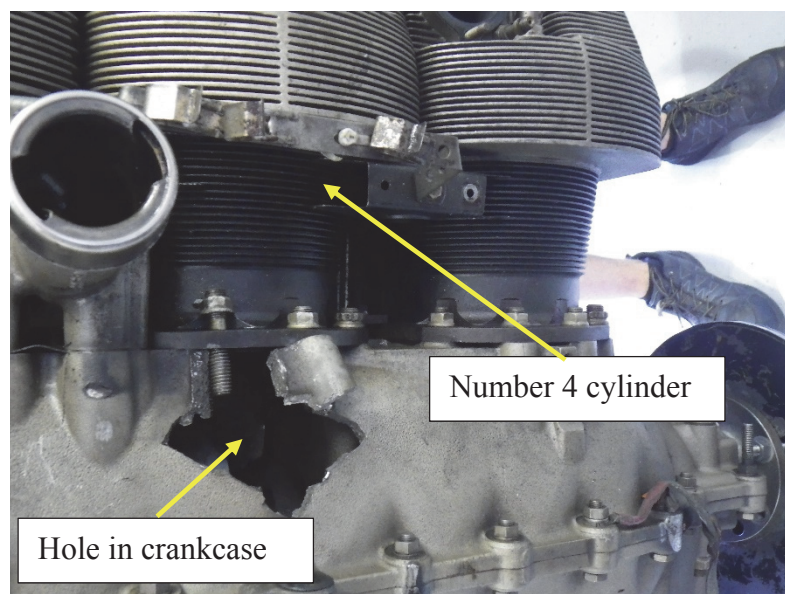
Figure 9

The bearing caps on the No 3 and No 4 piston connecting rods had become disconnected. Damage to the No 4 connecting rod indicated that it had then been struck by the crankshaft with sufficient force for it to knock a hole approximately 10 cm by 8 cm in the crankcase beneath the No 4 cylinder (Figure 9).

Hole in the crankcase caused by the No 4 connecting rod

Apart from the oil that had been lost through the hole in the crankcase, caused by the failed No 4 connecting rod, there was no other evidence of the engine having sustained an oil leak during the accident flight. Nor was there any evidence that the engine had been burning oil.

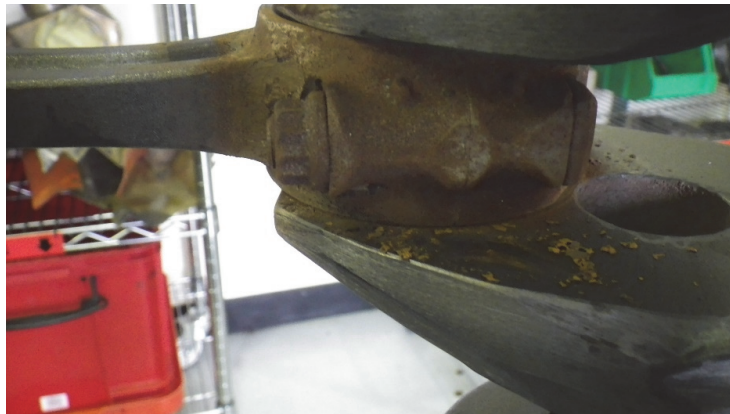
Figure 10

The No 2 piston connecting rod was seized on the crankshaft and the No 5 piston connecting rod was partially seized. The No 1 and No 6 connecting rods rotated normally. Except for the No 1 connecting rod, there was discoloration and corrosion on the bottom part of all the connecting rods, which was greatest on the inner four connecting rods (Figure 10). The bearing material on all the overheated connecting rods had extruded out of the bearing caps leaving the connecting rods running on the steel shells. There was no evidence that any of the bearings had rotated in their journals.

Corrosion and discoloration on connecting rod and bearing cap

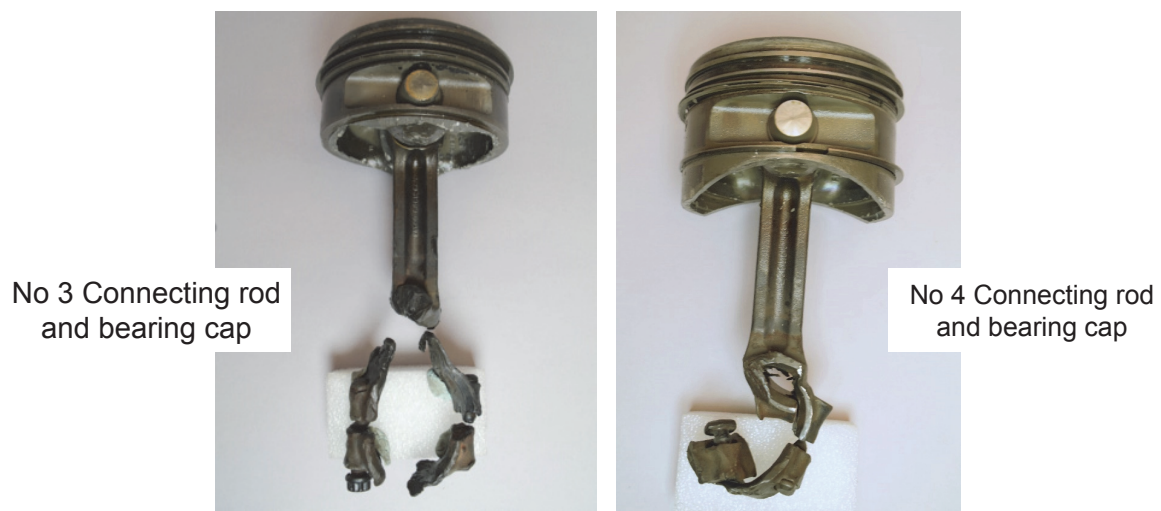
Figure 11

The bottom of the No 3 connecting rod and bearing cap had broken into four parts and the remnants of the bolts exhibited failure in overload. The skirt on the piston had also broken off (Figure 11). The No 4 bearing cap was intact, and distorted, and had separated from the connecting rod. The parts of the two bolts that remained in the bearing cap also exhibited necking associated with failure in overload.

Damage to No 3 and No 4 connecting rod and bearing caps

The parts had been badly damaged and based on the evidence available they concluded that the main bearings on the No 3 and 4 connecting rods had overheated sufficiently to cause the bearing material to melt and the strength of the steel bolts to reduce such that they failed in overload.

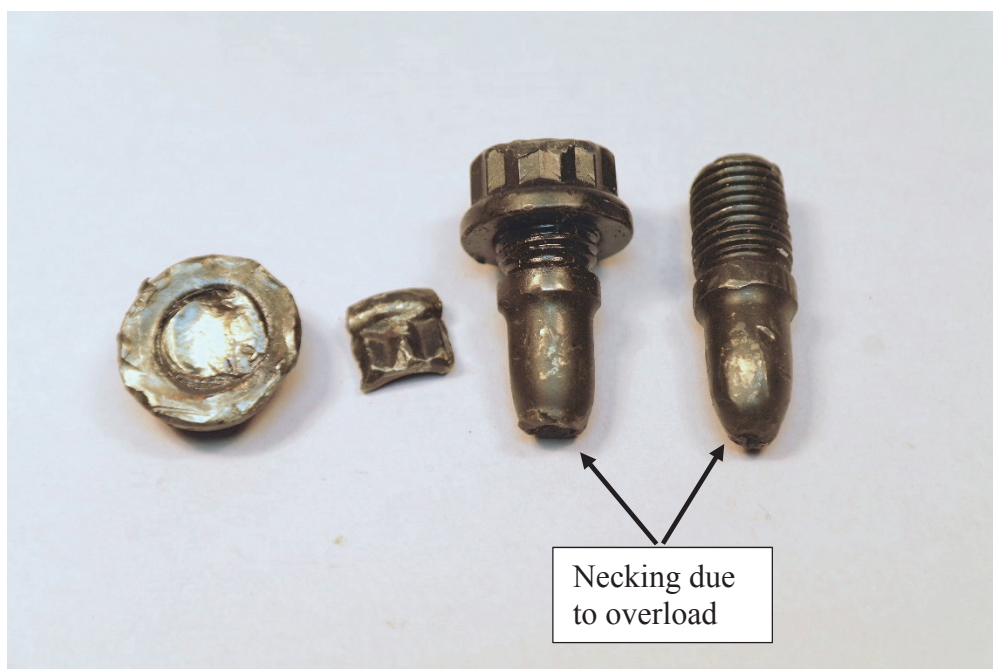
Figure 12

Parts of two bolts, that had failed in overload, a nut containing part of a bolt that had failed in shear and a broken part of a nut were found in the engine (Figure 12).

Parts of failed nuts and bolts recovered from the engine
