ACCIDENT

Aircraft Type and Registration:	ERJ 190-200 LR (Embraer 195), G-FBEJ	
No & Type of Engines:	2 General Electric Co CF34-10E7 turbofan engines	
Year of Manufacture:	2007 (Serial no: 19000155)	
Date & Time (UTC):	28 February 2019 at 0745 hrs	
Location:	Exeter Airport, Devon	
Type of Flight:	Commercial Air Transport (Passenger)	
Persons on Board:	Crew - 5	Passengers - 100
Injuries:	Crew - 1 (Minor)	Passengers - 1 (Serious)
Nature of Damage:	None	
Commander's Licence:	Airline Transport Pilot's Licence	
Commander's Age:	61 years	
Commander's Flying Experience:	13,211 hours (of which 3,069 were on type) Last 90 days - 77 hours Last 28 days - 15 hours	
Information Source:	AAIB Field investigation

Synopsis

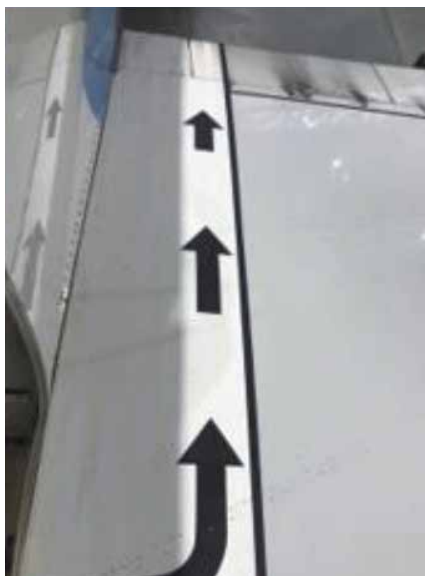
Figure 1

Passengers evacuating via the overwing exits reported that once out on the wing, there was confusion as to how they should get off the wing down to the ground. Passengers still in the cabin reported that this led to a bottle-neck forming around the overwing exits. Two passengers who evacuated via the left overwing exit were able to jump down from the wing and assist other passengers to the ground. Despite this, several passengers commented that it was a very long drop to the ground and some landed awkwardly, sustaining minor injuries. Many of the passengers who exited via the overwing exits commented that the wing surface was "very slippery" and one fell over resulting in a minor injury. The overriding comment from those who had exited via the overwing exits was that it was not obvious to them that they were meant to climb off the wing via the trailing edge and some re-entered the cabin to find an alternative exit route. A 61 cm-wide walkway was demarcated at the wing root in black paint, with arrows pointing towards the trailing edge (Figure 1). None of the passengers mentioned noticing this, but several did mention a lack of instructions, support or guidance once they were out on the wing.

Overwing exit escape route markings on E195 (view towards wing trailing edge)

Despite the presence of a marked exit route on the wing with a non-slip surface, many passengers who exited via the overwing exits reported being uncertain where to go once out of the aircraft. None of them mentioned noticing the marked walkway on the wing. The evacuation took place during daylight hours with good visibility. As noted in the RAeS paper, overwing exit route markings are not always readily identifiable and may be even less so in darkness. Poor weather conditions or the presence of smoke could also hinder identification of an exit route.

It is recommended that the European Union Aviation Safety Agency amends the certification requirements relating to the design, contrast and conspicuity of overwing exit escape route markings on commercial air transport aircraft, to ensure that the route to be taken from wing to ground is immediately apparent to evacuating passengers, in a range of emergency scenarios.

It is recommended that the Federal Aviation Administration amends the certification requirements relating to the design, contrast and conspicuity of overwing exit escape route markings on commercial air transport aircraft, to ensure that the route to be taken from wing to ground is immediately apparent to evacuating passengers, in a range of emergency scenarios.

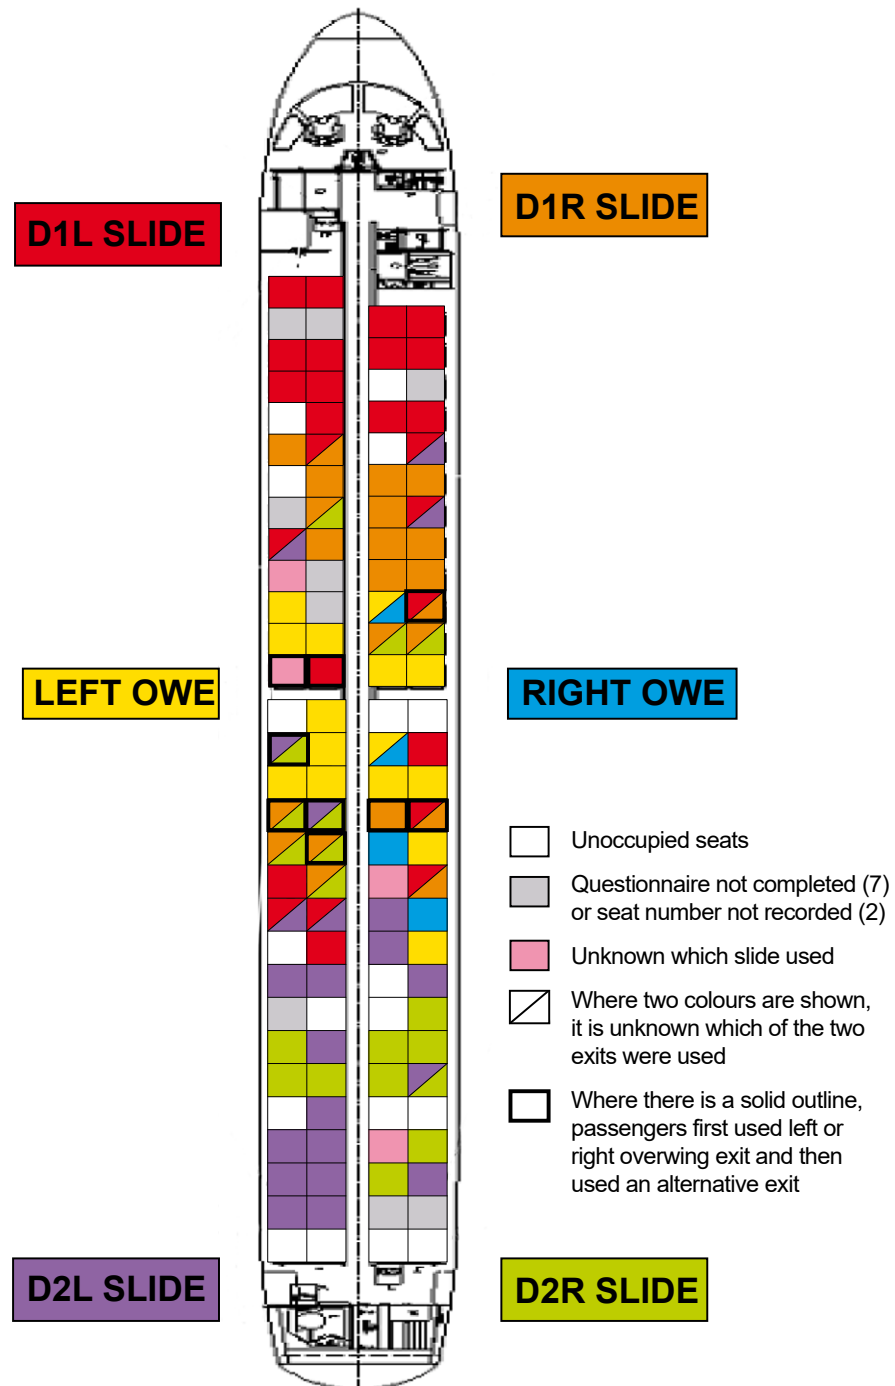
Figure 2

Evacuation routes used by passengers, correlated by seat position

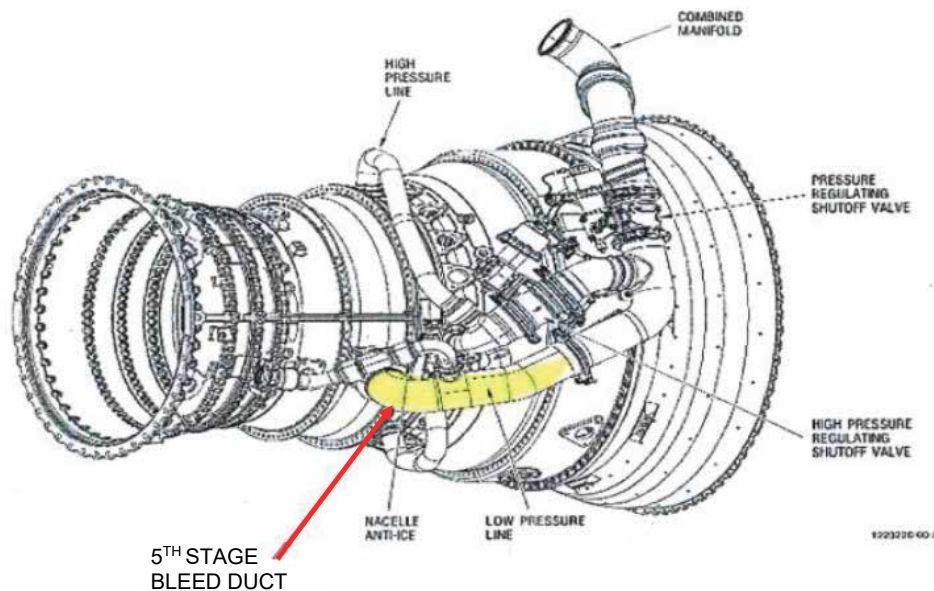
Figure 6

At low engine power settings engine bleed air is extracted from the ninth stage of the HPC while at high engine power settings, bleed air is extracted from the fifth stage of the HPC. The purpose of reaching 65 % N1 during the engine dry-out ground run is so that the engine speed is high enough that the ECS bleed source has switched to HPC fifth stage bleed, so that the fifth stage bleed ducts are dried out. A further caution states:

Engine schematic showing location of high pressure compressor fifth stage bleed duct

During the engine dry-out procedure following the compressor wash, the engines were run only at idle power. At idle power the engine power setting would have been insufficient for the engine bleed source to switch to the HPC fifth stage bleed. To dry out the fifth stage bleed ducts, the procedure recommended running the engine up to 65% N1. By not performing a high-power engine ground run, residual cleaning solution remained within the fifth stage bleed ducts.

In June 2020, the engine manufacturer updated ESM subtask 72-00-00-410-004 to require, rather than recommend, that a high-power engine dry-out run is conducted after a compressor wash using detergent.
