INCIDENT

Aircraft Type and Registration:	Airbus A321-231, G-WUKG	
No & Type of Engines:	2 International Aero Engine V2533-A5 turbofan engines	
Year of Manufacture:	2018 (Serial no: 8236)	
Date & Time (UTC):	16 January 2020 at 1925 hrs	
Location:	London Luton Airport, Bedfordshire	
Type of Flight:	Commercial Air Transport (Passenger)	
Persons on Board:	Crew - 7	Passengers - 157
Injuries:	Crew - None	Passengers - None
Nature of Damage:	None	
Commander's Licence:	Airline Transport Pilot's Licence	
Commander's Age:	32 years	
Commander's Flying Experience:	8,305 hours (of which 5,175 were on type) Last 90 days - 97 hours Last 28 days - 42 hours	
Information Source:	Aircraft Accident Report Form submitted by the pilot

Synopsis

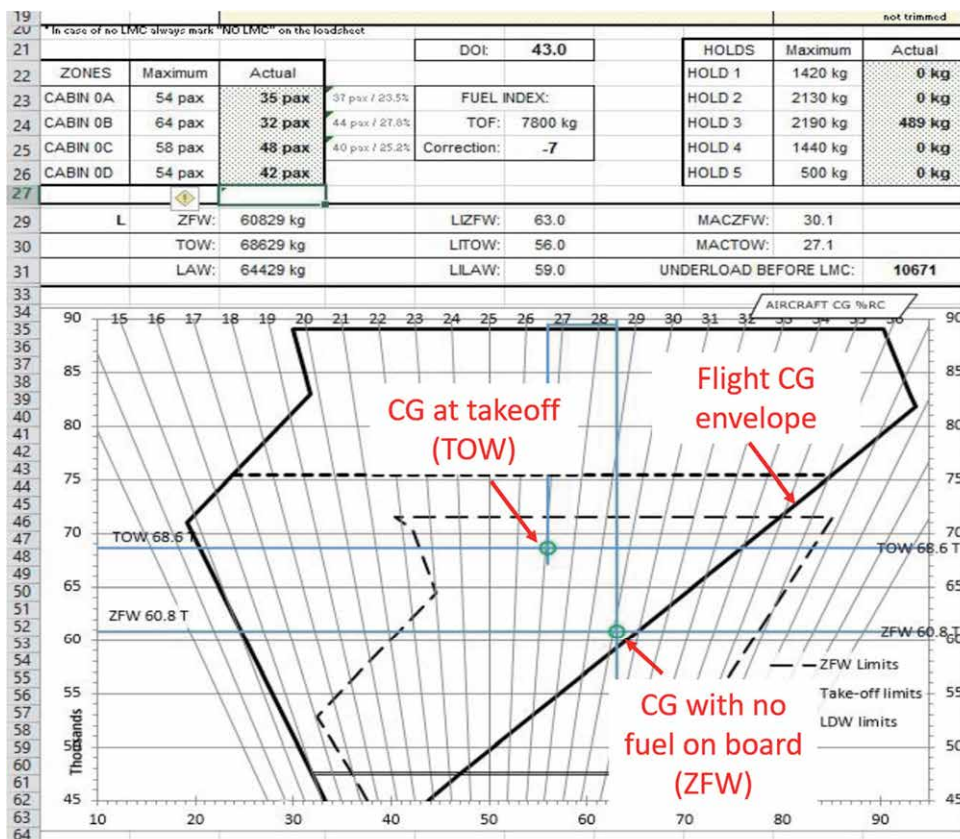
On the day of the incident, an A320 was allocated to the flight and this information was passed to OHD and PSD at Luton. Both departments received the information and began their respective activities towards producing a Load and Trim Sheet and checking in the passengers for an A320. Later, the OCC needed to change aircraft from the A320 to G-WUKG, an A321. An email informing OHD and PSD of the change was prepared but, due to a technical problem, was not sent. This was noticed later in the day, at 1405 hrs, and the OCC Duty Manager telephoned the OHD and informed them of the aircraft change. The OHD entered the new aircraft registration into the Load and Trim Sheet software but PSD were not informed and had already allocated passenger seating for the three passenger zones on the original A320. When all the passengers had passed through the boarding gate and taken their allocated seats for the A320, the software produced a Load and Trim Sheet with passenger distribution for the four zones of the A321, maintaining the CG within limits for the flight. This sheet was passed to the flight crew and is shown below at Figure 1.

Figure 1
The Load and Trim Sheet as calculated but not as loaded

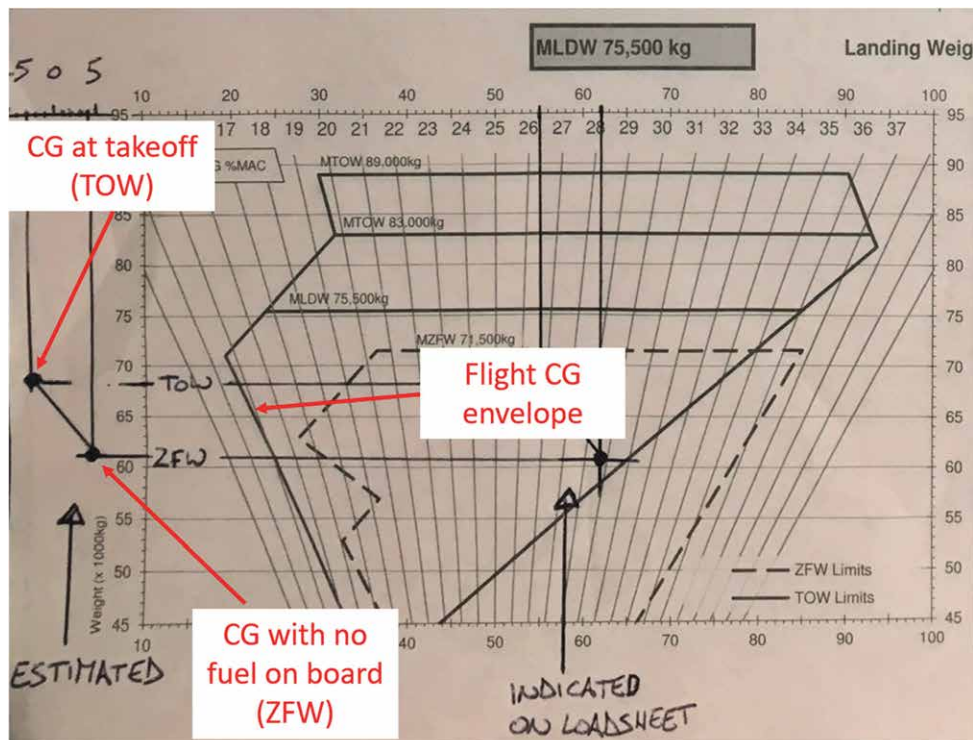
Figure 2

After the incident, the commander completed a Load and Trim sheet using the passenger seating allocation for the A320, but with the passengers seated in those seating positions in G-WUKG. The result, shown in Figure 2, shows that the total passenger weight was forward in the cabin placing the aircraft CG outside the permitted envelope.

The A321 Load and Trim Sheet that would have resulted on the incident flight

The incident occurred due to the aircraft change from an A320 to an A321 not being notified to both OHD and PSD. As a result, the passengers were seated at the front of the aircraft, placing the CG outside the forward limit of the operating envelope. The effect of this was that, at rotation, the aircraft appeared to the crew not to respond as expected to the normal side stick control inputs due to the forward CG. The PF required almost maximum aft control input and the PM selected TOGA thrust before the aircraft nose lifted. The crew analysed the problem but considered that an incorrect stabiliser setting, taken from the load sheet, had caused the problem. Only at the top of the descent for the destination did it become apparent that the passengers had possibly been incorrectly distributed in the cabin. The crew did not experience any unusual control response during the approach and landing.

- Improve the passage of information between the OCC and the flight crew when a change of aircraft variant takes place.
- Improve Ground Handling Agents' awareness of the implications of a change in aircraft variant.
- Distribute and make highly visible to all staff briefing material on this incident.
- Include any variant change at the flight and cabin crew briefing.
- Provide additional training for cabin crew on weight and balance distribution and its affects.
- Produce a Safety Bulletin to provide staff with a more detailed description of the incident.
- Issue a Crew Order (change to Operations Manual Part A) with enhanced awareness and guidance if suspicion is raised onboard.
