ACCIDENT

Aircraft Type and Registration:	1) DHC-8-402, G-JECK 2) EMB-145EP, G-SAJS
No & Type of Engines:	1) 2 Pratt & Whitney Canada PW150A turboprop engines 2) 2 Allison AE 3007/A1/1 turbofan engines
Year of Manufacture:	1) 2005 (Serial no: 4113) 2) 2001 (Serial no: 145390)
Date & Time (UTC):	16 June 2020 at 1646 hrs
Location:	Aberdeen International Airport
Type of Flight:	1) Commercial Air Transport (Non-Revenue) 2) N/A
Persons on Board:	1) Crew - 2 Passengers - None 2) Crew - None Passengers - None
Injuries:	1) Crew - None Passengers - N/A 2) Crew - N/A Passengers - N/A
Nature of Damage:	1) Damage to forward fuselage section and windscreen 2) Right engine nacelle dented
Commander's Licence:	1) Airline Transport Pilot's Licence 2) N/A
Commander's Age:	1) 31 years 2) N/A
Commander's Flying Experience:	1) 2,677 hours (of which 2,518 were on type) Last 90 days - 0 hours Last 28 days - 0 hours 2) N/A
Information Source:	Aircraft Accident Report Form submitted by the pilot and additional enquiries by the AAIB

Synopsis

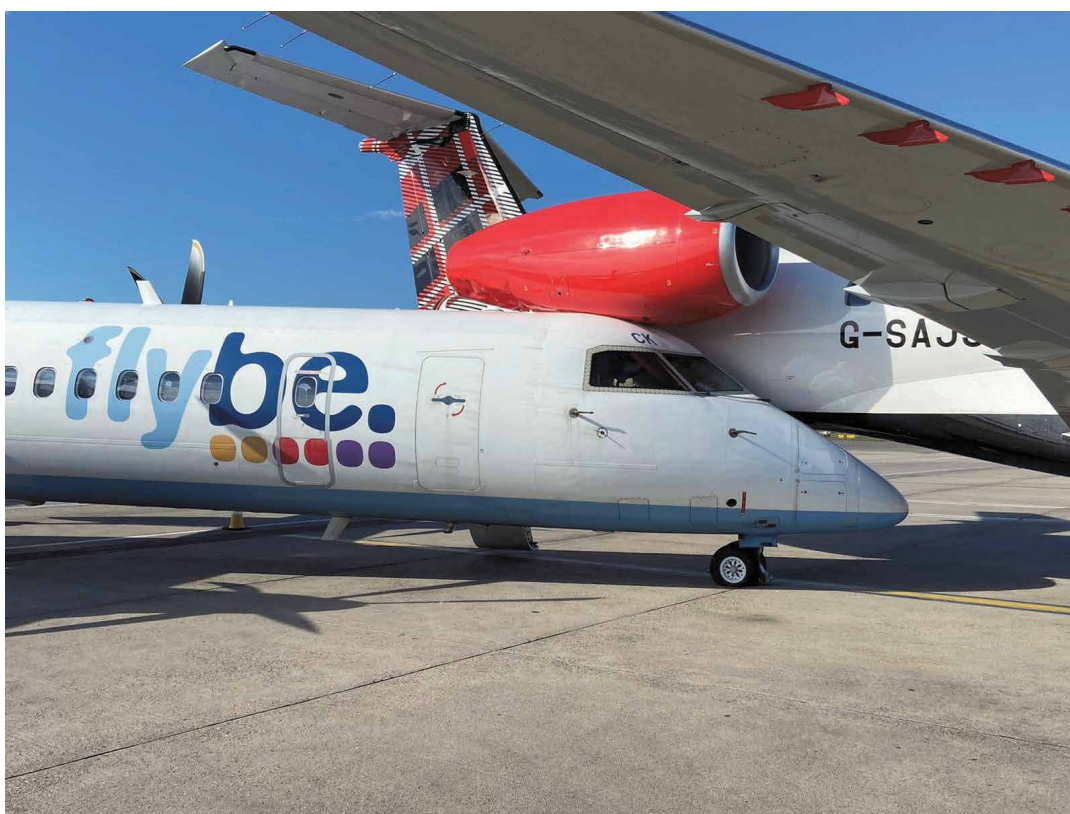
At a ground speed of about 5 kt, G-JECK struck the underside of G-Sajs's No 2 engine, causing its right landing gear to be lifted clear of the ground. G-JECK came to a stop with the No 2 engine of G-Sajs resting on top of its forward fuselage (Figure 2). There were no injuries. The pilots of G-JECK shutdown the aircraft and disembarked as the RFFS arrived.

Figure 2
G-JECK and G-Sajs

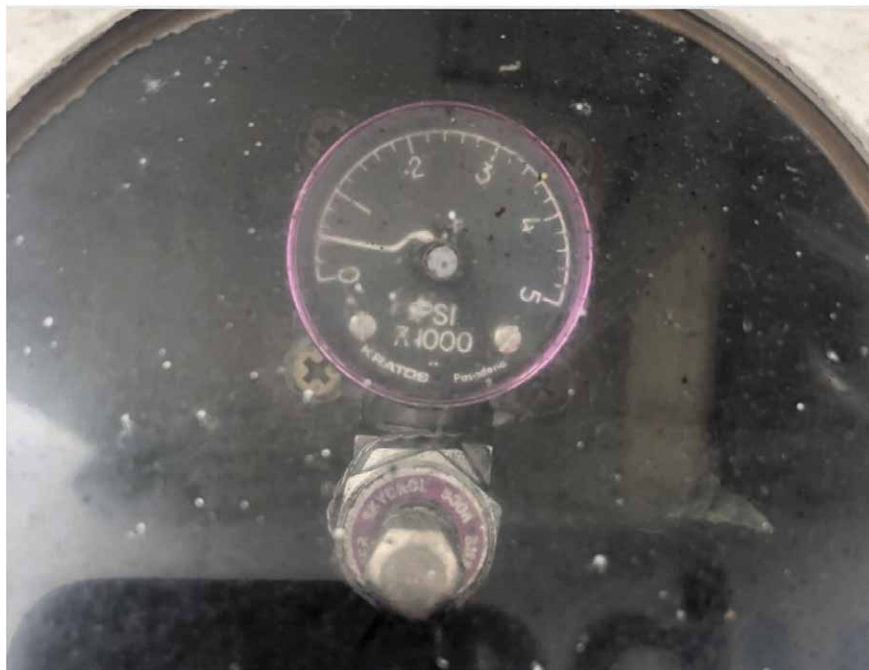
Figure 3

A photograph taken a few hours after the accident and before both aircraft were moved, showed that G-JECK's brake accumulator pressure was about 500 psi (Figure 3).

Brake accumulator pressure after the accident

The evidence from the pilots' walkarounds and photograph of the brake accumulator taken after the event, showed that the park brake hydraulic pressure could not have been more than the accumulator pre-charge pressure of about 500 psi. Therefore, to establish the hydraulic pressure in the park brake system it would have been necessary to have checked

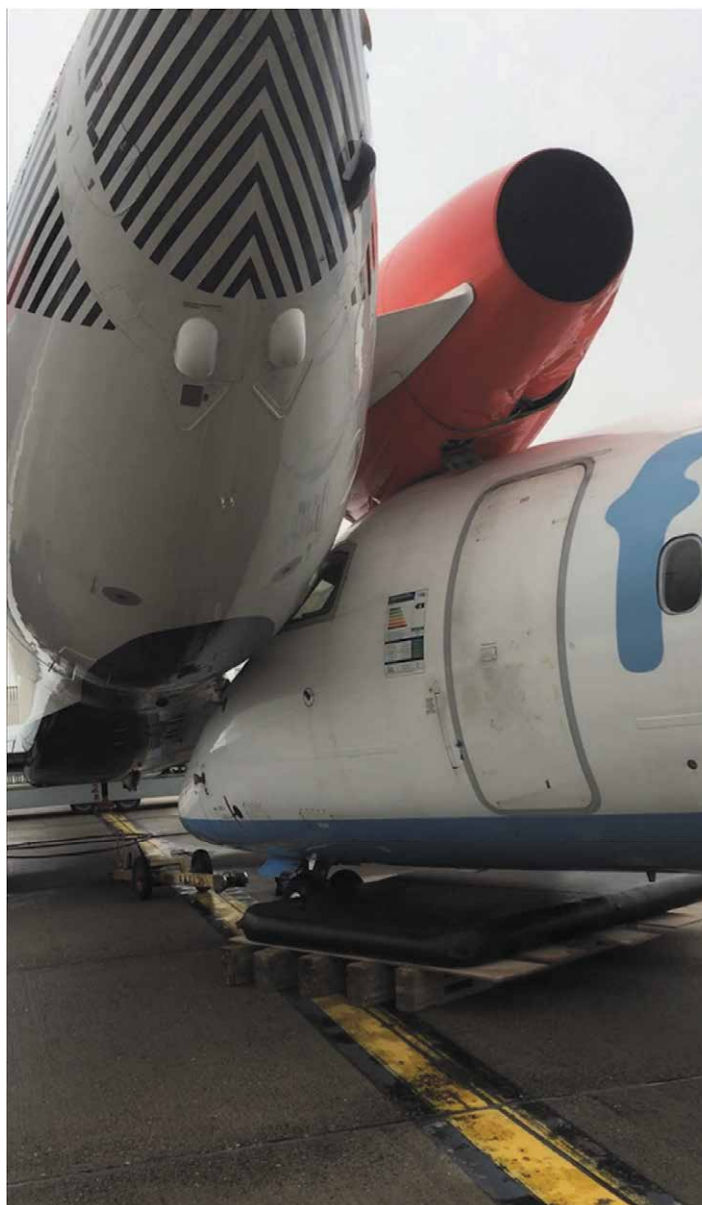
Figure 4

A specialist recovery team using airbags separated the aircraft (Figure 4). The upper fuselage skin, cockpit emergency escape hatch and cockpit window of G-JECK, and the No 2 engine nacelle of G-Sajs, were damaged.

G-JECK and G-Sajs during recovery

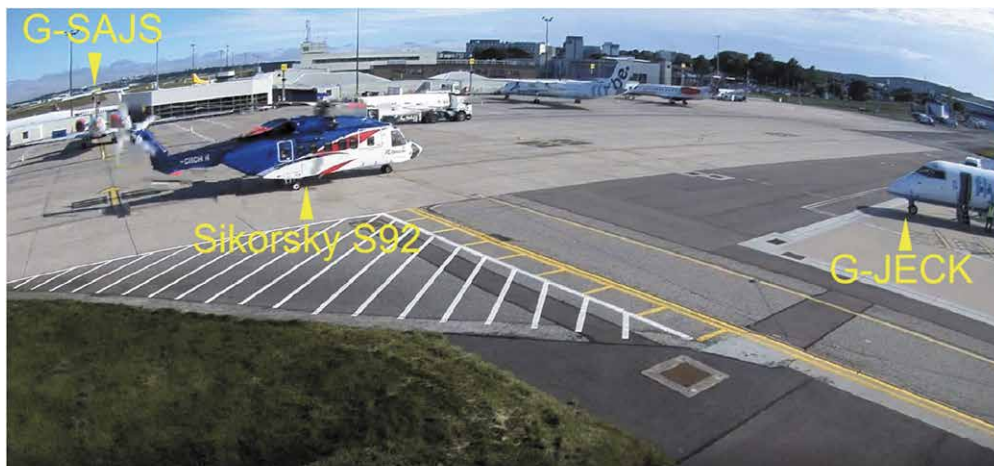
The recordings showed that at 1639 hrs a Sikorsky S92 helicopter had taxied past G-JECK, whilst a refuelling vehicle also manoeuvred nearby (Figure 6). At 1644:30 hrs, G-JECK started rolling forward. The aircraft's ground speed gradually started to increase and by 1645:23 hrs it had travelled about halfway across Taxiway D (Figure 7). At 1645:35 hrs, G-JECK struck G-SAJS (Figure 8) whilst travelling at a ground speed of about 5 kt.

Figure 6
Position of G-JECK and G-SAJS

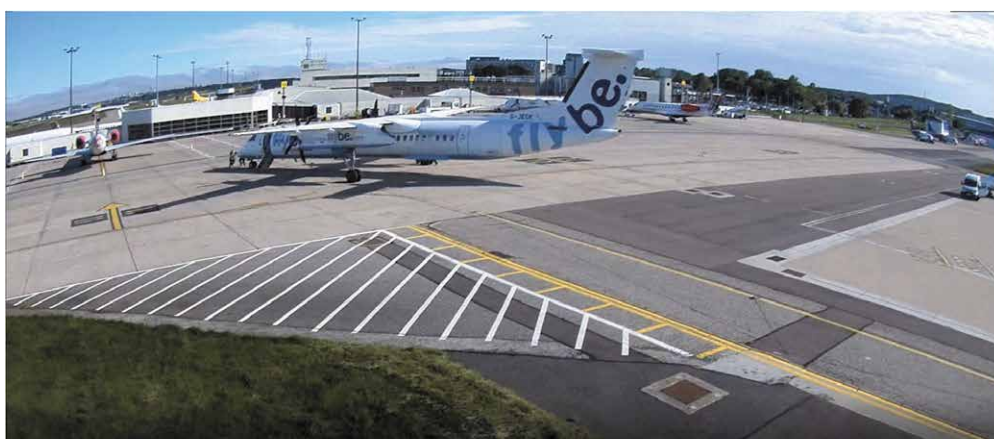
Figure 7
G-JECK as it rolled across Taxiway D

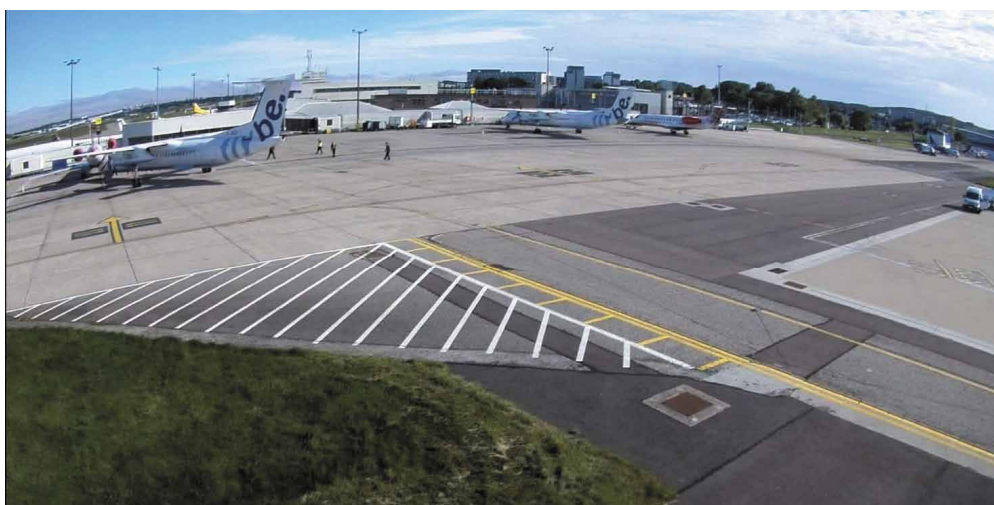
Figure 8
G-JECK as it collided with G-SAJS
