ACCIDENT

Aircraft Type and Registration:	Believer (UAS, registration n/a)	
No & Type of Engines:	2 electric motors	
Year of Manufacture:	2020 (Serial no: 3)	
Date & Time (UTC):	2 May 2020 at 1430 hrs	
Location:	Solent Airport, Hampshire	
Type of Flight:	Commercial Ops (UAS)	
Persons on Board:	Crew - N/A	Passengers - N/A
Injuries:	Crew - N/A	Passengers - N/A
Nature of Damage:	Destroyed	
Commander's Licence:	Not applicable	
Information Source:	Aircraft Accident Report Form submitted by the operator and additional enquiries made by the AAIB

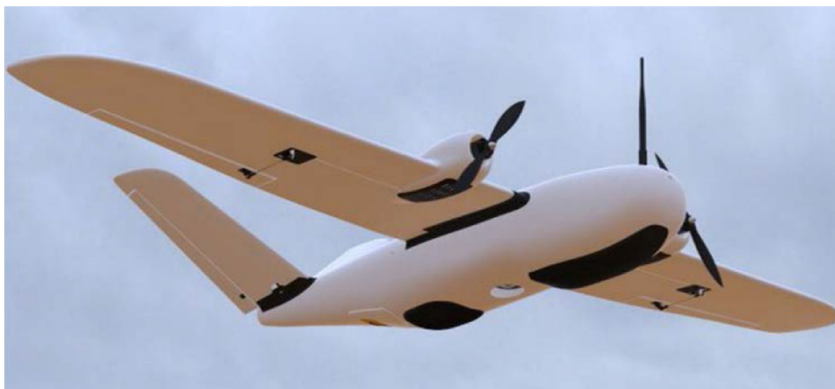
Figure 1

General view of the Believer UAS
