ACCIDENT

Aircraft Type and Registration:	Bell 206B3 Jet Ranger III, G-OPEN	
No & Type of Engines:	1 Allison 250-C20J turboshaft engine	
Year of Manufacture:	1994 (Serial no: 4300)	
Date & Time (UTC):	30 May 2018 at 1223 hrs	
Location:	Near Aldborough, North Yorkshire	
Type of Flight:	Private	
Persons on Board:	Crew - 1	Passengers - None
Injuries:	Crew - 1 (Fatal)	Passengers - N/A
Nature of Damage:	Aircraft destroyed	
Commander's Licence:	Private Pilot's Licence	
Commander's Age:	70 years	
Commander's Flying Experience:	255 hours (of which 224 were on type) Last 90 days - 0.5 hours Last 28 days - 0 hours	
Information Source:	AAIB Field Investigation

Synopsis

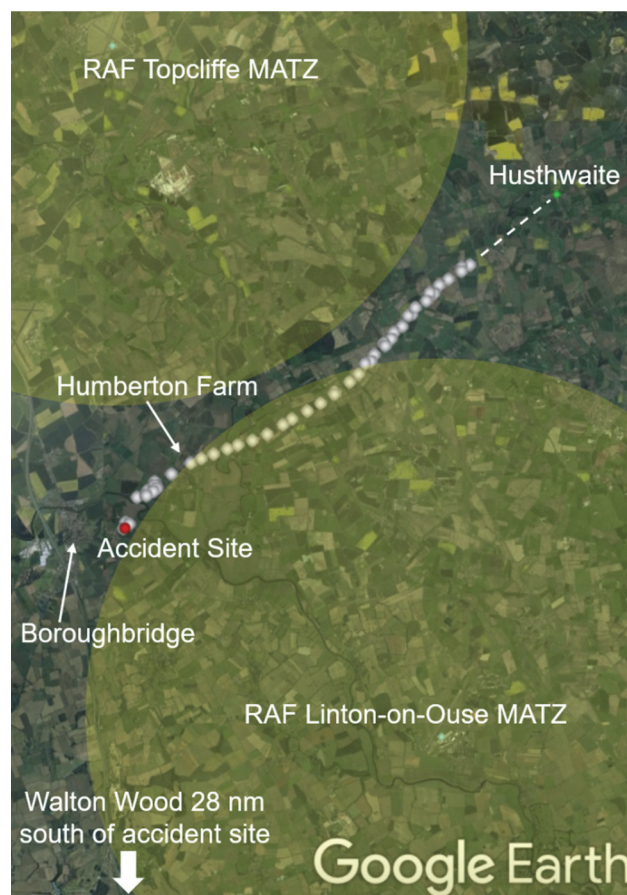
Figure 1

At 1218 hrs the pilot contacted RAF Linton-on-Ouse ATC and requested a Basic Service. He reported he had just lifted from a private site at Husthwaite, destination Walton Wood, and was routing via Boroughbridge flying through "the gap". He reported he was at an altitude of 700 ft. Linton ATC issued a squawk and provided a Basic Service. The radar track of the route flown (Figure 1) shows that the helicopter flew slightly left of the planned track and penetrated the Linton-on-Ouse MATZ.

Radar track of G-OPEN
(Map data: Google, Landsat / Copernicus)

In the last minute before the accident, radar shows the aircraft descending to 520 ft, climbing to 1,020 ft and then descending back to 520 ft and the ground speed reducing to below 30 kt. It is not known whether these were intentional or unintentional climbs and descents. These were not observed by any witnesses, so it is not known whether the helicopter entered cloud at this time. It is possible the pilot was experiencing a varying cloud base and was changing height to remain clear of cloud. If the pilot was experiencing reducing visibility it would be logical to reduce speed, so this may have been the reason for the reducing ground speed. Alternatively, the pilot may have been becoming disorientated in the challenging weather conditions and was not aware of the change in altitude. The radar trace shows the helicopter flew left of his intended route and entered RAF Linton-on-Ouse MATZ (Figure 1).

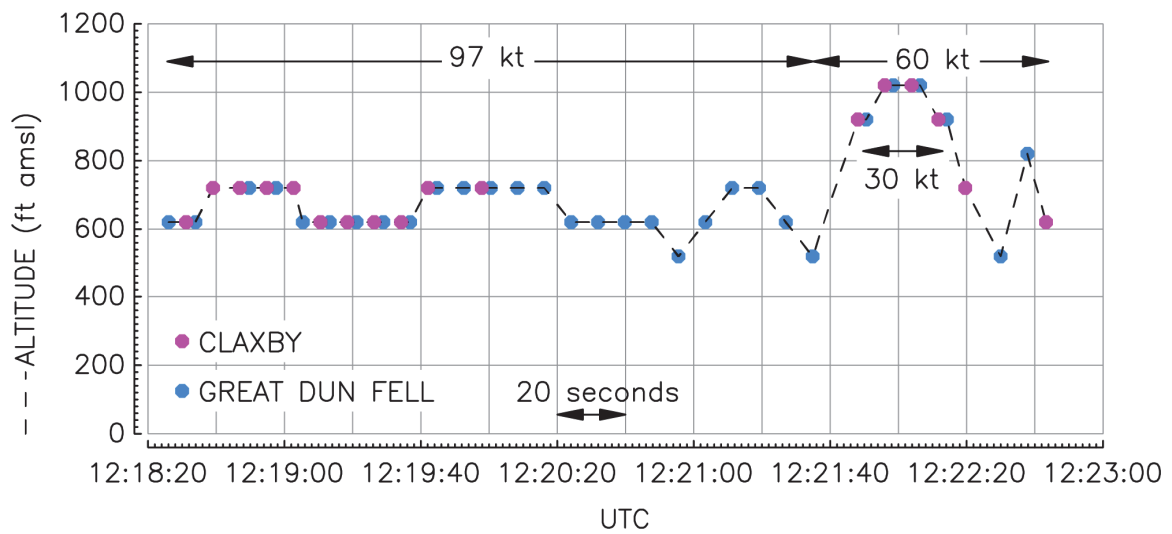
Figure 2

Secondary surveillance radar (SSR) returns from the helicopter were recorded for the flight starting 1.5 nm from the takeoff point and ending in the vicinity of the accident site. The returns included Mode C altitude information (rounded to the nearest 100 ft, ± 50 ft) and indicated that the helicopter flew between 520 and 720 ft amsl at an average groundspeed of 97 kt until approximately 1 nm from accident site (Figure 2).

At this point, just over one minute before the last recorded data point, the helicopter was at 520 ft amsl, before climbing to 1,020 ft amsl 16 seconds later. This equates to a climb rate of between 1,500 and 2,250 ft/min, given the ± 50 ft resolution of the altitude data. It then descended at a similar rate before climbing to over 800 ft amsl and descending again. The average groundspeed during these climbs and descents was approximately 60 kt. For the period the helicopter was above 920 ft amsl during the first climb the average groundspeed was 30 kt (these groundspeeds are highlighted in Figure 2).

SSR Mode C altitudes for accident flight with average groundspeed indicated (note that the ground height along the route varied from 130 ft at the start to 40 ft near the accident site)

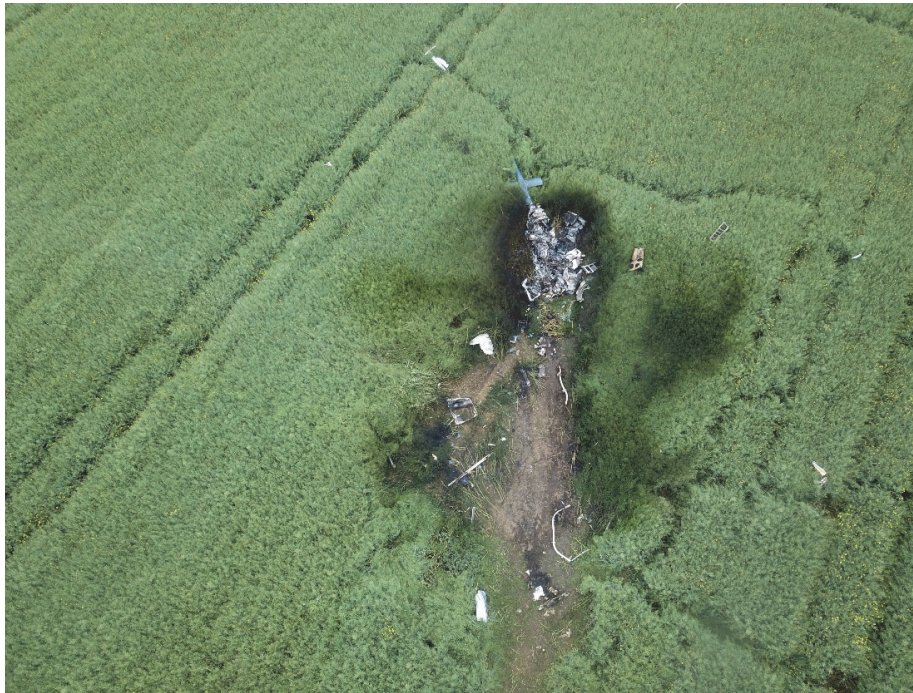
Figure 4

Cut marks in the standing crop provided evidence that both the main and tail rotors had been rotating at impact. One of the main rotor blades struck the ground, causing the main rotor assembly to separate from the airframe and the helicopter to become inverted. Both blades were found still attached to the rotor head, approximately 31 m beyond the main wreckage. One blade was largely intact. The other blade exhibited extensive damage and a 75 cm section at the blade tip was absent; this was found approximately 70 m from the main wreckage, having detached and travelled opposite to the helicopter's direction of flight when the blade struck the ground.

The post-impact fire consumed much of the fuselage, cockpit, flight controls and fuel system. The top of the cabin, the flying control components on the transmission deck, together with the engine, sustained crushing damage as a result of the helicopter becoming inverted.

Aerial view of the accident site

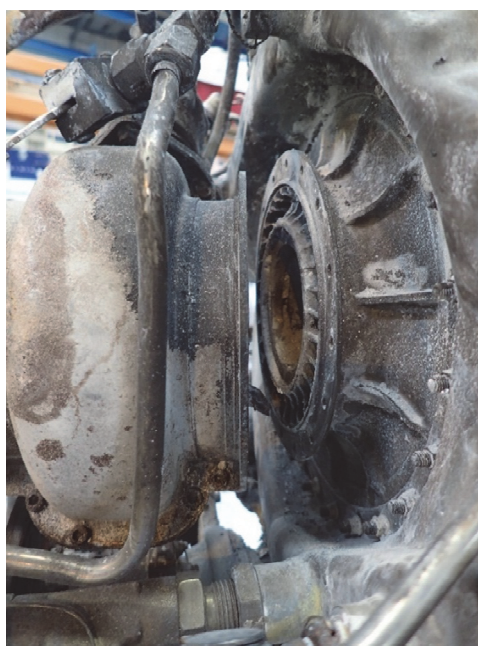
Figure 5

The compressor front support exhibited crushing damage and the axial portion of the compressor had separated from the centrifugal impeller shroud, remaining attached to the engine only by the oil and anti-ice supply and scavenge lines (Figure 5). None of the 16 attachment bolts were found at the accident site or recovered from the wreckage.

Axial compressor detached from impeller shroud

The axial compressor had separated from the impeller. It was concluded that bending loads arising from the impact damage sustained to G-OPEN's compressor front support housing caused the attachment bolts to fail, leading to separation of the axial compressor.

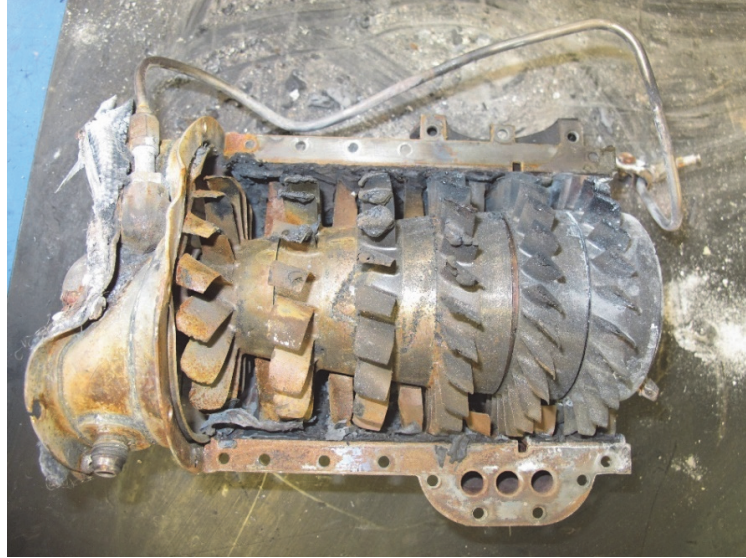
Figure 6

However, disassembly of the axial compressor showed distinct evidence of rotational damage; the rotor blades from the first three stages of the axial compressor were bent opposite the direction of travel (Figure 6) and all the stator vane stages were bent in the direction of travel (Figure 7). Additionally, the tie bolt was fractured into two pieces.

Axial compressor rotor blades

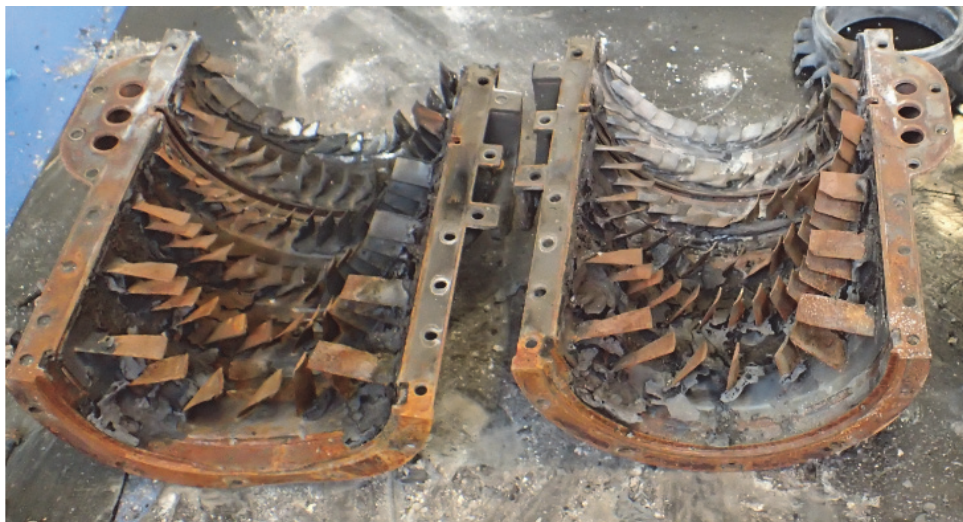
Figure 7

Axial compressor case halves and stator vanes

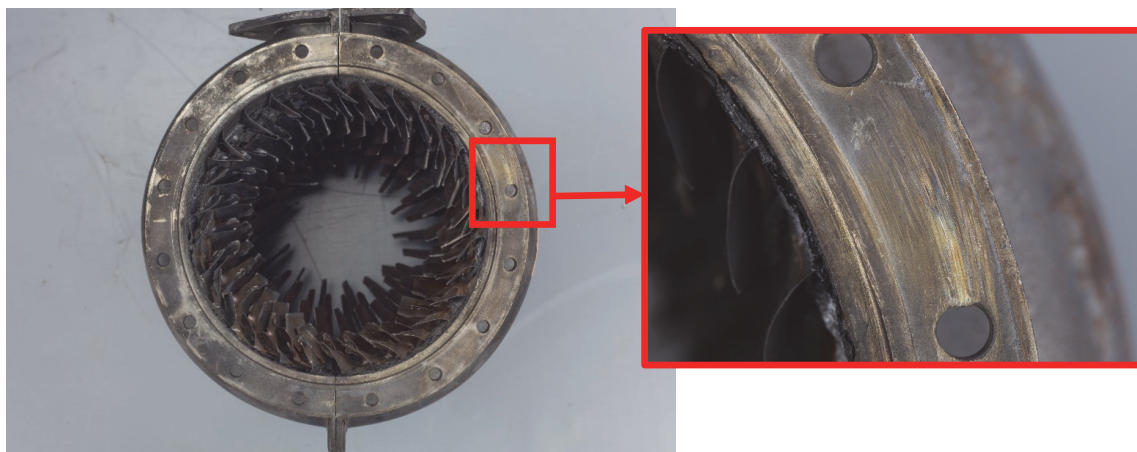
Figure 8

Laboratory examination of the axial compressor and impeller shroud attachment flanges identified bending deformation. The location and direction of this deformation indicated that it most likely resulted from the impact damage sustained at the forward end of the axial compressor. Mechanical damage adjacent to a number of the fastener holes, an example of which is shown in Figure 8, was consistent with fasteners being present in those holes at the time of impact.

Axial compressor case flange showing mechanical damage at one of the fastener locations
