ACCIDENT

Aircraft Type and Registration:	Piper PA-32R-301T Saratoga, N517FD	
No & Type of Engines:	1 Lycoming T10-540 SER Piston Engine	
Year of Manufacture:	2001 (Serial no: 3257263)	
Date & Time (UTC):	16 May 2018 at 1026 hrs	
Location:	Fair Isle Airfield, Shetland Islands	
Type of Flight:	Private	
Persons on Board:	Crew - 1	Passengers - 5
Injuries:	Crew - None	Passengers - None
Nature of Damage:	Right main landing gear partially collapsed, right stabilator bent and damage to lower rear fuselage	
Commander's Licence:	Commercial Pilot's Licence	
Commander's Age:	64 years	
Commander's Flying Experience:	3,372 hours (of which 2,270 were on type) Last 90 days - 90 hours Last 28 days - 50 hours	
Information Source:	Aircraft Accident Report Form submitted by the pilot

Synopsis

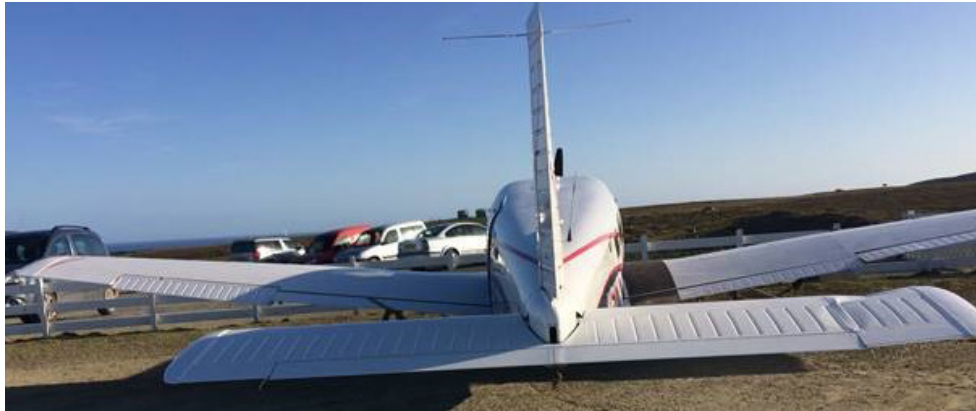
Figure 1

The aircraft slowly slid off the prepared surface before coming to rest on the adjacent rough ground, with the right main landing gear partially collapsed and the right rear fuselage resting on the ground. None of the occupants were injured and they were able to disembark normally. There was no evidence that the right wing had touched the surface but the rear horizontal tailplane, the stabilator, had been bent by ground contact (Figure 1).

N517FD after being moved to a parking area and with the right stabilator bent upwards
(Picture used with permission)
